Good Samaritan Hospital Clifton Avenue Garage

The Clifton Avenue Garage, built in 1966, is the oldest of three parking structures at Good Samaritan Hospital, Cincinnati, OH. It consists of one on-ground and three supported parking levels.

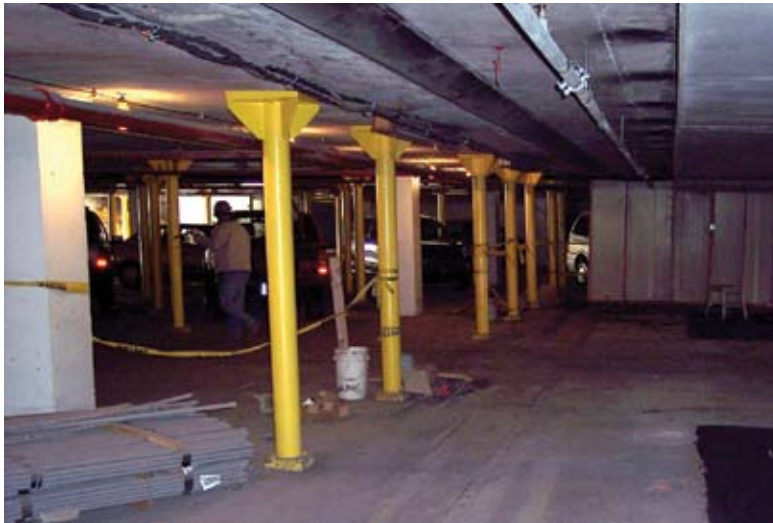
Repair project with shoring in place

During the performance of this work, the majority of the existing steel shoring remained in place. It was necessary, however, to remove specific pieces of this system and install temporary shores to access repair areas.

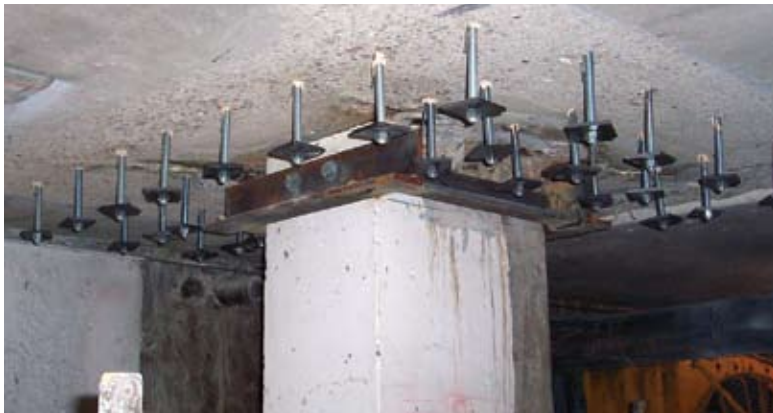
Typical repair around columns

- Concrete repairs occurred at existing slabs, columns, and walls. There was a heavy concentration of reinforcing steel in the slabs around columns that had experienced significant corrosion. Also, because the lift slabs were tied to the perimeter walls, restrained movement caused significant damage to wall and stair-tower elements;
- Although the basis of the new PT design assumed a nearly 100% long-term failure of the existing PT, efforts were nonetheless made to retain as much of the original PT system as was practical. Existing PT anchors adjacent to two of the stair towers were significantly corroded. At these

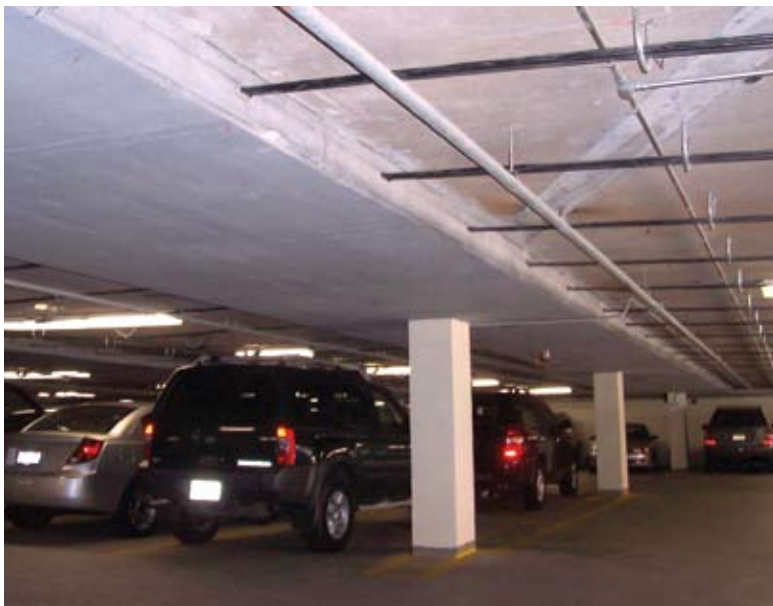
Completed parking bay

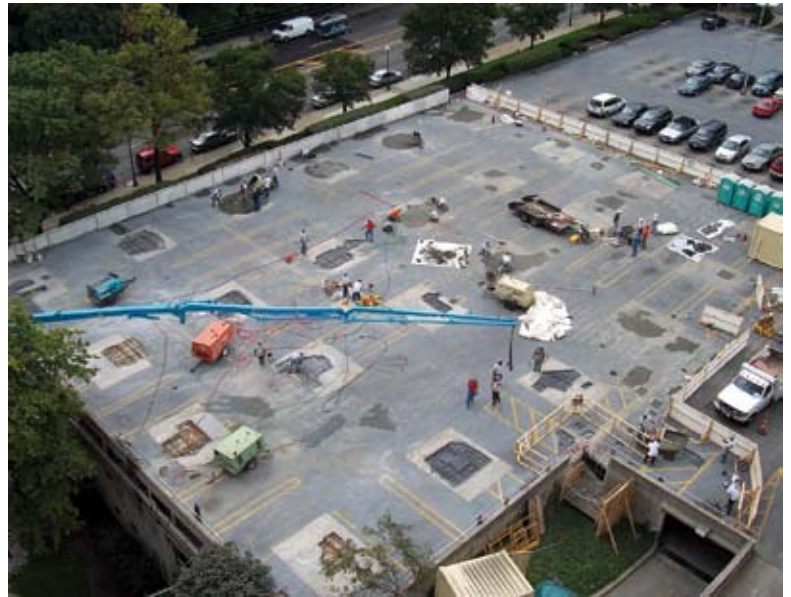
Top deck of garage during repairs

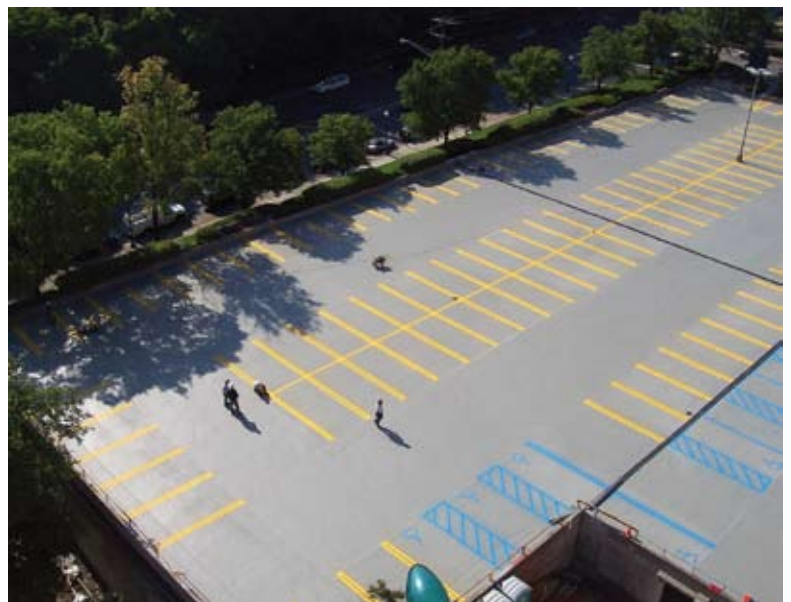
Top deck of garage after all repairs, deck coating, and striping

After structural repairs were completed, existing expansion joints on all levels were replaced with new winged compression seals. A new urethane deck coating system was installed on the intermediate levels and the roof level membrane was recoated.
