# Co-op City's Parking Deck Rehabilitation

## Co-op City Parking Deck

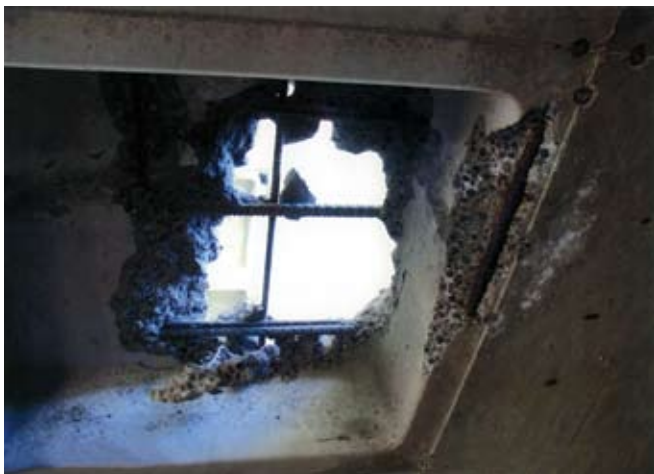
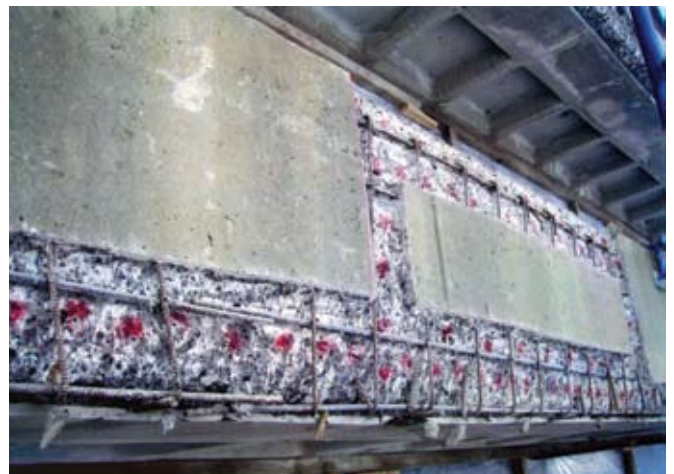
*Existing conditions before repair*

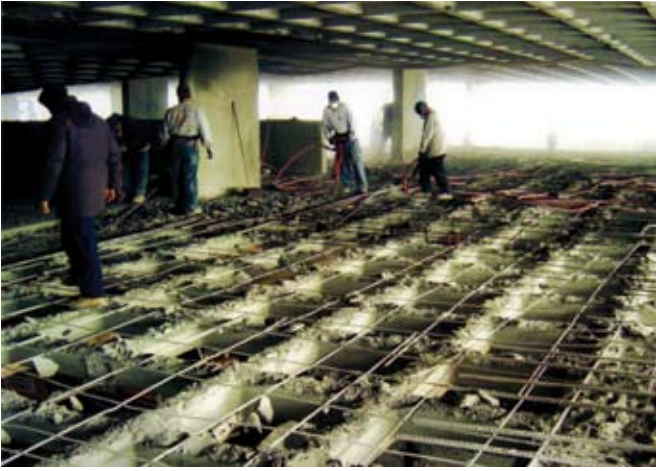
*Demolition of a top slab*

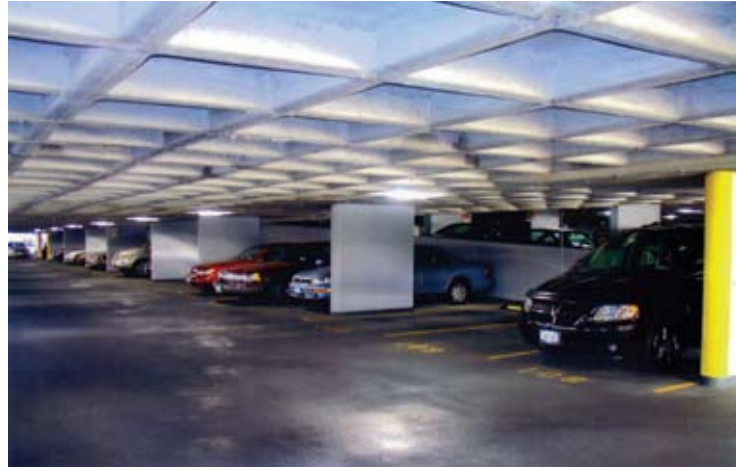
*A finished interior with new striping and wheel stops*

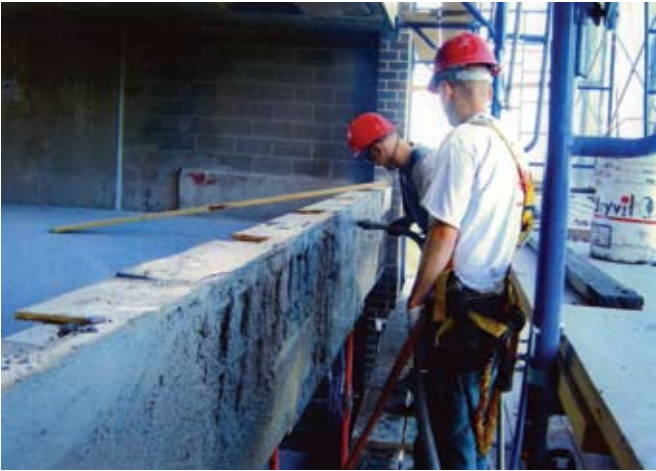
*Façade work and parapet patching*

At first, the contractor repaired the parapet walls by hand-patching. The material supplier came to the job site and demonstrated low-pressure spraying to apply repair mortar. The contractor realized that this method would improve the finished product by achieving a better bond and a denser patch. It would also make the repair process quicker. This is just one example of the teamwork between contractor, designer, owner, and manufacturer, leading to the success of this project.

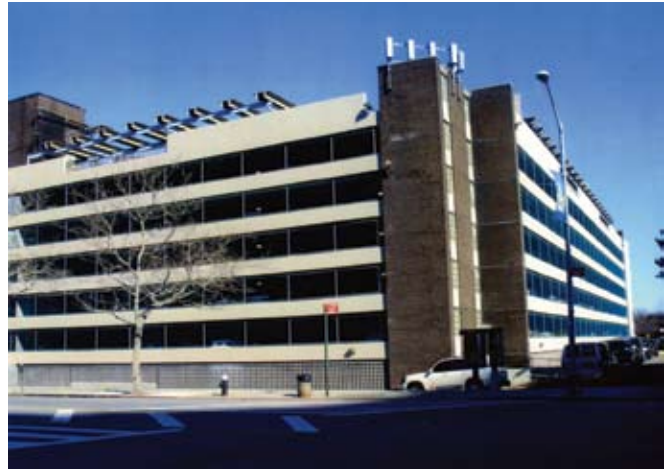
*A finished garage exterior*

The scope of this job was enormous. Besides the thousands of yards of concrete, there were approximately 50,000 50 lb (22.7 kg) bags of repair mortar used on this project. A combination of shotcrete and hand-patch mortar was used. After all the repairs were made, the outsides of the buildings were coated with a breathable acrylic coating. Approximately \$658,000 was spent in mortar and coatings alone.
