Fairview Hospital Parking Garage

The Fairview Hospital Parking Garage is a six-level, precast concrete parking garage (approximately 735 cars), built in 1975. The hospital is located in a residential area, so a very limited area is available for employee, patient, and visitor parking. The original parking garage construction consisted of precast concrete double-tees placed on precast columns and beams. A concrete topping was then installed over the precast tee units. Heavy use of deicing salts over the years,

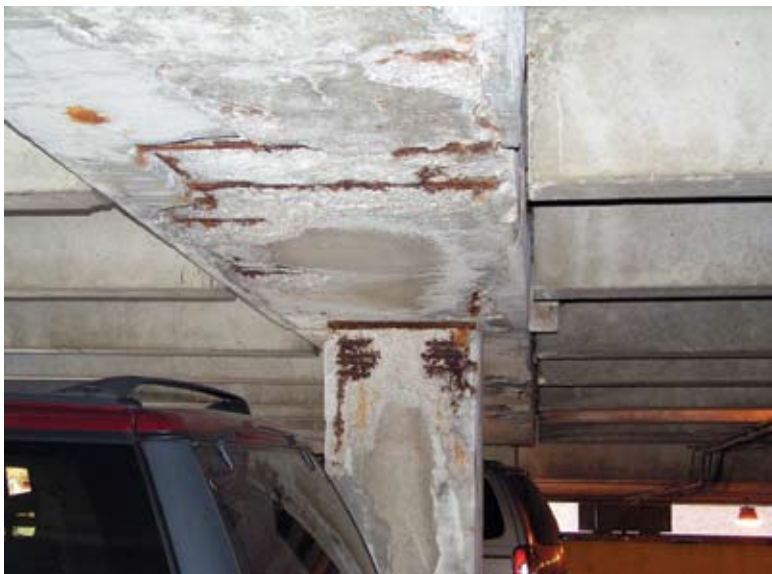
Column deterioration prior to repair

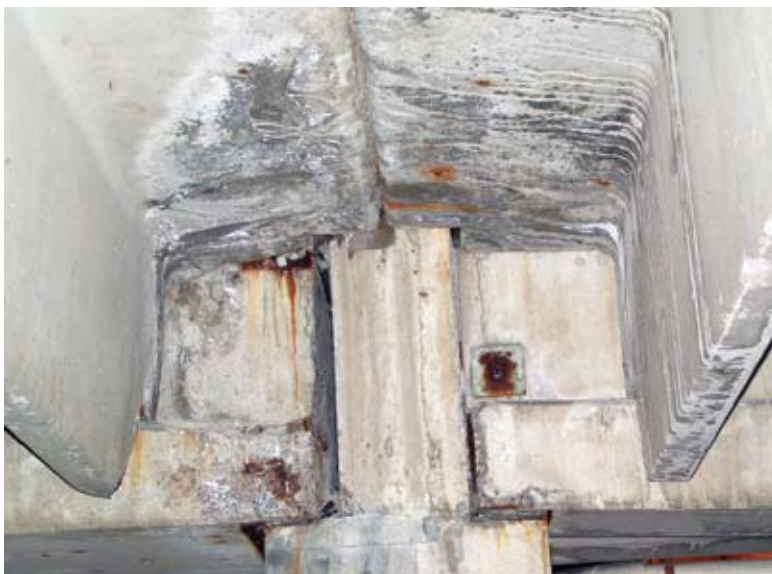
Double-tee deterioration prior to repair

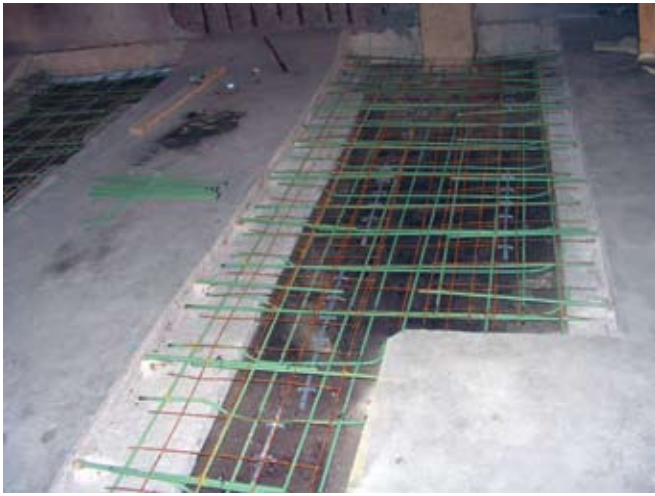
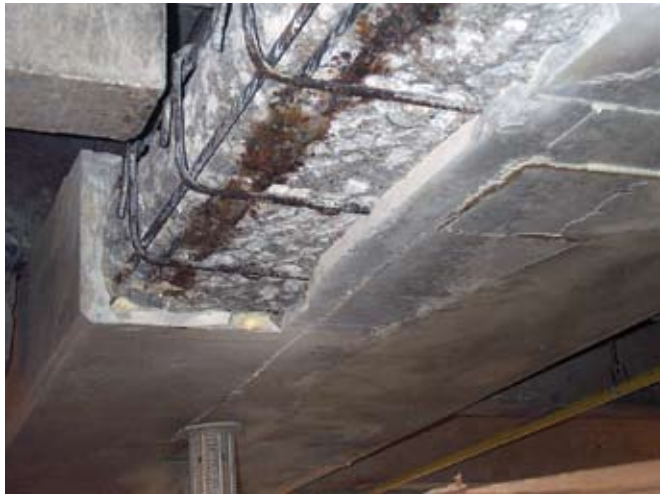
Deck surface preparation, and in some areas, full-depth repair Surface preparation of a beam

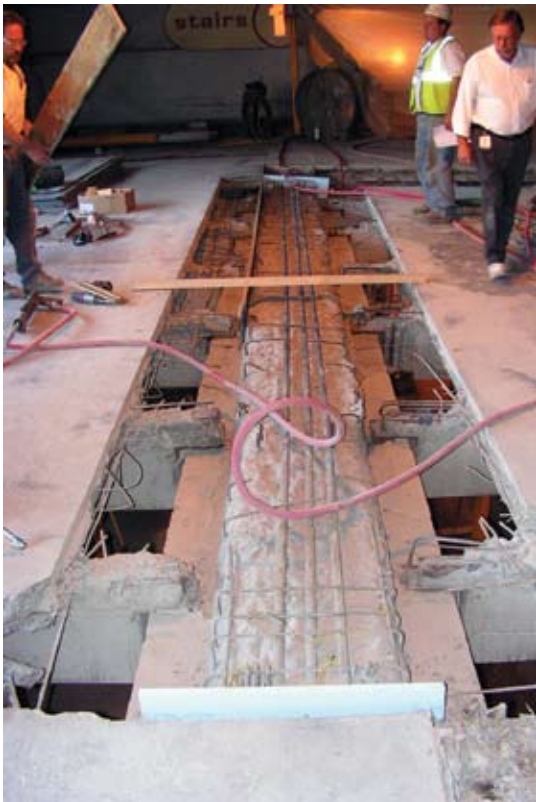
Preparation for full-depth replacement

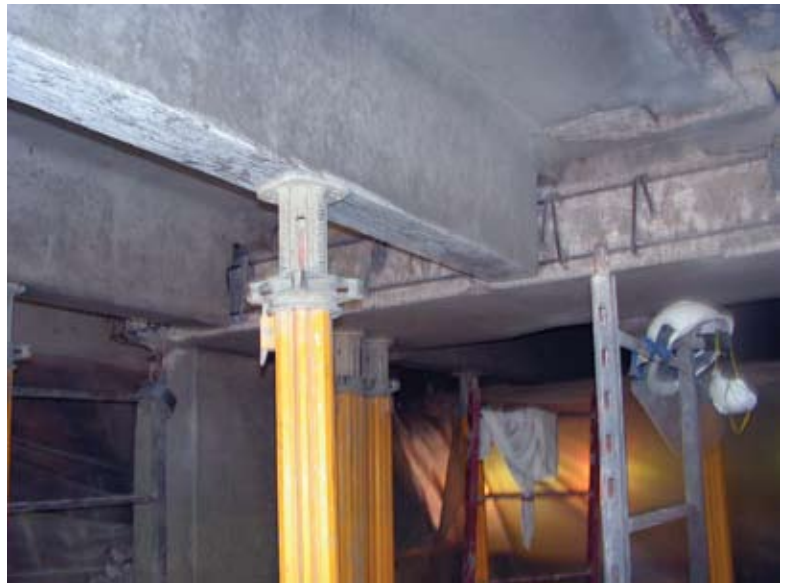
Shoring

At times, it became difficult to place shoring. Shoring was necessary to stabilize the repair area and minimize deflection during the repair material curing period, all the while supporting the upper levels that remained accessible to traffic.

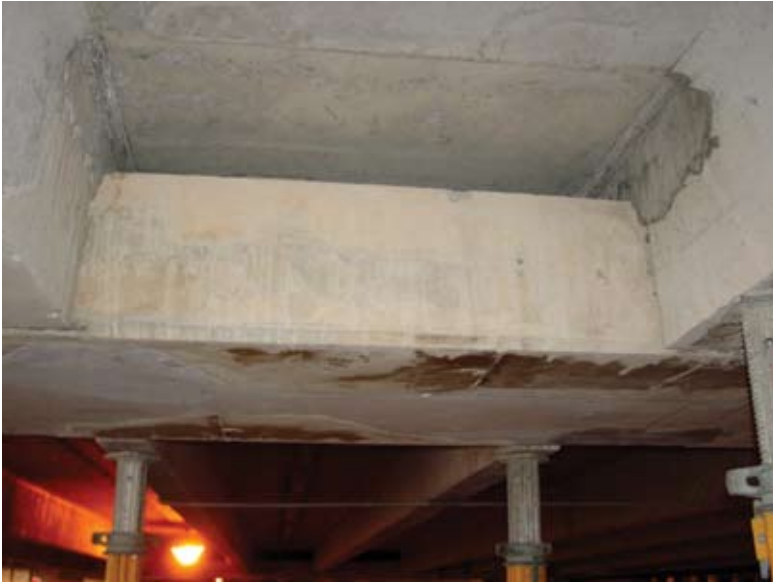
Underside of finished deck repair
