Garage No. 49

Post-Tensioned Slab Repairs

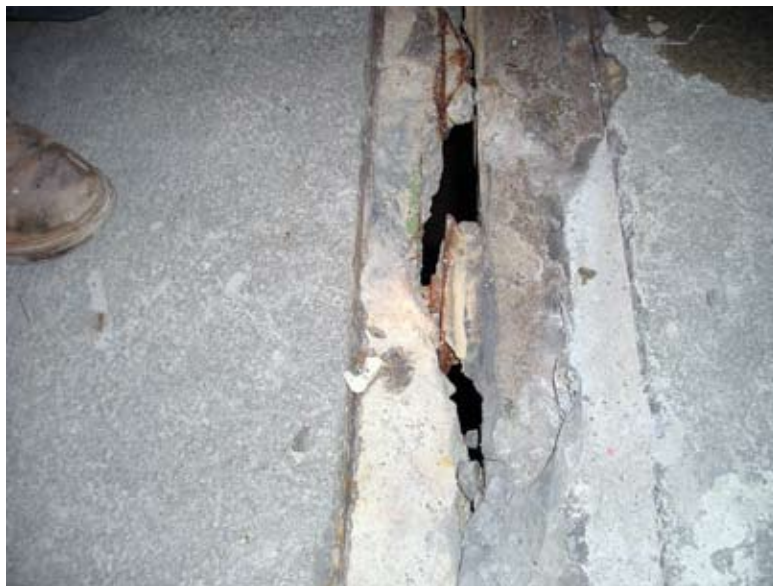
At the construction joints, the intermittent shear keys were found to be structurally deficient and prone to shear fatigue failure. Design details showed the concrete shear keys to be rectangular keys, approximately 24 in. (61 cm) long, installed intermittently between tendon anchorages at the construction joint. In actuality, the shear keys were 12 in. (30 cm) long, with a triangular profile, and appeared to have been installed too low within the slab, not at middepth as intended.

Example of existing conditions of spalled and/or loose concrete present behind existing intermediate anchors

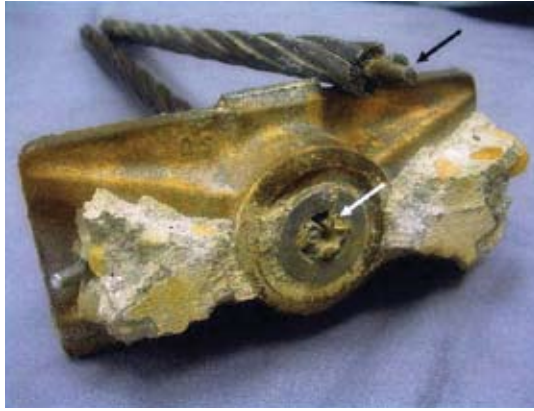
Fracture surfaces from tendon and anchor samples sent for tensile and forensic testing

In-place test results indicated that tensile overloading was the most likely cause of the broken tendons in the slab. Although the outer wires failed along the primary shear plane at an angle to the wire axis, shear failure was not the direct cause of the breakage. The additional vertical force component imposed on the tendons due to the slab weight and service loads increased the tension force in the tendons beyond their capacity, resulting in tendon breakage. It is likely that the shear key failures and tendon breakages had developed in a progressively deteriorating manner over a period of time.

Analysis showed that the shear forces involved would easily increase the tensile force in each tendon to beyond its ultimate tensile capacity, causing rupture of the tendon, especially because the tendons were already experiencing outer diameter damage from the wedges biting into the individual wires. As failure of the individual outer wires took place, the inner wires had to carry the full effective post-tensioned force in addition to the overload from the deflected slab and traffic wheel loading. These wires broke gradually as evidenced by the necking and ductile failure of the inner group of wire within each strand.
