## Historic Category

# Repair of Cabrillo Bridge in Balboa Park

San Diego, California

Submitted by BASF Building Systems

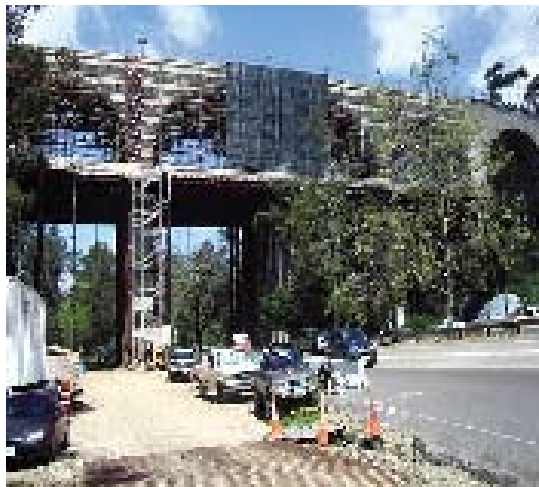
*Fig. 2: The entire underside had a very extensive scaffolding system*

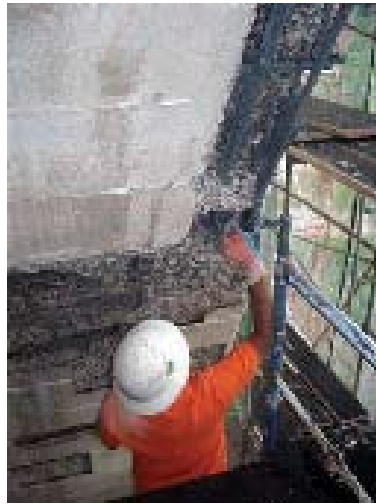
Fig. 4: Deeper repairs held low by 1 in. (2.5 cm) to the surface

Deeper repairs to full depth were first formed and poured using one-component, shrinkage-compensated micro concrete. The forming was held low by 1 in. (2.5 cm) to the surface. Low-slump, fast-setting, portland-cement-based, multi-purpose smooth repair was hand applied to complete the repair (refer to Fig. 4).

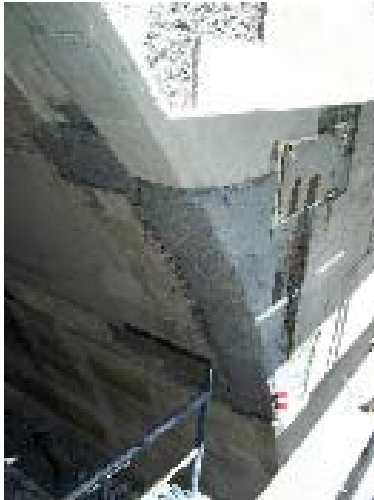
Fig. 5: Use of smooth repair mortar to complete repair. Note recreation of form lines

Low-slump, fast-setting, portland-cement-based, multi-purpose smooth repair was hand applied to complete the repair (refer to Fig. 5).

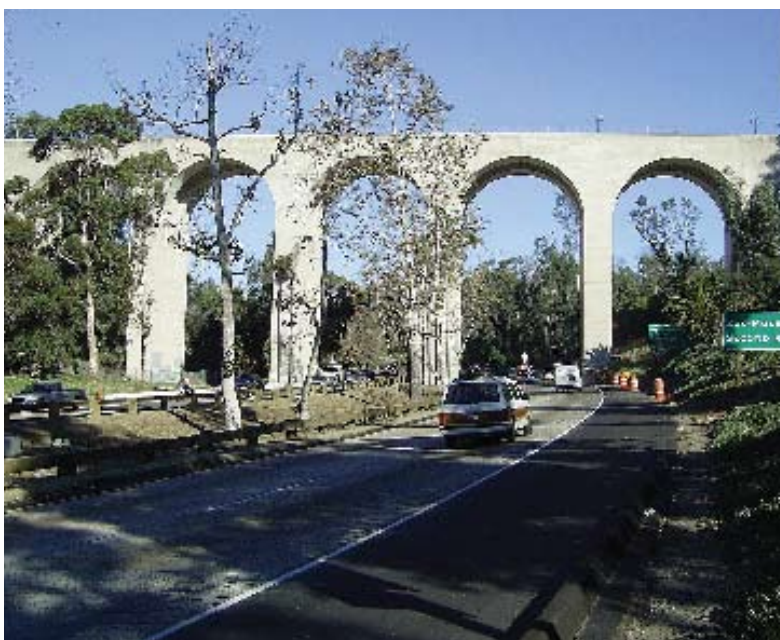
Fig. 6: The Cabrillo Bridge with all historical restoration work complete. Note it does not appear "patched"
