Grand Rapids Community College (GRCC) North Building Parking Structure Restoration

Grand Rapids, Michigan

Submitted by Carl Walker, Inc.

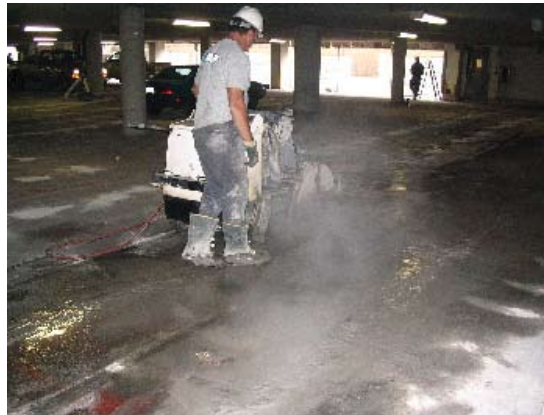
Fig. 1: Sawcutting for slab removal

Demolition activities that created excessive noise were confined to the hours between 5:00 p.m. and 10:00 p.m. Monday through Friday, and between 9:00 a.m. and 10:00 p.m. on the weekends. Concrete demolition by saw-cutting (Fig. 1) reduced the level of noise during day operations. Concrete slurry from saw-cutting operations was controlled to prevent contamination of the storm drainage system. To minimize the effects of fumes from deck coating products, a 96% solvent-free (low-odor) deck coating system was specified and was installed during nights and weekends when the building was not occupied.

Saw-cutting was allowed in areas where existing concrete reinforcement was not salvaged. Saw-cutting of the concrete slab expedited the concrete removal process and generated relatively low levels of noise.

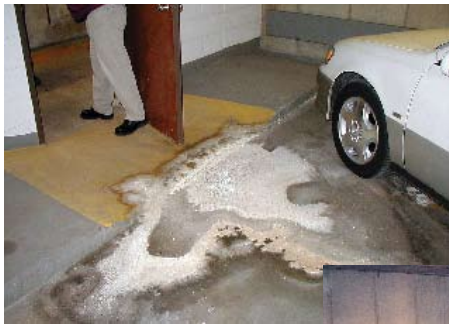
One of the factors that contributed to the accumulation of chloride ions and moisture in the original slab was poor drainage (Fig. 2). The original slab at Level G2 provided drainage in one direction only. The new slab was designed with an improved

Fig. 2: Ponding and ice near exit

bidirectional drainage profile, drains were relocated, and new drains were added to maximize drainage.

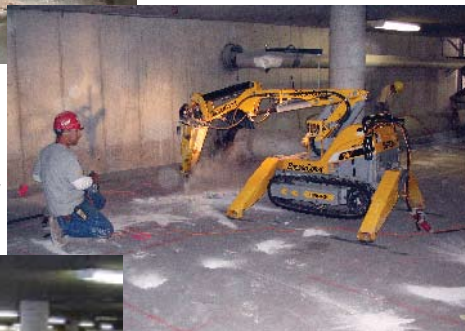
Fig. 3: Demolition robot used for slab demolition and removal

The remote-controlled demolition robot (Fig. 3) was operated from a portable cable or wireless control box and used a motor that generated no exhaust fumes.

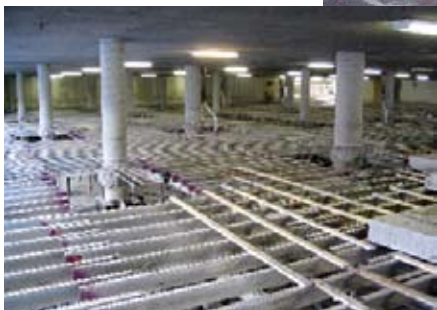
Fig. 4: Unique shoring systems were used on the project

Shoring of the original slab started immediately after the demolition of mechanical and electrical items and concurrently with the installation of lateral bracing. One of the challenges associated with shoring was to maintain an access aisle for deliveries to the building (Fig. 4).

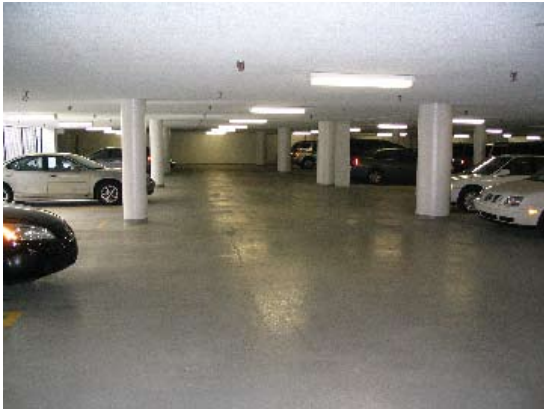
Fig. 5: Finished slab with deck coating

A special deck coating was also applied over the slab-on-grade (Fig. 5). This application required special preparation of the concrete surface to account for moisture that could inhibit bonding of the coating to the slab-on-grade.

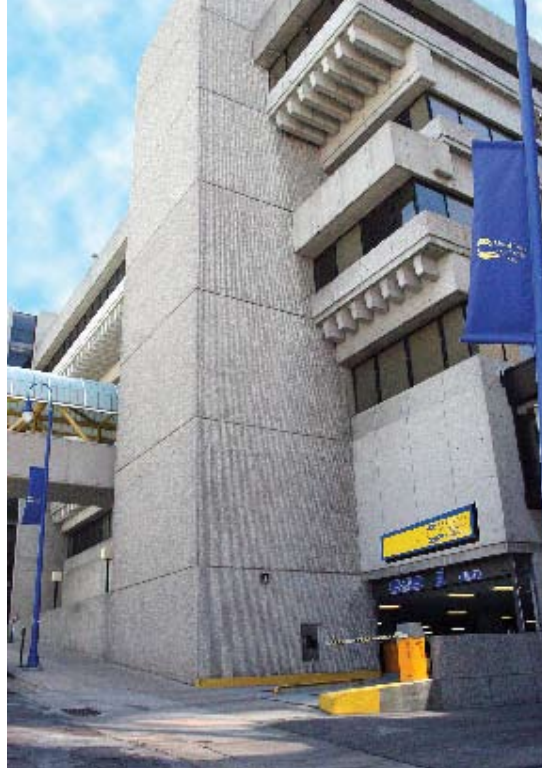
Fig. 6: Parking levels below office and classroom space
