Hallmark Condominiums Balcony Repair

Alexandria, Virginia

Submitted by C.A. Lindman, Inc.

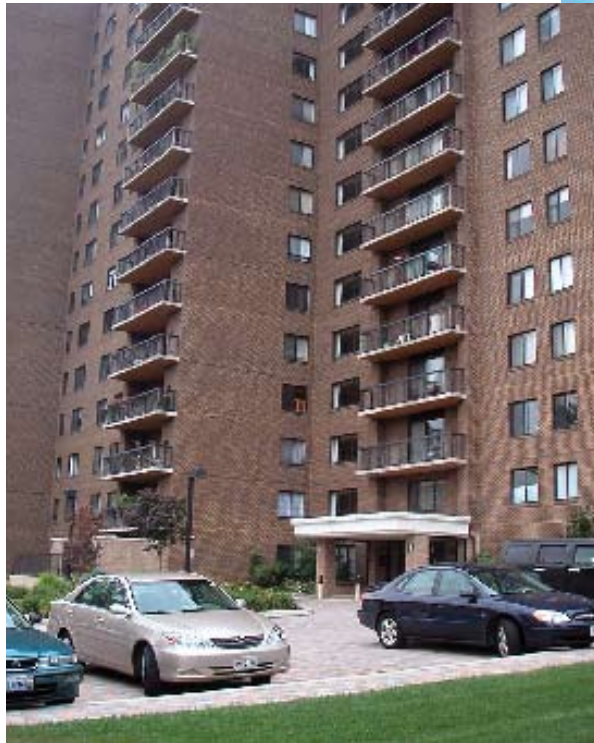
Fig. 1: Repair work done in 1991 has held up very well for 15 years

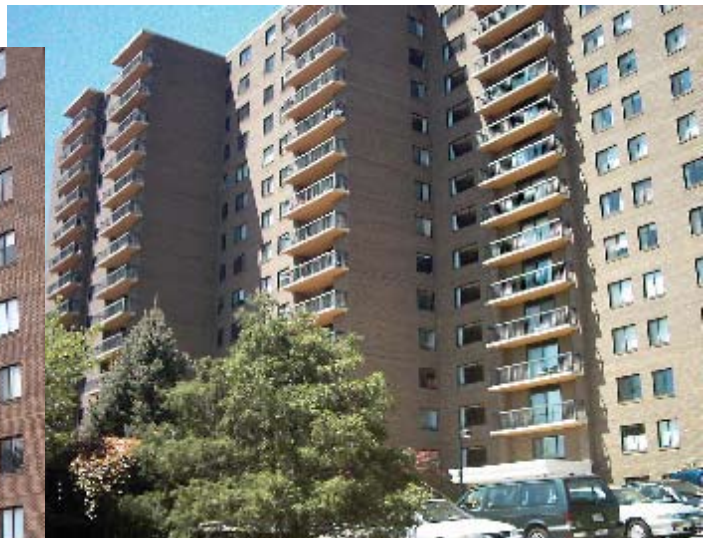
Fig. 2: Phase II work completed in 1991

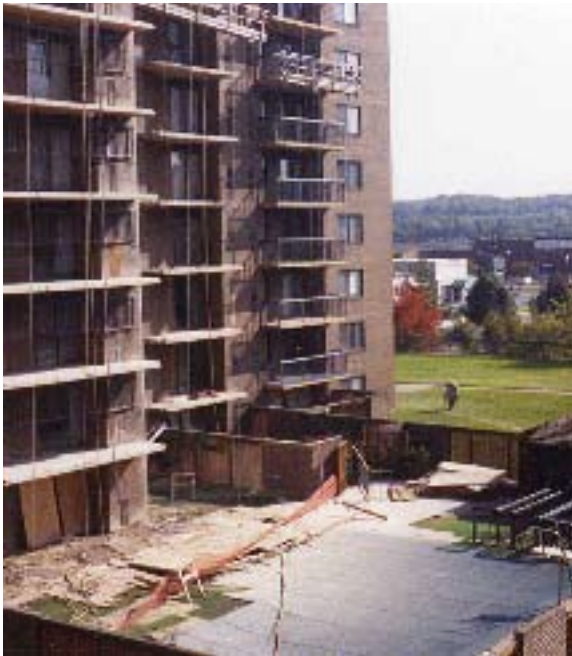
Fig. 3: Phase II work being performed

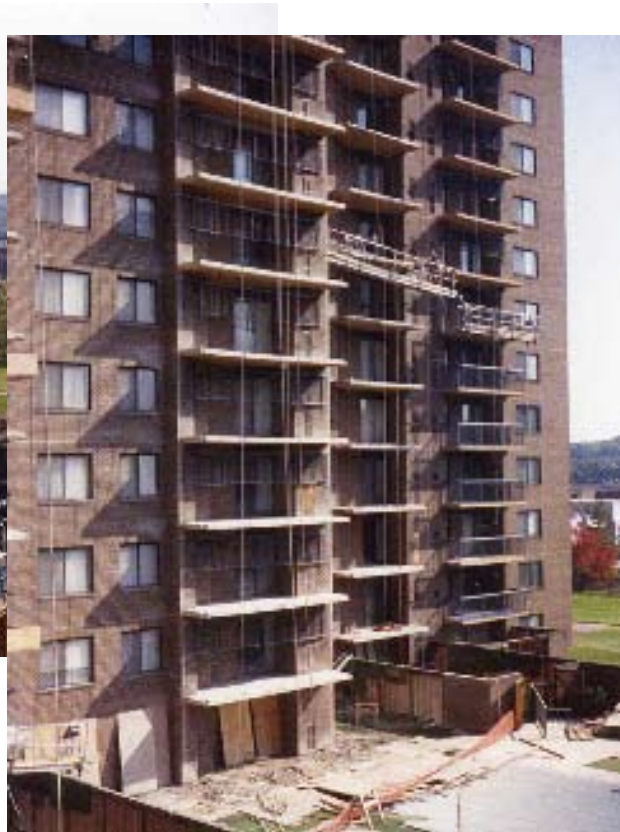
Fig. 4: Phase II work showing swing stage

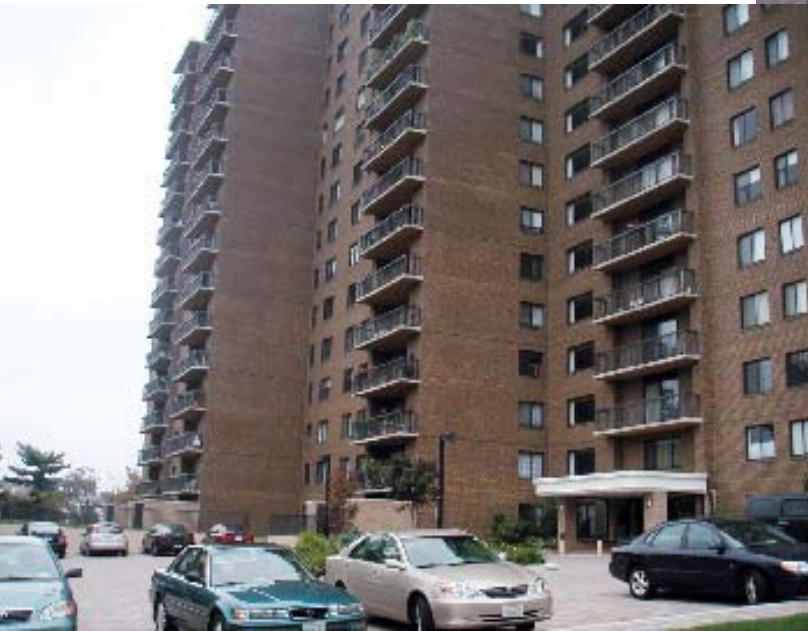
Fig. 5: Hallmark Condominiums 15 years later

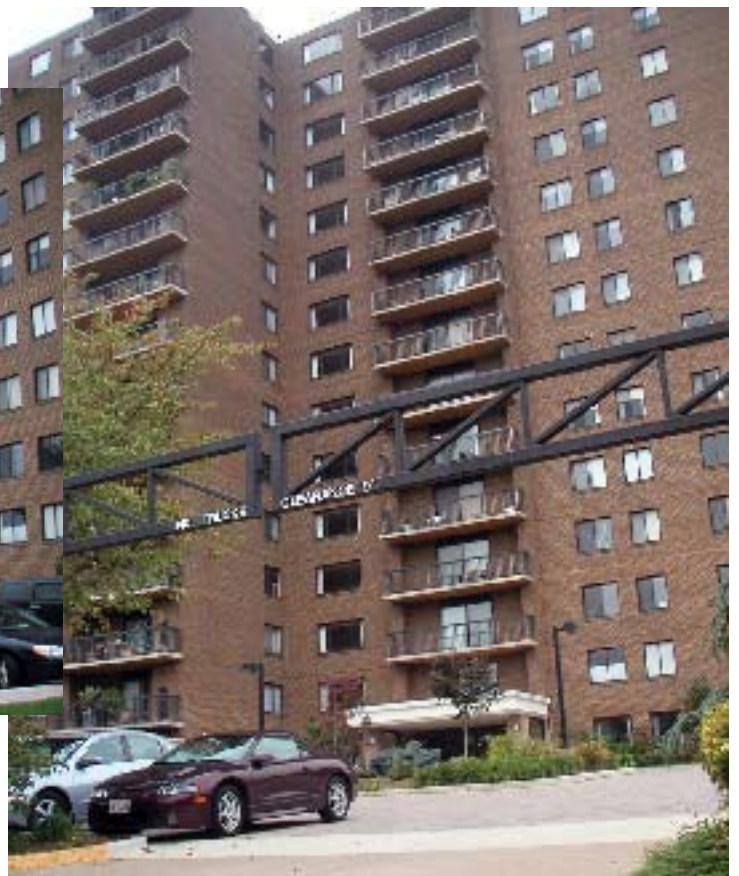
Fig. 6: Another shot of the balconies 15 years later
