# Hyperbolic Cooling Tower Column and Lintel Beam Cathodic Protection

Jacksonville, Florida

Submitted by Existing Structures Engineering

2006 Award of Excellence

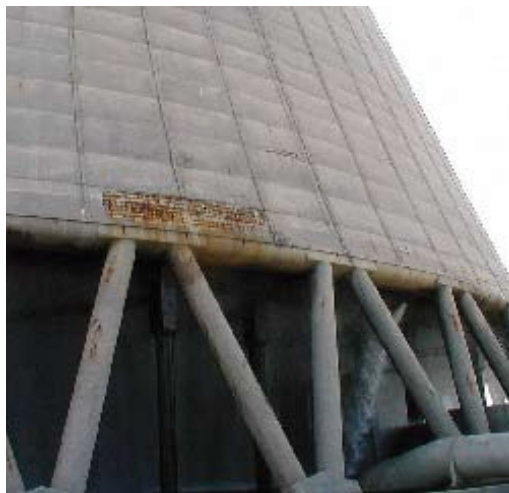
Fig. 2: Corrosion-induced deterioration of the columns and lintel beam

During the operation, practically all surfaces in the basin are subject to "immersion" conditions. The columns and lintels are in a "splash zone" environment, subject to intermittent wet and dry conditions. As a result, these towers are extremely susceptible to corrosion-induced deterioration (Fig. 2).

The owners first noticed deterioration on the veil, perimeter columns, and lintel beam in the form of severe corrosion of the reinforcing steel. Visual inspections noted concrete cracking, spalling, rust staining, and delamination. Several factors contributed to the deterioration. First, the cooling tower uses brackish water from the nearby St. John's River that contains high volumes of chlorides—highly corrosive to reinforcing steel. Additionally, airflow from the nearby Atlantic Ocean and St. John's River traveling through and around the cooling tower produces high oxygen and chloride levels at the columns and lintel beam. Once the brackish water and salty air start the corrosion process, the reinforcing steel begins to rust and expand—causing cracks in the concrete that become greater conduits for more chloride and oxygen intrusion. The result—delamination and spalling.

The investigation found the lintel beam and columns to be in poor condition, exhibiting heavy cracking and spalling. Chloride testing results exceeded the chloride threshold value of 2.2 lb/yd<sup>3</sup> (1.3 kg/m<sup>3</sup>) at all measured depths. Active corrosion of the reinforcement was the cause of the deterioration.

Repairing corrosion-induced deterioration typically involves removal of deteriorated concrete, undercutting around the reinforcing steel, cleaning and protection of the reinforcing steel, and reestablishing the original concrete section. However, the principal investigator also recommended installing a protection system, recommending a cathodic protection system consisting of encapsulating zinc mesh anodes within a stay-in-place fiberglass form filled with cementitious grout. The zinc mesh is attached to the existing reinforcing steel by welding a wire to the mesh and then welding it onto the reinforcing steel of the structure. This process causes the zinc mesh on the fiberglass jacket to corrode before the reinforcing steel—giving the structure a more durable repair. Because the system is self-regulating, easy to install, maintenance-free, and cost-effective, it was ideal for this application.

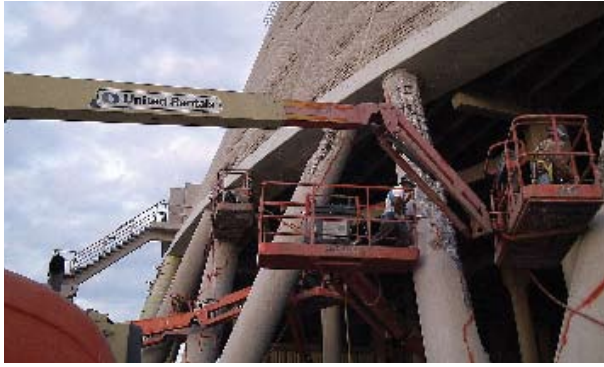
*Fig. 3: Delaminated concrete removed with pneumatic chipping guns*

The scope of the repair project included installation of 120 lintel beam jackets and 240 column jackets for a total of 34,000 ft<sup>2</sup> (3160 m<sup>2</sup>) of jacketing. Procedures included removing delaminated concrete with pneumatic chipping guns, profiling concrete surfaces to a minimum ICRI CSP No. 3 (Fig. 3), and cleaning the corroded reinforcing bars using 35,000 psi (240 MPa)

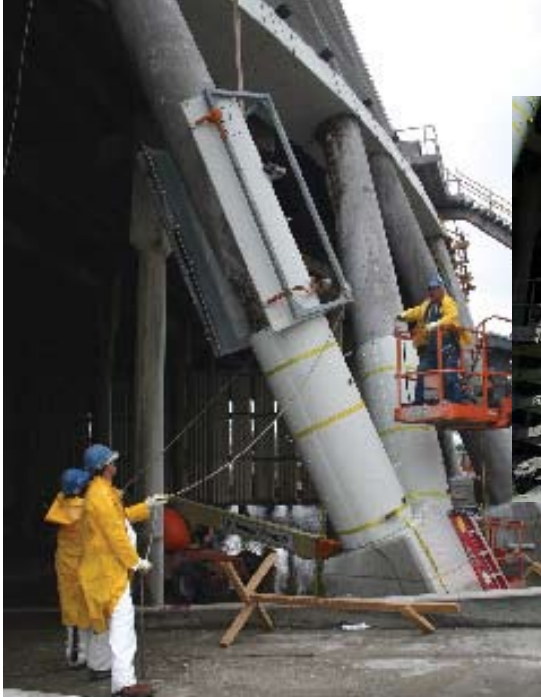
*Fig. 4: Jackets for the columns being lifted into place, held open with quick-release straps attached to the lifting bracket*

Jacket installation on the columns was challenging because of the compound angle of the columns. To address this concern, the contractor designed and fabricated a lifting bracket that, once lifted off the ground, was at the correct angle to slide the jacket into place.

For each column, the jacket was actually in six pieces—two pieces each for the bottom, middle, and top. Placement started at the bottom with the two pieces resting on the foundation and subsequent pieces supported by the ones below. Each section of jacket was lap spliced and held in place with stainless steel fasteners. Brackets held up the jackets through the grout port-holes and the jackets held open with straps attached to the lifting bracket (Fig. 4). Once the jacket was around the column, the strap was released and the jacket would close around the column. Next,

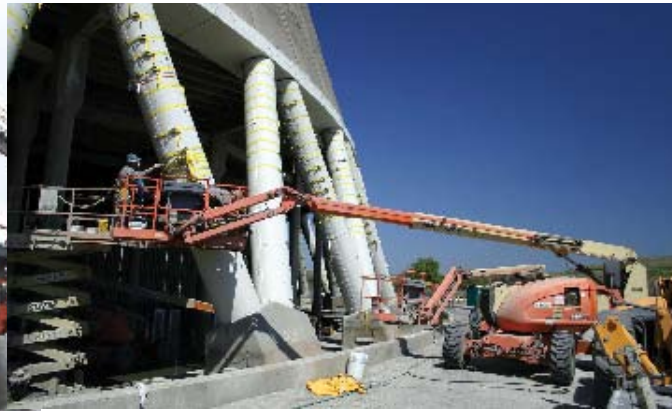
*Fig. 5: Ratchet straps being wrapped around each column jacket to increase hoop strength and keep the jacket from warping during grouting*

ratchet straps were wrapped around each section of jacket to increase hoop strength and to keep the jackets from warping during grouting (Fig. 5). Grouting was performed through ports built into the jacket at 2.5 ft (0.8 m) vertical intervals, alternately placed on either face of the column.

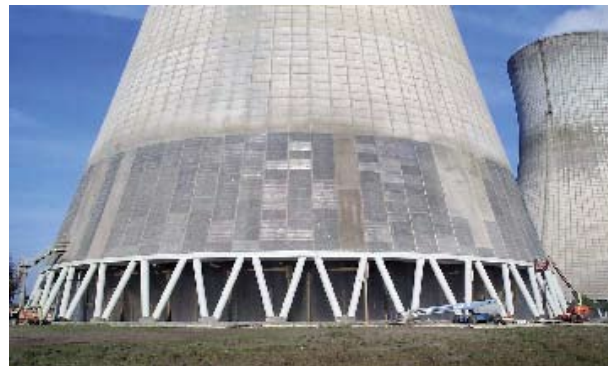
*Fig. 6: Finished work on 120 lintel beams and 240 column jackets*

Daily meetings with the owner and other contractors were invaluable. Coupled with the skill of the crew of 35, which put in more than 16,000 hours with no injuries, these challenges were successfully addressed and the client’s aggressive schedule met to complete what turned out to be the largest cathodic protection system installation for the contractor (Fig. 6).
