Mayorhold MSCP Renovation

Northampton, United Kingdom

Submitted by C-Probe Systems, Ltd.

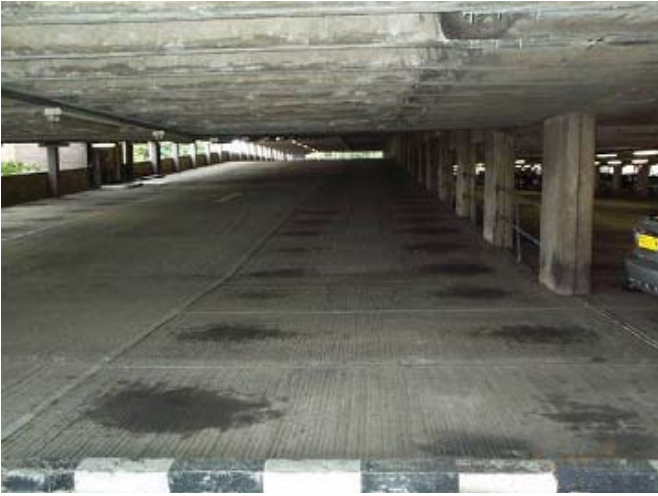
The repair areas, however, were observed to be emerging mainly from leaking expansion joints/day joints. The downstand beams associated with these areas were in more serious condition than other midspan beams. There were also corrosion and spalling issues associated with the reinforcement in the deck surface over the beams.

Expansion and day joints were the focal point for growth of the corrosion issues

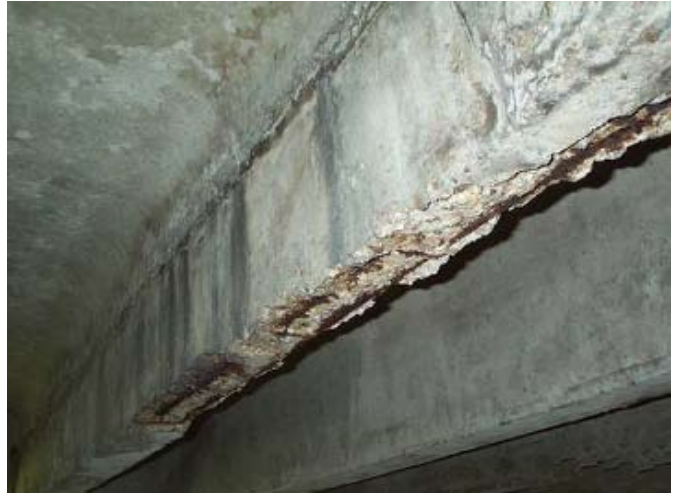
Heavy corrosion was found in some areas

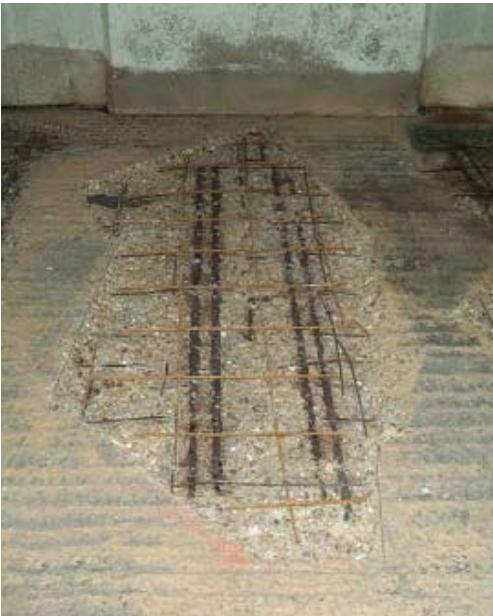
Corrosion of the structure

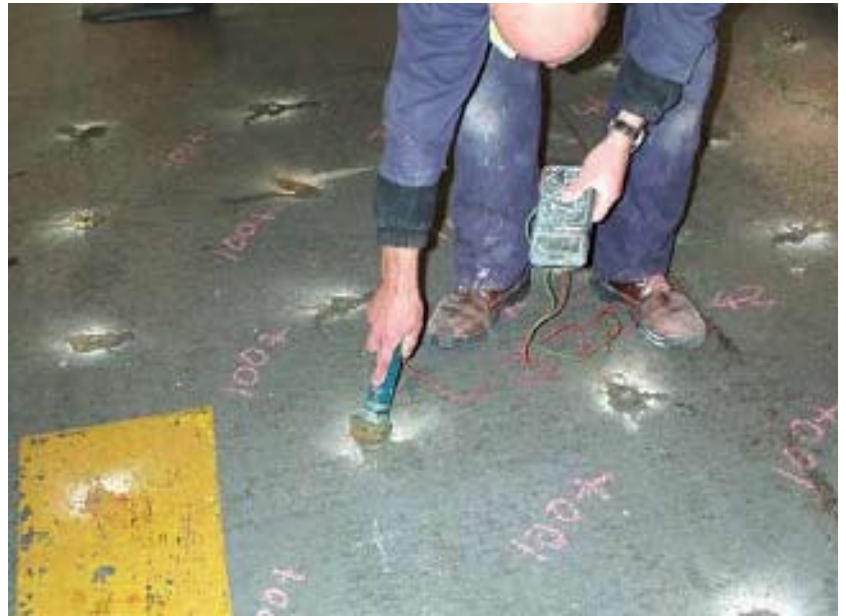
Inspection and evaluation of the structure

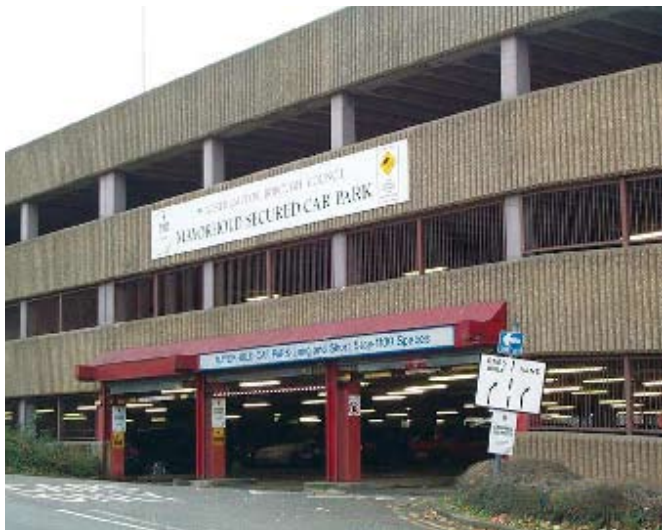
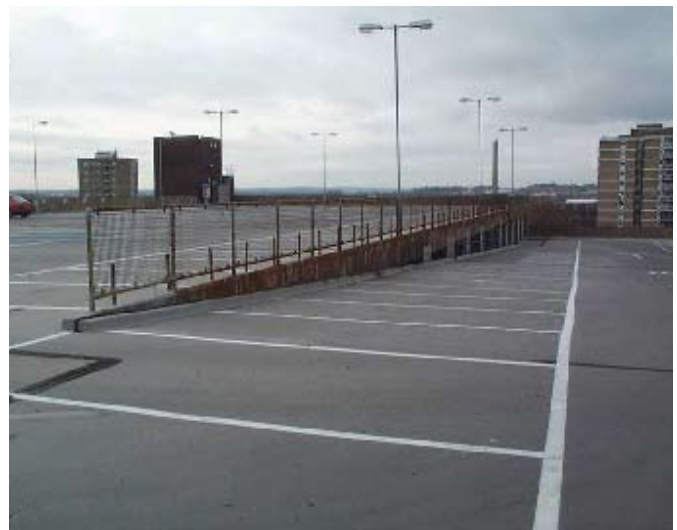
External appearance before (top) and after (bottom) refurbishment

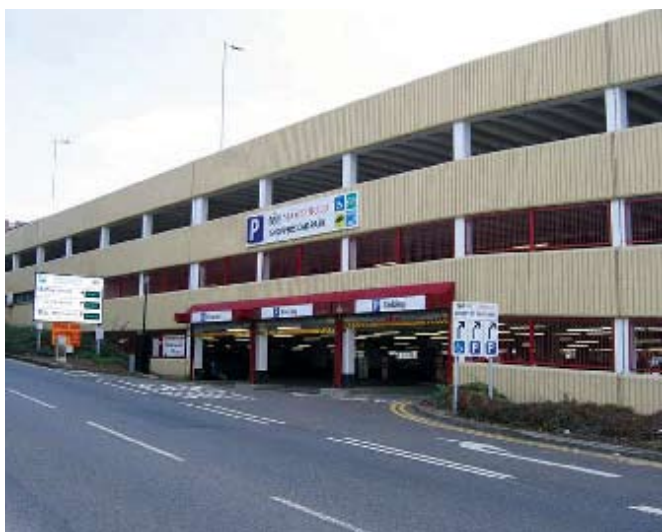
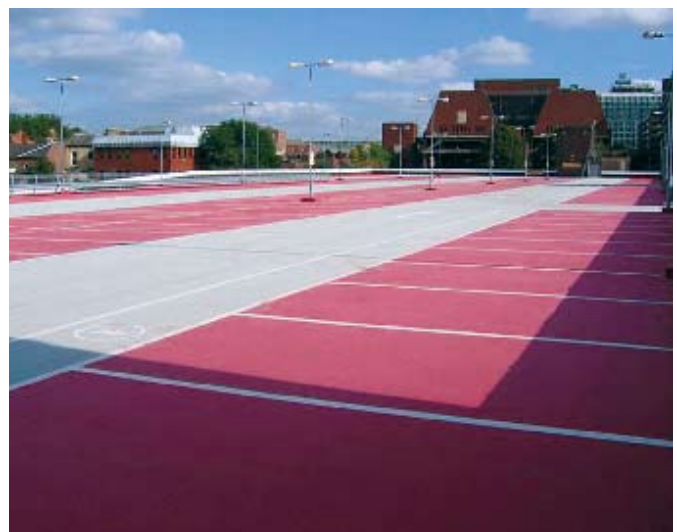
Top deck appearance before (top) and after (bottom) refurbishment

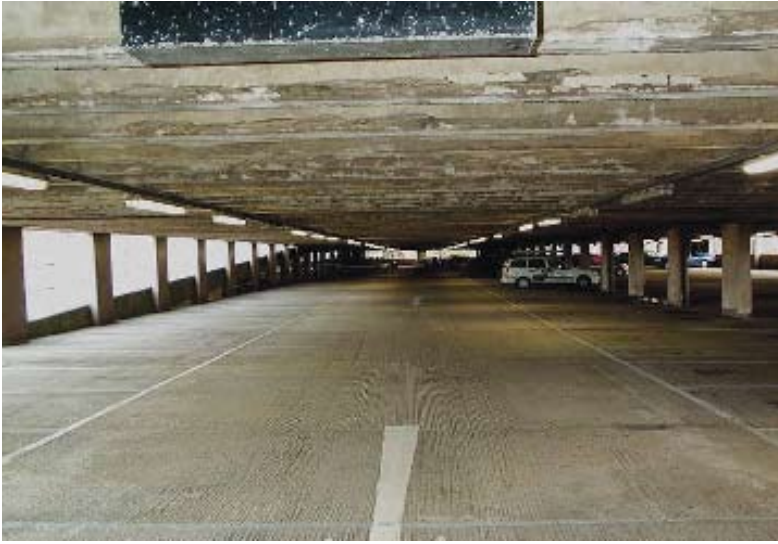
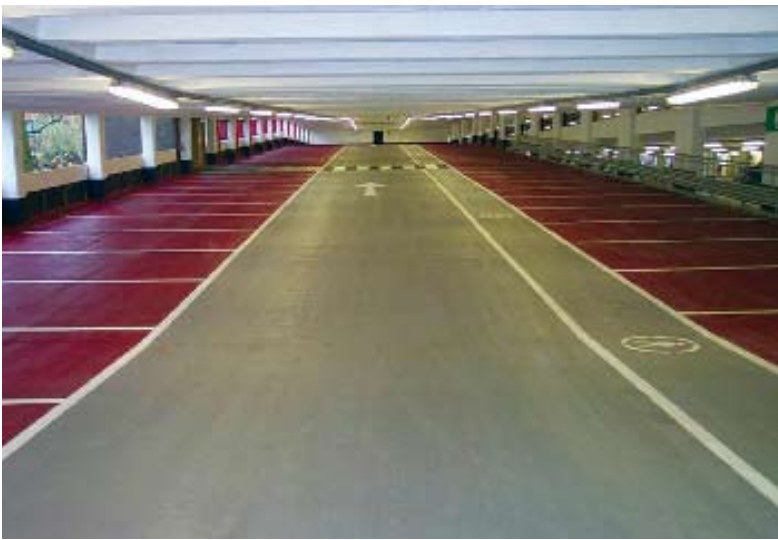
Internal appearance before (top) and after (bottom) refurbishment

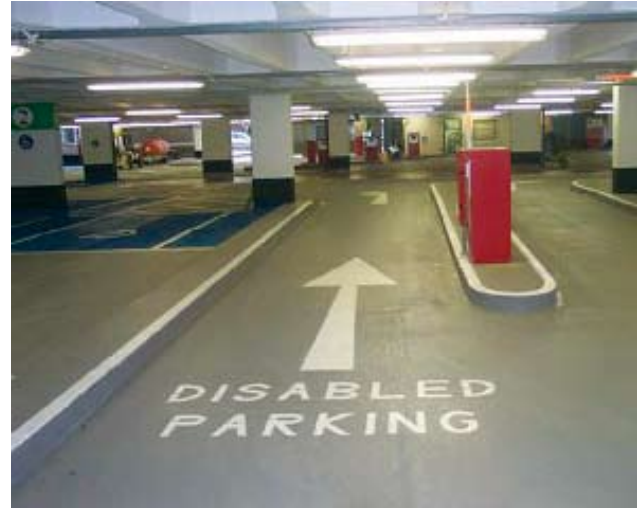
Disabled parking area clearly delineated

Color-coding of the deck has allowed feature enhancement to demark disabled parking, driving aisles, and parking bays as well as entry/exit clarity. Disabled features were added in the form of additional ramps to facilitate access to elevators.
