State Highway 183 MacArthur Boulevard Overpass Emergency Repair

Irving, Texas

Submitted by Sika Corporation

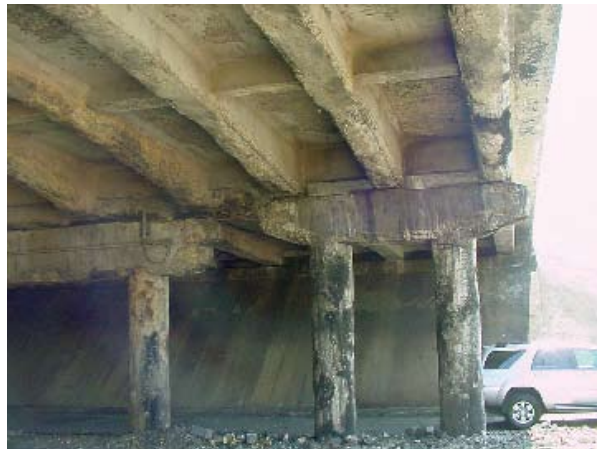
On the morning of Saturday, May 28, 2005, a 3000-gal. fuel tanker heading east on State Highway 183 barreled through a guardrail and spiraled off a bridge at about 6:30 a.m. before landing upside down and exploding on MacArthur Boulevard. The explosion severely burned and cracked the highway's concrete bridge. It took firefighters 30 minutes to extinguish the blaze. Officials initially closed all lanes in both directions of both roads before reopening State Highway 183 westbound lanes at 11:15 a.m. It took 11 hours to clean up the wreckage. There was extensive heat, and the concrete on the bridge columns and beams spalled and "popped" as a result.

Fig. 1: View looking east of the charred remains of Bent 4 and adjacent areas

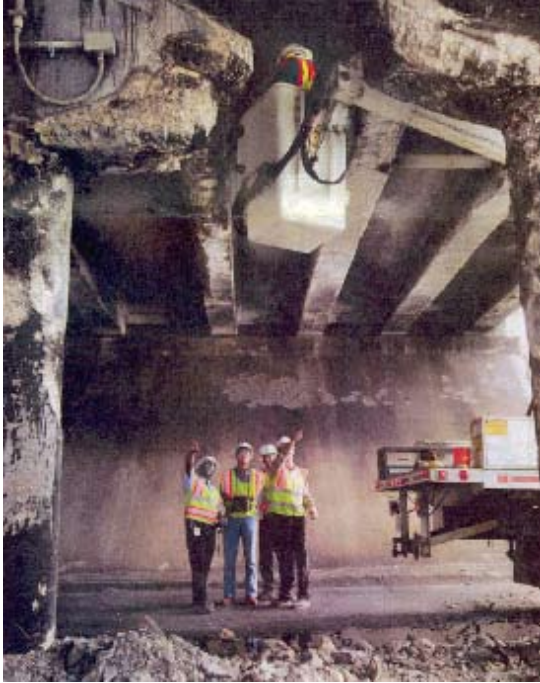
Fig. 2: TXDOT engineers inspect the damage

Four cores were taken from the columns and caps with the most severe fire damage. These cores were visually inspected by TXDOT engineers to determine if the fire had affected the structural integrity of the bridge. Examination of the cores revealed that the fire had not damaged the inner reinforcing steel and concrete.

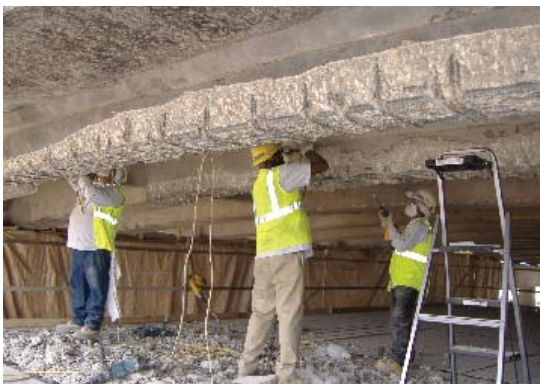
Fig. 3: Removal of delaminated concrete along the beams and deck

Demolition of the beams started on June 19 at the south side of the bridge between Bent 4 and Abutment 5 and proceeded northward. Originally, it was estimated that 500 ft³ (14.2 m³) of concrete required removal. It quickly became evident that this quantity would be exceeded. Ultimately 1000 ft³ (28.3 m³) of concrete was removed.

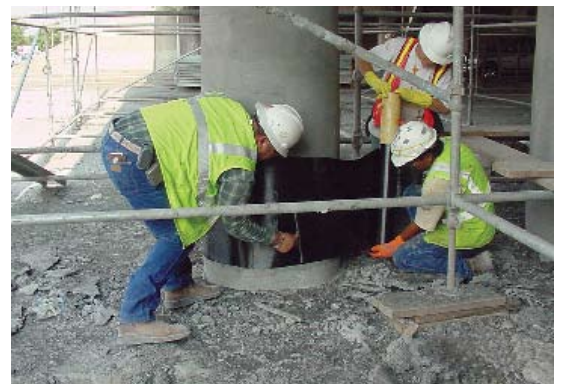
Fig. 4: Installation of CRFP to Column 10

- Strengthen by wrapping the columns with carbon fiber-reinforced polymer (CFRP); and
- Put elastomeric, breathable coating over the CFRP for UV stability and aesthetics.

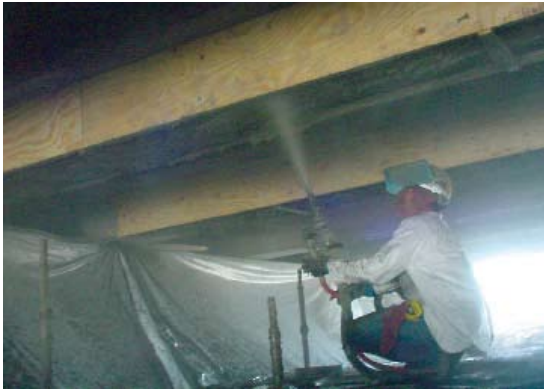
Fig. 5: Wet-spray shotcrete applied to underside of beam

Columns, beams, diaphragms, and the bridge deck were all repaired using high-velocity, wet-spray application. Two pumps were used with a third on hand to serve as a backup.

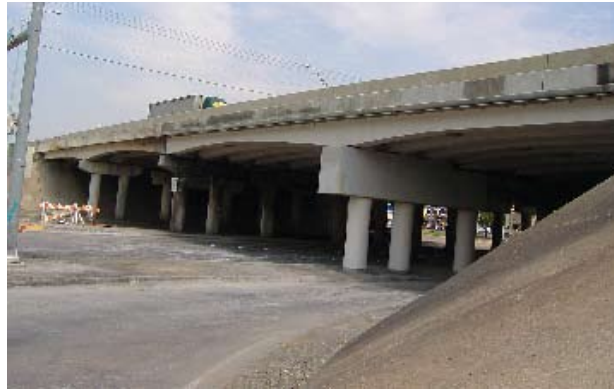
Fig. 6: Completed substructure looking northwest. Bent 4 with the large "straddle" bent is in the foreground

- Remove delaminated concrete; and
- Repair the two caps by encapsulating and combining them into one large “straddle” bent using form and pump concrete.
