Xerox Square Tower Façade Restoration

Rochester, New York

Submitted by Structural Preservation Systems, Inc.

2006 Award of Excellence

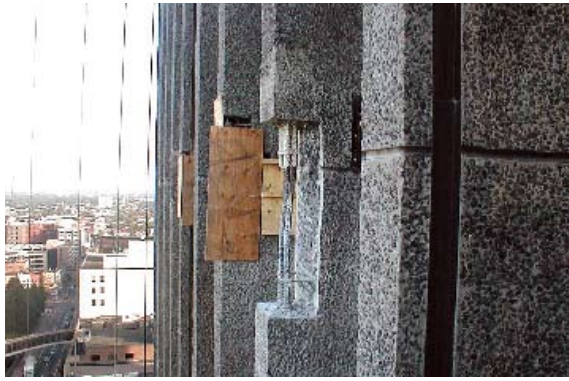
In 1999, a façade inspection employing hammer soundings and minor destructive testing along with a detailed mapping survey was conducted. The investigation revealed corrosion-induced delaminations and cracks in the concrete as well as extensive interior honeycombs. These honeycombs were presumed to be contributing factors to moisture transfer to the steel reinforcement that caused the subsequent corrosion. Water was also penetrating the building through sealant joints at various locations—including along failures in the gasket system at the window perimeters. Subsequently, recommendations were made for the repair of the building's concrete structure, sealants, curtain wall system, and other remedial repairs.

Fig. 2: Typical location of deteriorated concrete after demolition

Concrete repairs were necessary from the second floor entablature to the roof level, replacing portions of deteriorated cast-in-place columns and precast sections on all four elevations. Each repair site was sounded—the concrete with compressive strengths ranging from 12,000 to 15,000 psi (88 to 103 MPa)—and chipped with 15-lb pneumatic chipping guns (in many locations up to 6 in. [15 cm] of material was removed) and sounded again. The edges were sawcut and detailed before the exposed steel was sandblasted and coated with a protective coating (Fig. 2). The engineer then inspected and sounded each site to ensure that no loose or delaminated areas remained before each patch was formed and the concrete mixture hand-poured (Fig. 3). In total, 1638 ft³ (46.4 m³)

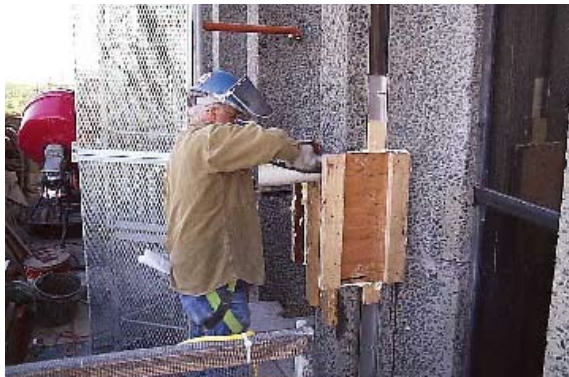
Fig. 3: Placing concrete into formed repair location

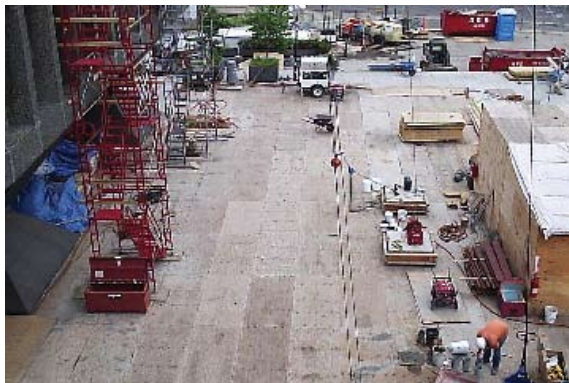
Fig. 4: The entire plaza area was fenced and covered with a flooring system to protect the paver system

Protection from, and containment of, falling debris and dust was a constant challenge in this downtown area. Along with large nets placed where required, the contractor installed tight rubber gaskets at the access equipment interface to contain the debris. Additionally, the entire plaza area was fenced and covered with a flooring system to protect the paver system (Fig. 4).

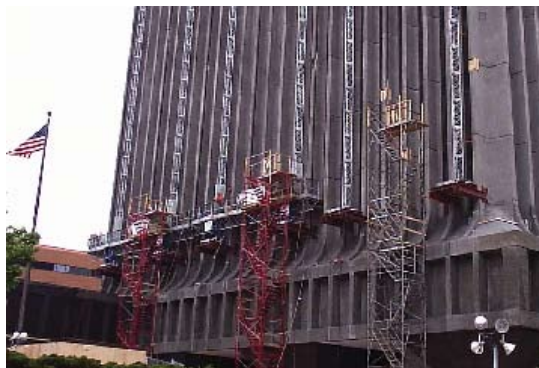
building at 20-ft (6 m) intervals. Overall loading was a major consideration because the existing construction consisted of a supported concrete slab over the plaza deck and could not be used for bearing the load of the equipment. The equipment had to be anchored to the building's exposed columns with designed steel platforms attached to the columns using all-thread steel and epoxy anchors. Access to the platform and the mast climbers above the second floor entablature required construction of 40 ft (12.2 m) high stair towers from the plaza level (Fig. 5).

Fig. 5: Mast climbers shown with the 40 ft (12.2 m) high stair access towers from the plaza level

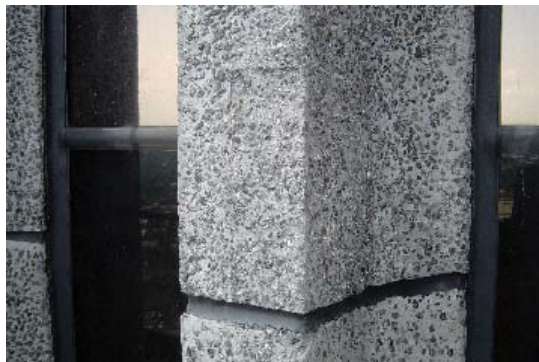
Fig. 6: Completed repair profile—a beautifully exposed garnet aggregate finish

Another critical step in ensuring a consistent finish was coating each mixture with a cementitious retarder. The retarder, along with favorable weather, temperature, and humidity, allowed the concrete at the surface of the patch to strengthen at a slower pace. When the form was removed, the surface layer of the concrete could be removed with a combination of mechanical means and power washing. The result—a beautifully exposed garnet aggregate finish (Fig. 6).
