Country Club Towers Apartments: Balcony, Plaza Retaining Walls, and Garage Improvements

Arlington, Virginia

Submitted by Tadjer-Cohen-Edelson Associates, Inc.

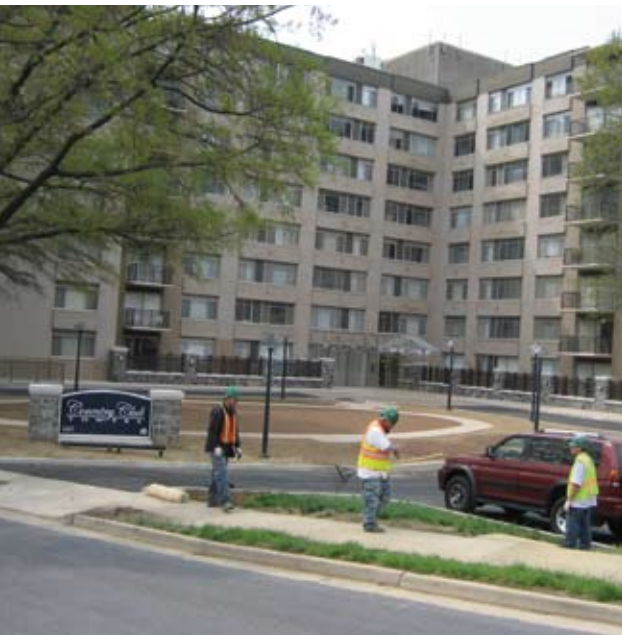
The two plazas are on an elevated, conventionally-reinforced concrete deck over the parking garage. The concrete decks have a waterproofing membrane covered by asphalt pavement, concrete sidewalks, and planters and terraces surrounded by brick walls. The plazas had several problems, including leaks into the garage below, cracked and spalled brick at the terrace and planter walls, and the appearance was very outdated. The leaks through the slab caused a moderate to severe level of corrosion of reinforcing steel and concrete spalling at the structural deck.

The north plaza area

For the plazas, the first step was to remove everything down to the structural concrete deck. Concrete repairs were performed per ICRI guidelines, and then new hot rubberized waterproofing was installed over the entire surface. After the waterproofing was complete, new asphalt pavement, terraces, sidewalks, a perimeter wall at the south plaza, and curbs were installed.

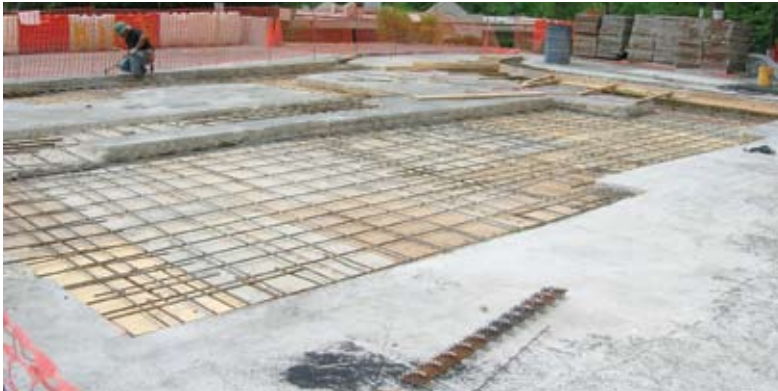
South plaza deck concrete repairs

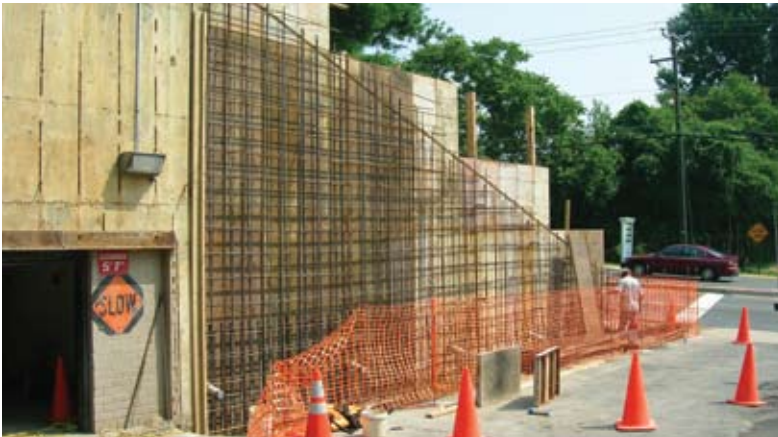
There is also a brick masonry retaining wall at the north side of the driveway and a stone masonry gravity retaining wall at the pool deck. The brick retaining wall at the driveway had extensive cracking in the brick and mortar joints. It also had the same outdated appearance as the brick walls at the plazas and at the south end of the garage. The stone masonry retaining wall adjacent to the pool deck was bowed outward at midheight with a horizontal crack running the length of the wall. Many of the stones had fallen out of the wall or were loose and about to fall. There was a steady flow of water through the wall as well. The area at the pool deck had been closed off for fear the wall could collapse at any time.

Steel reinforcement for the new driveway retaining wall

The brick retaining wall was not included in the original scope of work but it was determined that it needed replacement during the course of the project. A new reinforced concrete retaining wall was placed with synthetic stone at the face and stone coping at the top to match the pool retaining wall and the south wall of the garage.

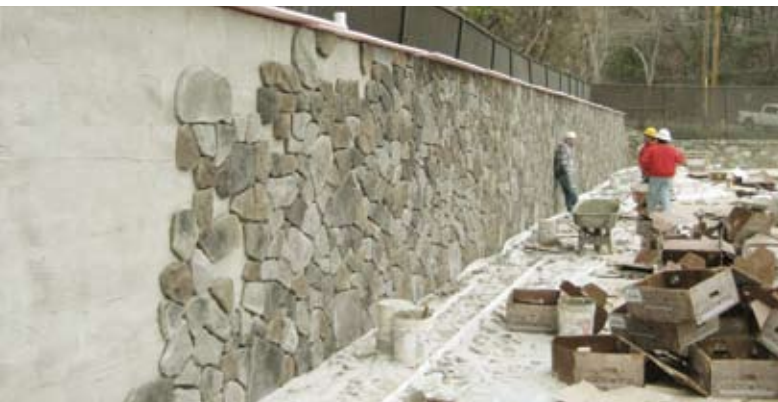
Installing synthetic stone at the pool retaining wall

The stone masonry gravity retaining wall at the pool deck could not be removed for the repairs due to the proximity of a house and garage at the top of the wall. The retaining wall was stabilized by installing a new reinforced concrete retaining wall, including drainage system, in front of the existing wall. After the new retaining wall was poured and cured, synthetic stone was installed at the face and stone coping at the top to match the stone masonry at the terrace walls as closely as possible.

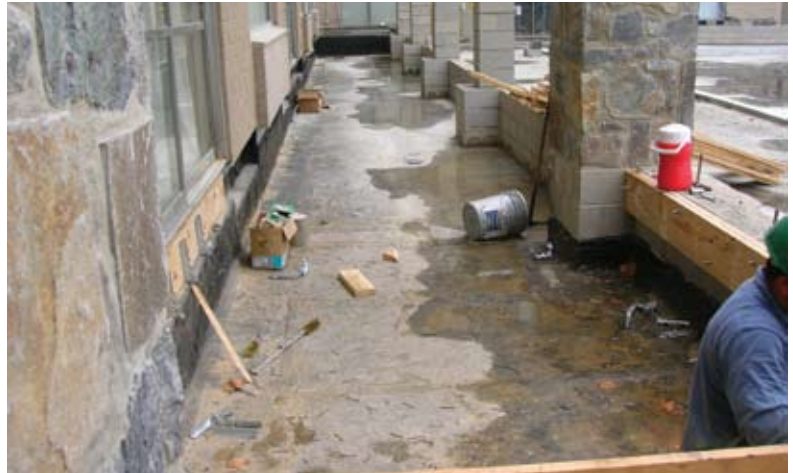
Construction of the terraces

The terraces were designed with reinforced masonry walls faced with real stone. The CMU was placed with vertical reinforcing bars embedded in the structural slab and horizontal joint reinforcement every other course. Wood decking installed at an angle was called for in the renderings. A concrete footer was designed and installed to support the masonry walls for the terraces on grade. French drains were installed to prevent ponding under the wood decks.

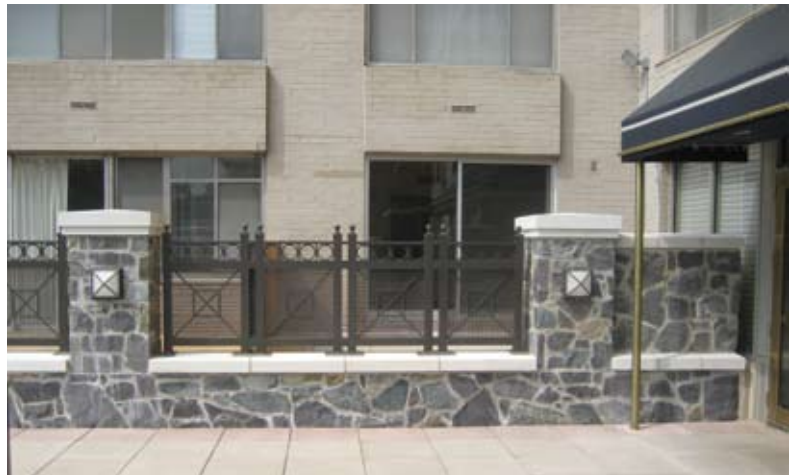
New stone masonry terrace with custom aluminum railing, stone coping, and new lights
