Marriott Frenchman's Reef and Morningstar Beach Resort Balcony Repairs

St. Thomas, U.S. Virgin Islands

Submitted by C.A. Lindman, Inc.

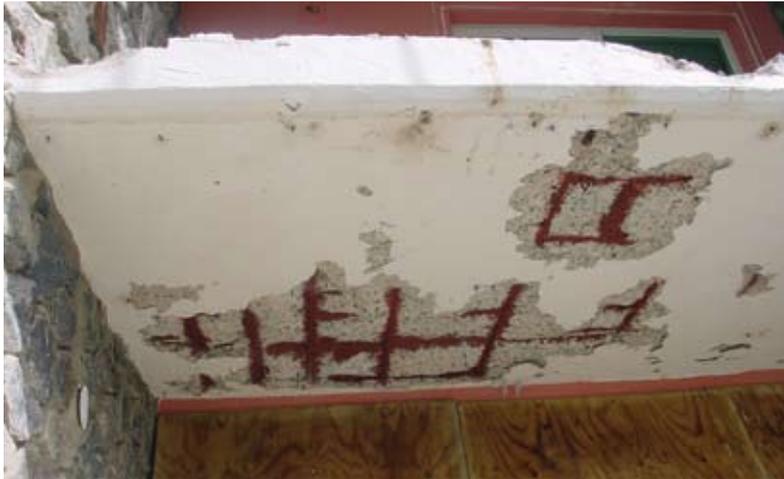
salinity of the concrete had caused accelerated rusting of reinforcing steel and resulted in the large spalls and delaminations that were then evident. The engineer's plan to address the problem involved not only removal and replacement of failed concrete in accordance with ICRI repair guidelines, but also installation of an active suppression cathodic protection system to inhibit any further deterioration of original concrete that had not yet failed.

Deterioration on the balconies

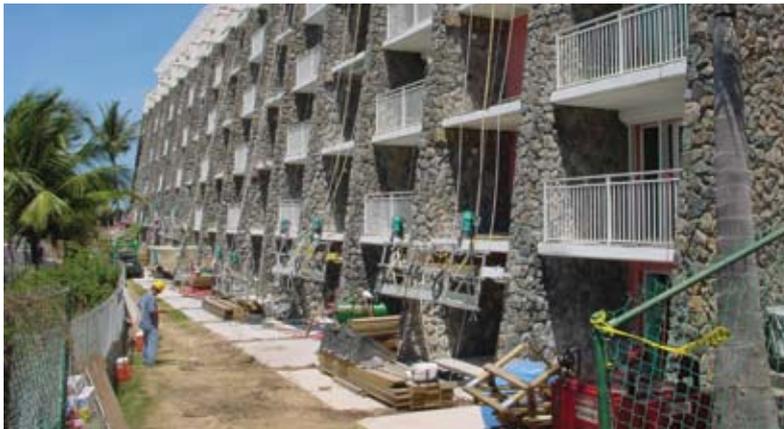
Sea Cliff balcony repairs underway

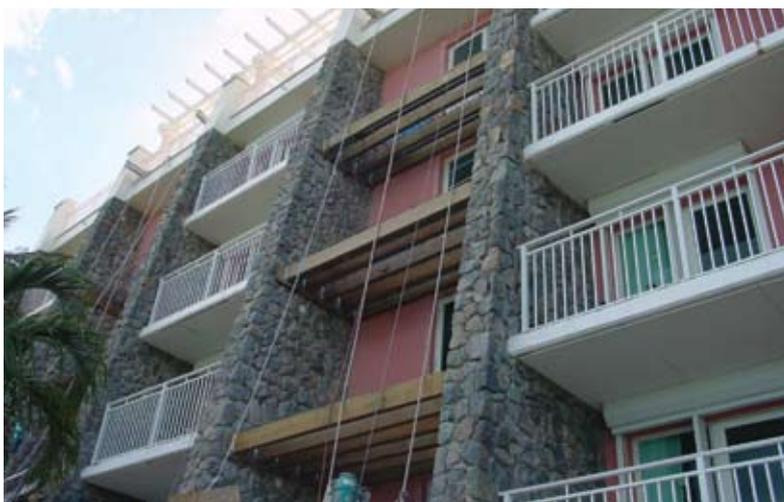
Balconies being readied for new concrete

in a vertical alignment is repaired, with forms for the repairs shored down to the intact balconies below, the schedule for the Sea Cliff job did not allow two work cycles at each tier of balconies. The contractor developed a very creative system of joists hung under each balcony to support forms, so all balconies in a tier could be demolished at the same time, and all new concrete could be placed back in one pour date. This process was the key to making the finish schedule, and worked exactly as planned.

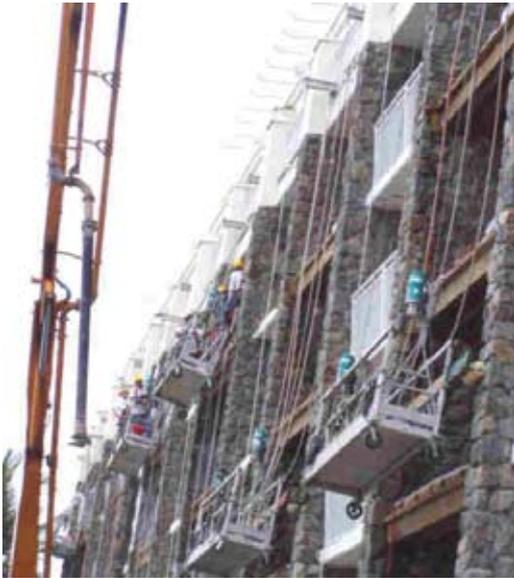
Repairing balconies

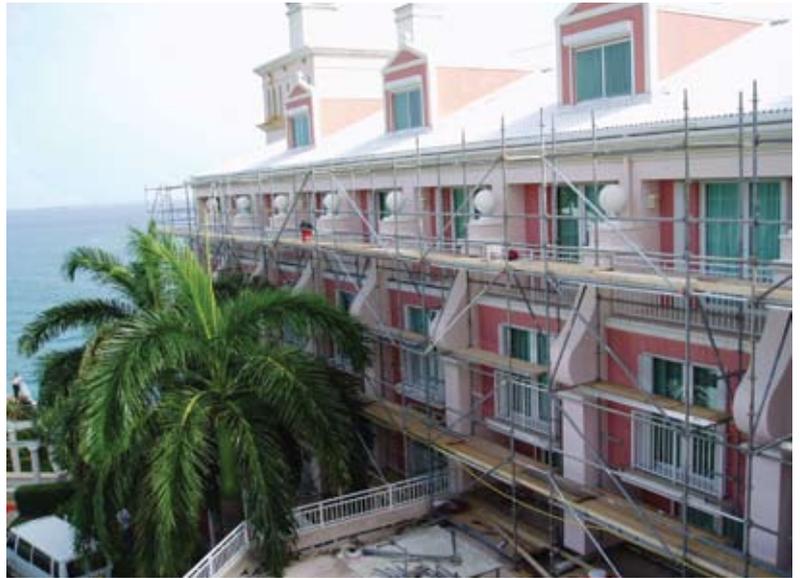
Ocean Tower building with full scaffolding in place

The contractor engaged a specialty scaffold subcontractor from near their mid-Atlantic headquarters, who transported two containers full of system scaffolding that, when erected, covered fully half of the façade area of the Ocean Tower building. The owner again had a schedule complication, this time requiring full demobilization and shut down of the project for a 1 week period in the middle of the job, to conform to the Resort's contractual requirement with a national mortgage company who rented the entire resort for the full week. As with the Sea Cliff building, strong advance planning allowed smooth performance of the work during the two mobilizations of the Ocean Tower Balconies job, with project completion in November 2006 on time and within budget.
