## Parking Structures Category

# 55 East Monroe Street Parking Garage Rehabilitation

Chicago, IL

Submitted by Klein & Hoffman, Inc.

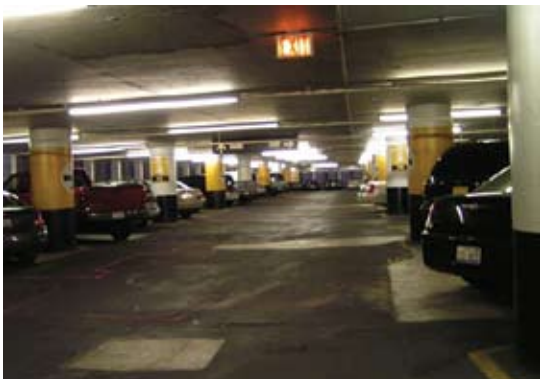
Parking Levels P-3 to P-9 were badly deteriorated, especially on the top surfaces. Extensive repairs had been performed to these decks, many of which had failed. It was estimated that the extent of deterioration on the top side ranged from 30 to 70% of the surface areas. Although there was some delamination and cracking on the bottom surfaces of the decks, it was far less extensive than on the top surfaces.

*The parking garage before rehabilitation*

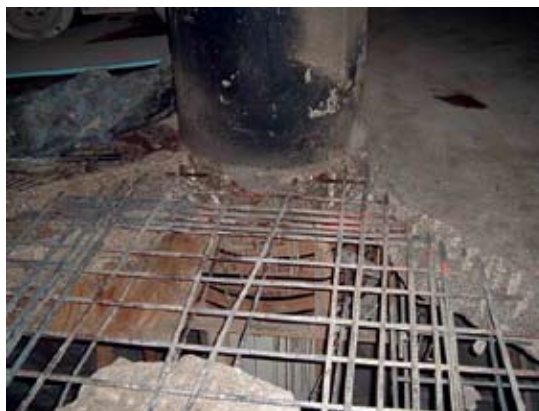
*Sequencing of full slab removal of column with 46 stories above it. The slab removal was done in four quadrants. Note shear collar at top of columns added to reestablished shear*

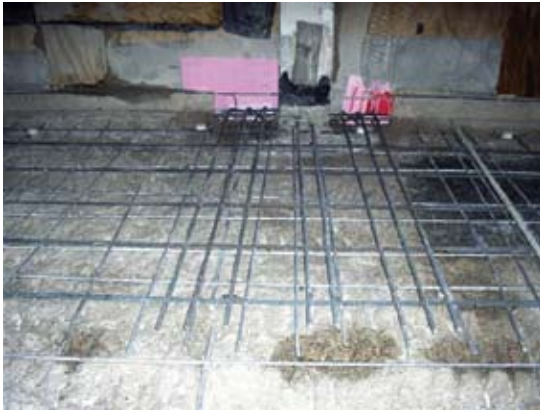
The suspected cause for many of the existing repair failures was due to the halo effect, or anodic ring effect, around the perimeter of the patches. The ICRI definition of anodic ring effect is a "corrosion process in which the steel reinforcement in concrete surrounding a repair area begins to corrode preferentially to reinforcement in the newly repaired area." Other factors contributing to the deterioration were insufficient bar coverage at various locations, extremely high chloride levels, and buried electrical conduits.

*Anodes have been placed to mitigate the halo effect. Note that the additional top reinforcement has been placed around the column to meet current code requirements*

- Use of lightweight bonded overlay with a design mixture closely matching substrate concrete;
- Hydrodemolition would be used for concrete removal which provided an excellent profile for bonding an overlay;
- Most of the existing reinforcing could be reused if undamaged, having minimal corrosion, and if adequately cleaned;
- Passive cathodic protection was used to mitigate the halo effect where reinforcement extended into

substrate concrete with the use of embedded galvanic anodes;

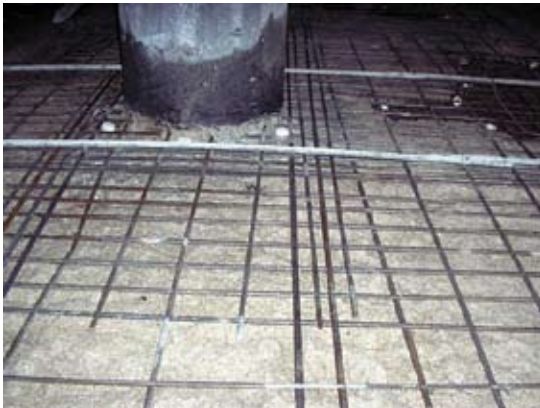
- **Punching shear changes:** The current code requires that unbalanced moments must be considered when checking for punching shear. Based on this requirement, the slab was significantly overstressed at many of the exterior columns. To solve this problem, the slab was tapered at the exterior walls to increase the thickness of the total slab.
- **Detailing changes since 1963:** ACI currently offers no guidance of how to handle detailing changes. Our approach was to comply with the code when possible and to assume that all other detailing issues would be grandfathered as acceptable.

*Tapering of slab to resolve punching shear issue*

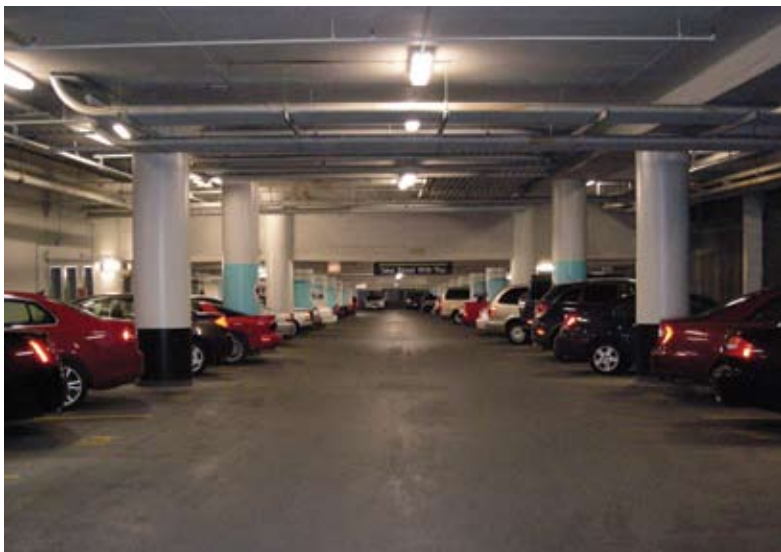
*The parking garage after rehabilitation*
