Restoration of Arkwright House—10 Years Later

Manchester, UK

Submitted by C-Probe Systems, Ltd.

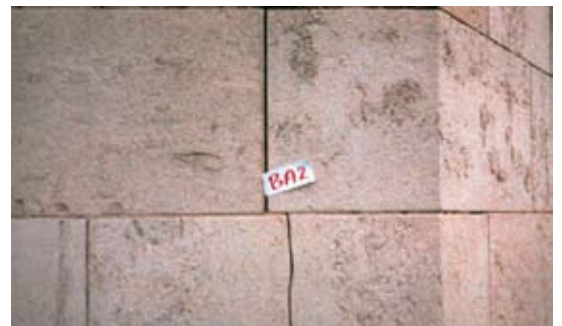
The build-up of exfoliated rust layers, sometimes expanding as much as 0.4 to 0.8 in. (10 to 20 mm) for only 0.08 to 0.12 in. (2 or 3 mm) of base steel, caused tensile forces to build up behind the masonry, resulting in cracking and movement of the block and brickwork. This physical effect in turn exacerbated the problem by acting as a path for further moisture ingress and an acceleration of corrosion.

Aesthetic deterioration caused by the cracking of the stonework

- Replacement of cracked and displaced portland stone (to three elevations) and brick to the rear light wells;
- Rebuilding of Levels 6 and 7 with empathy to historic technique and aesthetics;

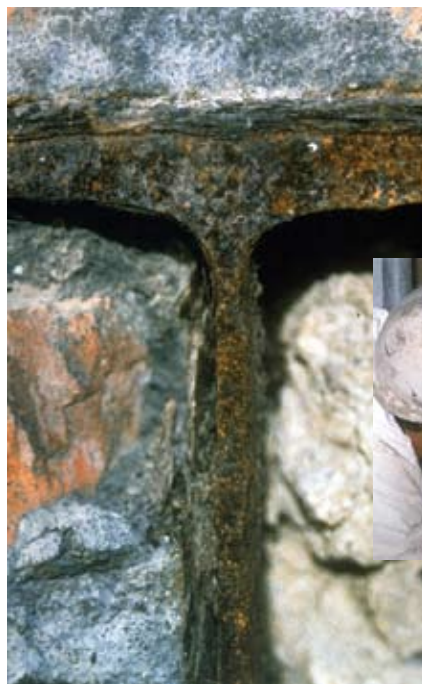
Unfortunately, the mortar can act as a direct path for moisture penetrating through the structure and cause corrosion of the stanchions behind the cladding.

View of steel frame with diminished cross section to the flange and web and demonstrating exfoliated rust layers

Traditional repair was unavoidable in many places and indeed the corrosion management scheme was devised to minimize this aspect of the work. This was achieved by removing the external cladding, removing the corrosion products by the needle-gun method, and treating the steelwork with

a formulated coating finish for future protection prior to reestablishing the façade.

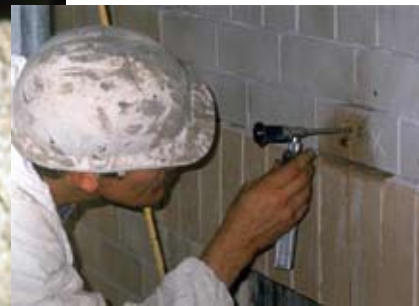
Using anode drill holes to perform final inspection for voiding with bore scope

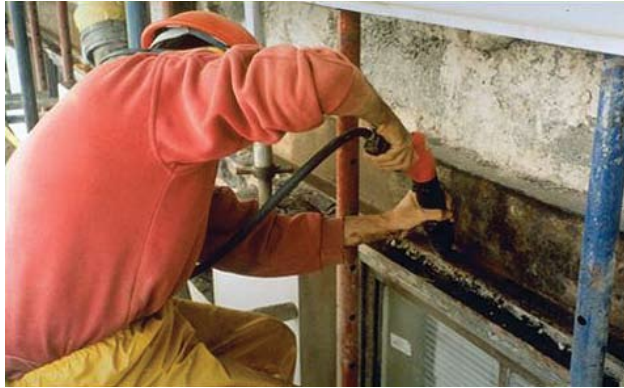
Labor-intensive preparation by needle gunning corrosion product from deconstructed sections of the façade

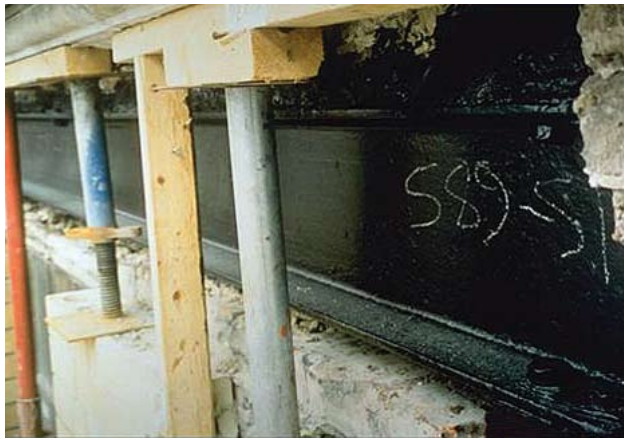
Following prime coat, a final high build coat is applied prior to rebuilding the façade

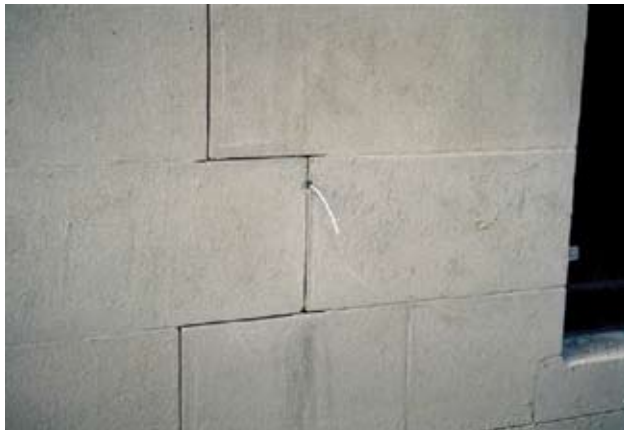
Installation of discrete anodes complied with conservation policy and the principle of "minimum intervention"

The final installation saw 3700 anodes drilled in externally and is controlled in 24 zones (four per building level) that are networked together internally via the risers and the cables managed within the suspended ceiling space to avoid internal disruption.

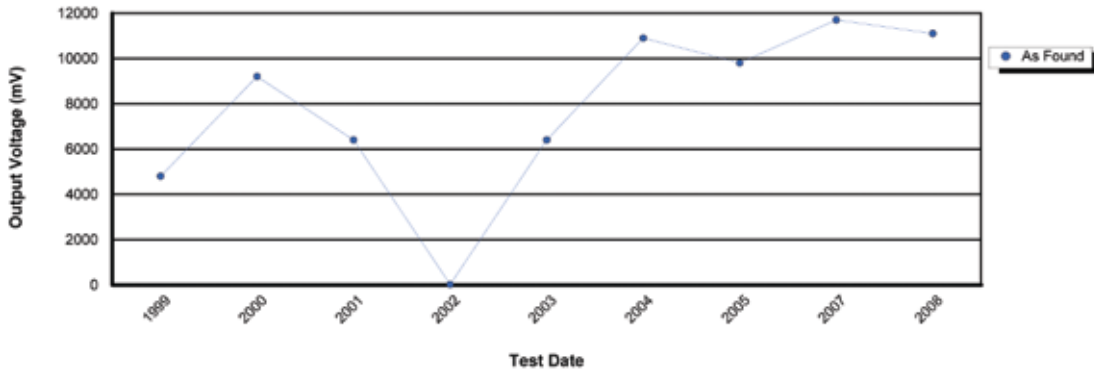
Daily As Found Voltages (mV)

Note that the power is supplied in constant current mode and the driving voltage varies with environmental demand (zero represents an outage).

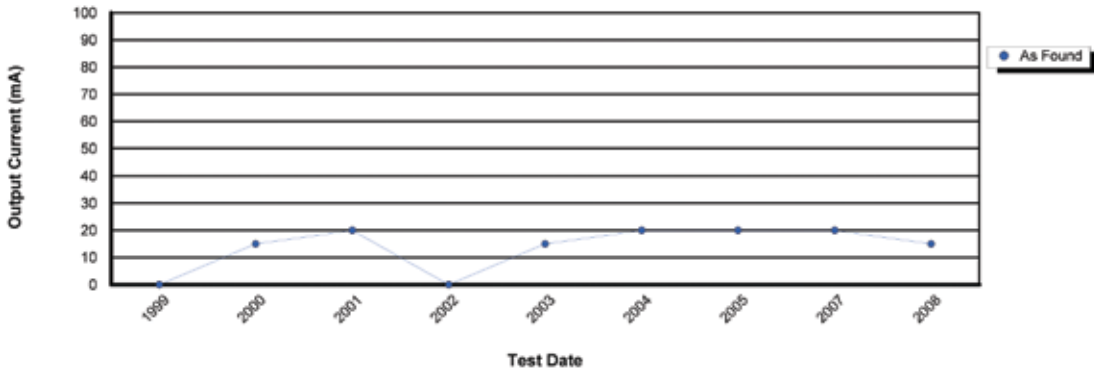
Daily As Found Currents

The current supplied (apart from the outage in 2002) has been consistently 20 mA or less, representing around 3% of capacity but providing consistent protection.

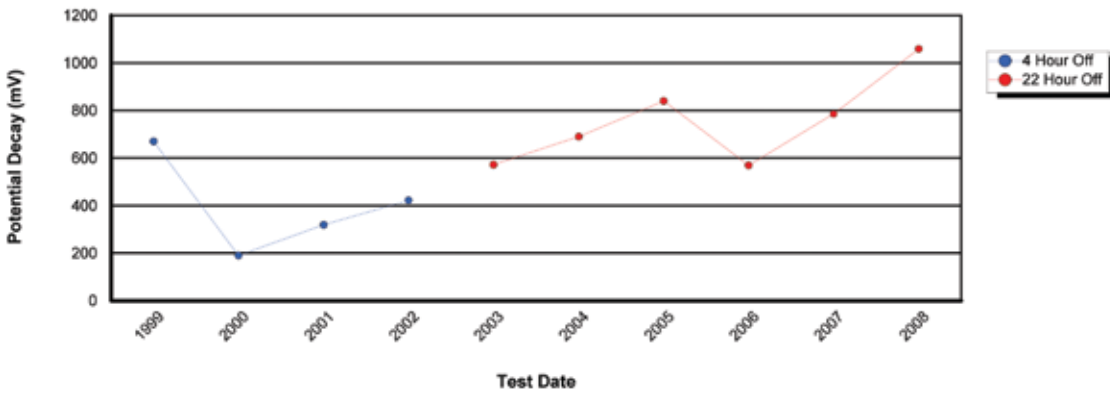
Electrode Potential Decays

The data demonstrate a consistent achievement of 100 mV potential decay and a shift of end of decay potential towards a less active potential (-360 mVCSE toward -275 mVCSE) that would represent a move from high to medium risk if left unenergized.

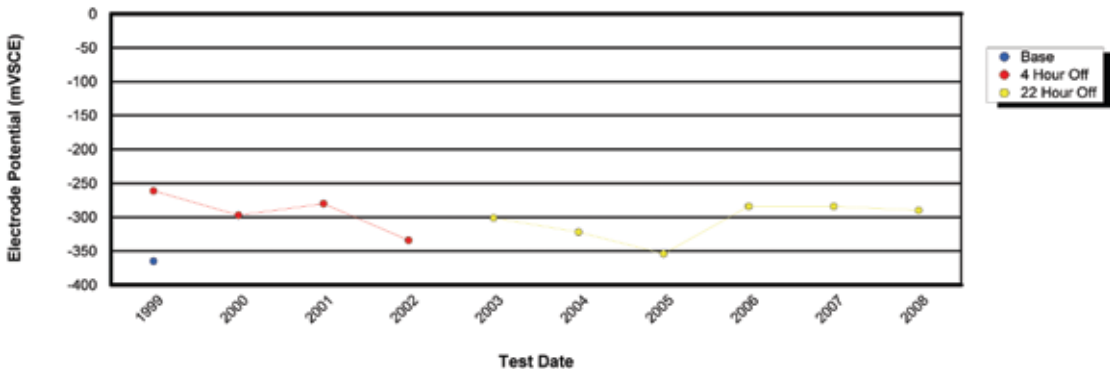
End Of Decay Potential

The data also show us that without the ICCP system operating, the building would revert to a corrosion condition even after 10 years of operation.

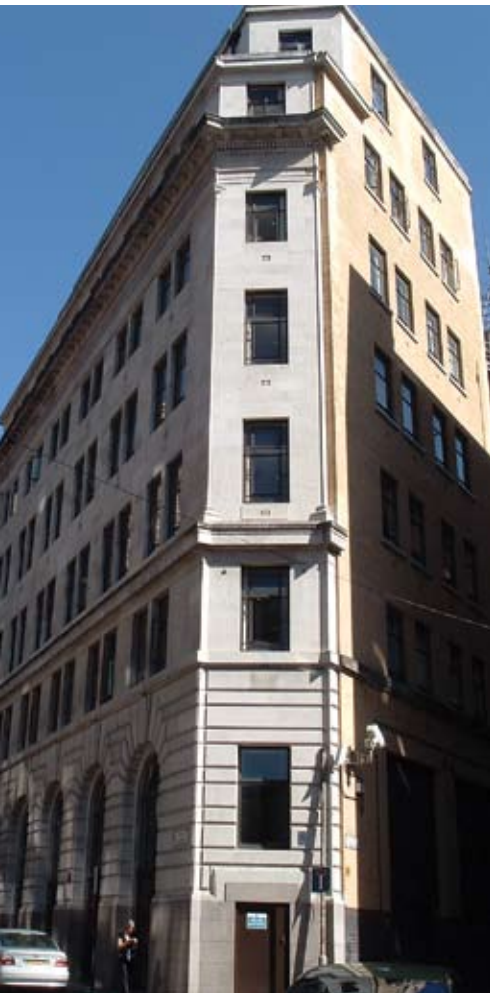
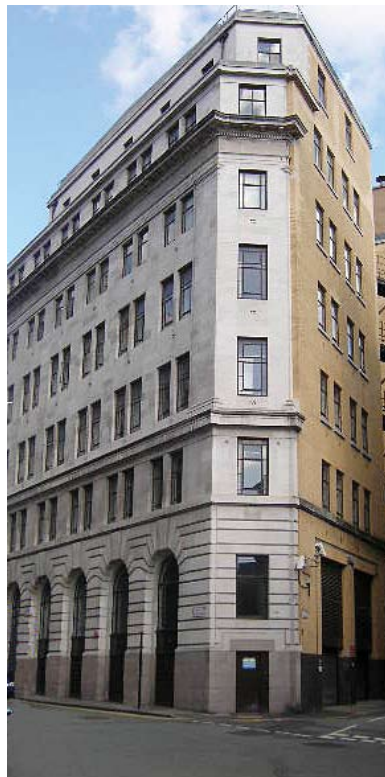
A view of Arkwright House after the works have been completed (left) and after 10 years since restoration was completed (right), showing no signs of deterioration
