# CCNPP Intake Structure Repair and Cathodic Repair Project

Lusby, Maryland

Submitted by Structural Preservation Systems

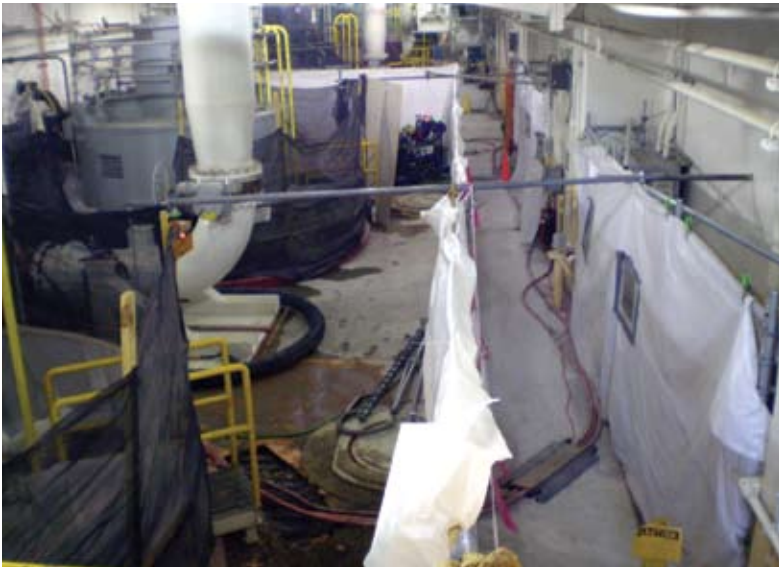
*The setup of the protective area demonstrated the phasing and challenges of all the equipment that had to be worked around*

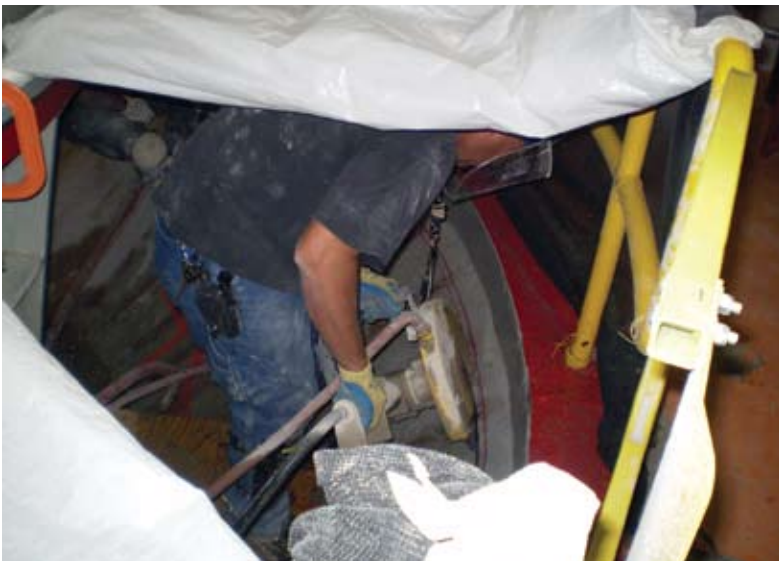
*Saw cutting of slots in CWB. Tight quarters made planning of the work critical to the success of the project*

For the intake floor, an average of 6.5 in. (165 mm) of concrete was removed, a cathodic protection ribbon was installed, and a new concrete floor was placed to replace the old floor. With the CWB and SWP, concrete was removed to 1 in. (25 mm) under the reinforcing steel, a cathodic protection ribbon was installed, and the concrete was replaced. In areas where concrete was removed, the cathodic protection ribbon was installed at 12 in. (305 mm) on center and 1 in. (25 mm) above the reinforcing steel. The patches could then be formed and repaired with new concrete. In areas where the concrete was sound, the ribbon still had to be embedded into the concrete. To allow for proper ribbon placement, 1 x 2 in. (25 x 50 mm) slots were cut into the concrete, which then had grout placed over them. Approximately 3.5 mi (5.6 km) of saw cutting was required to install the ribbon in the concrete surface.

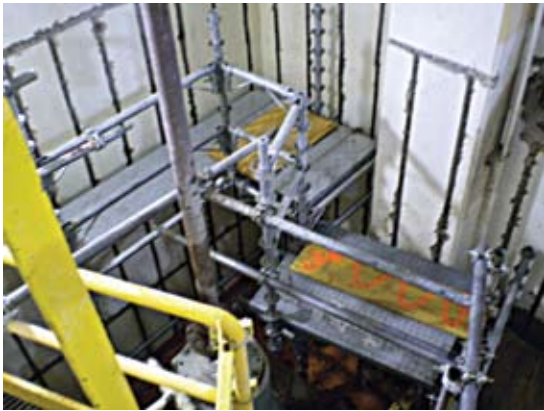
*Intricate scaffolding required to cut slots and perform concrete demolitions in SWPs*

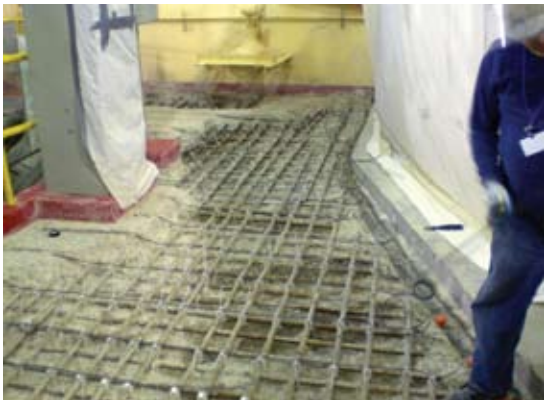
*Anodes were attached with zip ties to a nonconductive spacer to keep it off the reinforcing steel, preventing shorting of the system*

Placing the overlay on the intake structure floor presented other challenges. The ICCP system is 1 in. (25 mm) above the reinforcing steel and cannot touch the steel (this would result in a short of the system, which renders it useless). To overcome this challenge, the entire floor was decked with boards. As placement and finishing operations progressed, the boards were pulled up and removed from the work area. Additionally, the location of the concrete truck access in relation to the placement point exceeded 400 ft (122 m). This required a concrete mixture design that used ice, retarder, and plasticizer to ensure all placed concrete met strict NRC criteria.

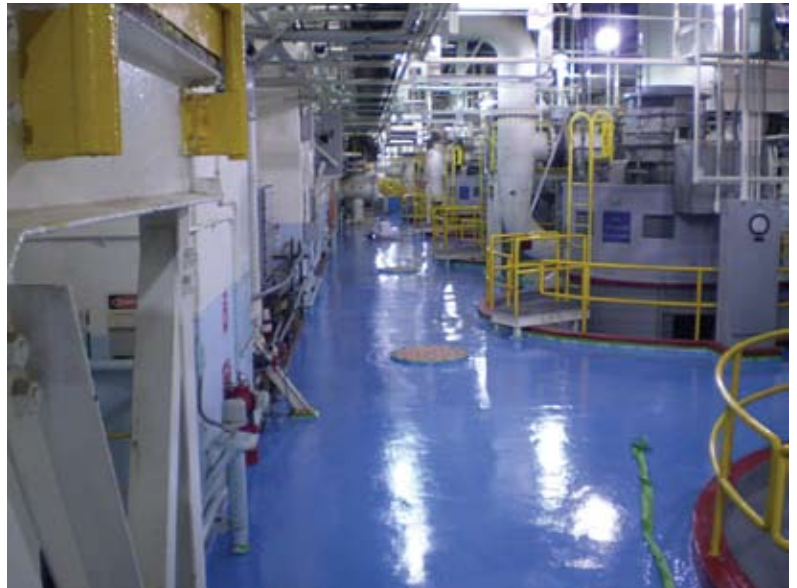
*Project completion—Unit 2 of intake structure after floor coatings*
