Restoration of Large Diameter Prestressed Concrete Cylinder Pipelines

Water Flow, New Mexico
Submitted by QuakeWrap, Inc.

San Juan Generating Station, New Mexico

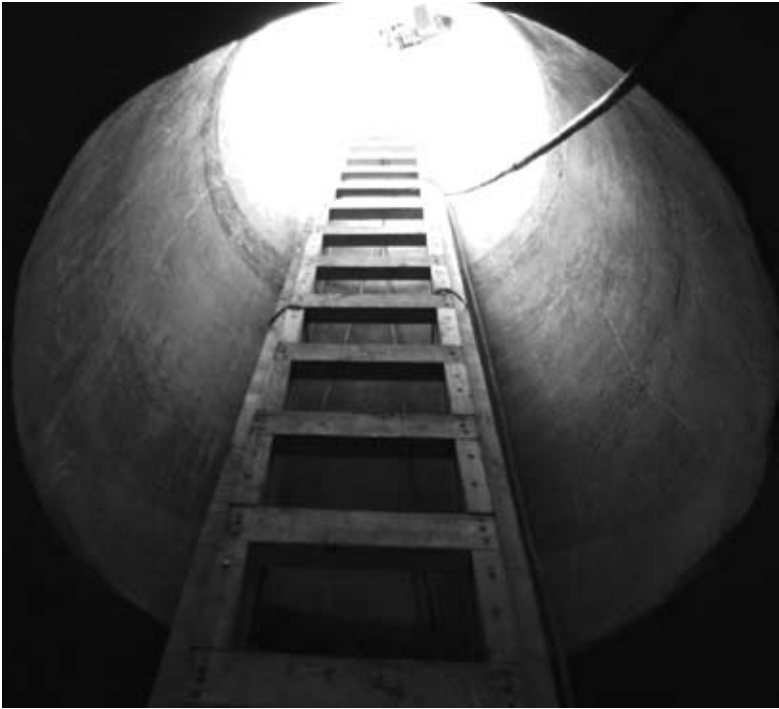
The only access to pipe was through 30 in. (760 mm) diameter manholes

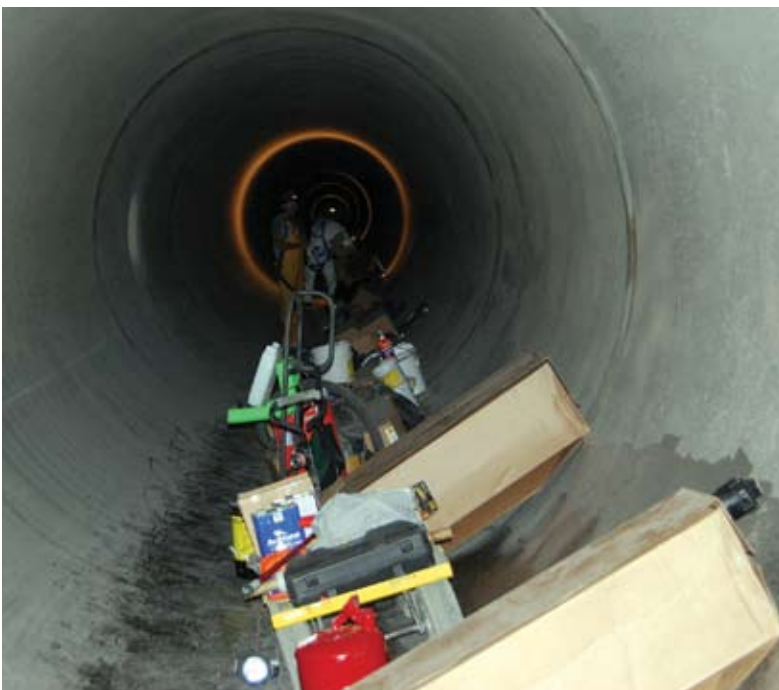
Materials were spaced out throughout the 840 ft (256 m) long section of pipe

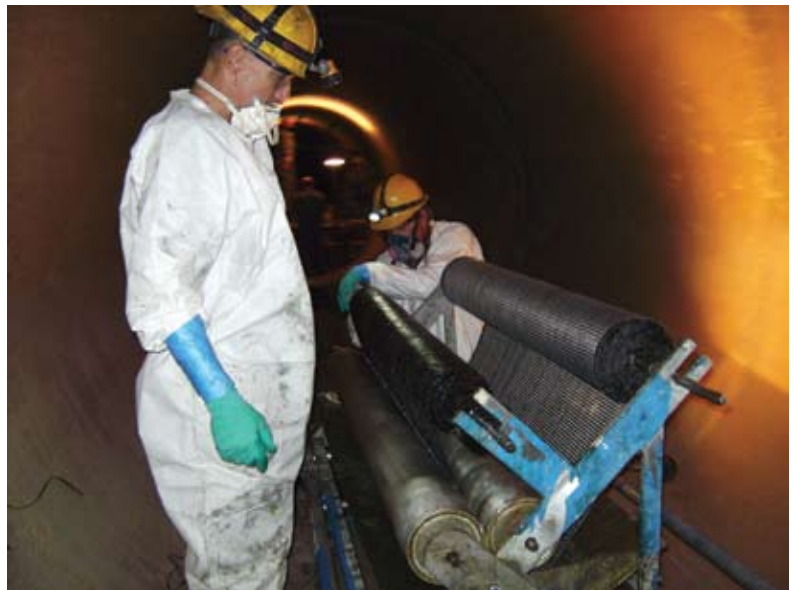
Saturating machine reassembled inside the pipe

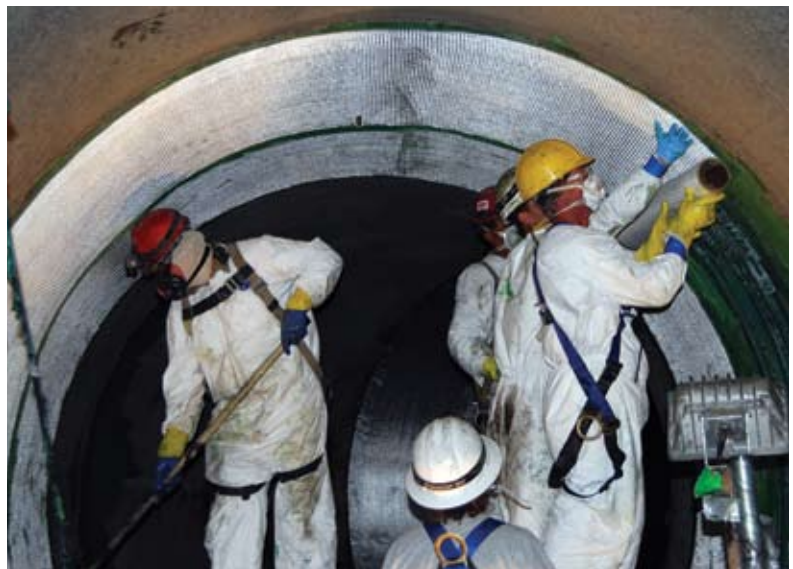
Installation of glass fabric on pipe

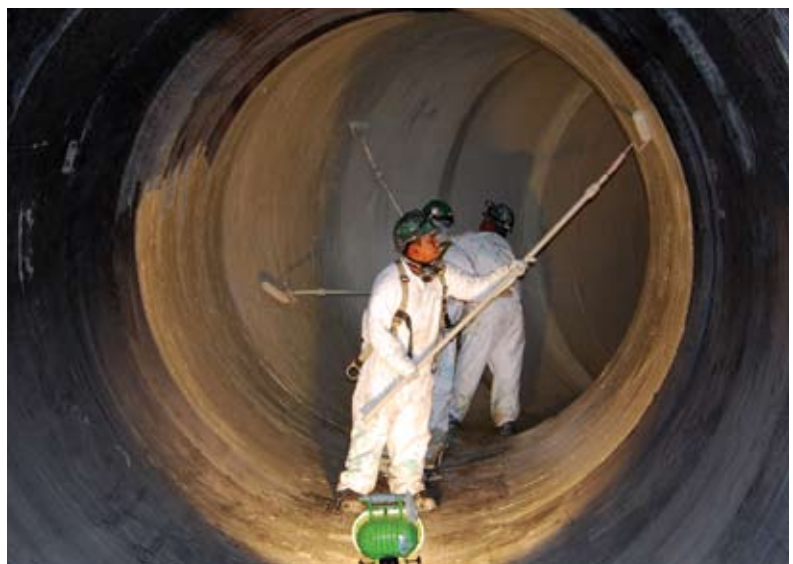
Application of final finish coating over installed FRP
