# Missouri State University's Historic Quad Restoration

Springfield, Missouri

Submitted by Structural Engineering Associates, Inc.

2008 Award of Excellence

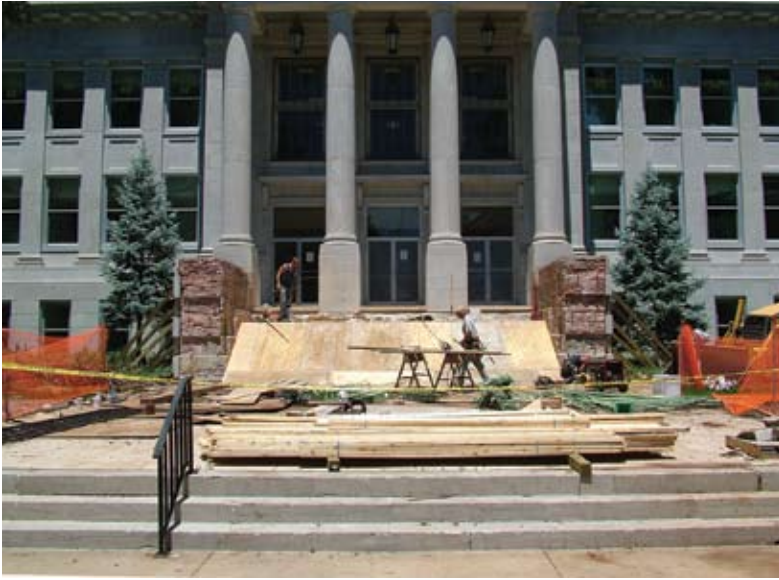
Sicheluff's front steps were constructed of concrete with limestone treads with walls constructed of brick and stone veneer. Corrosion was so significant that full removal and replacement of the concrete stairs was required. After the new concrete stairs were constructed, a new sheet-applied waterproofing membrane was installed to prevent water and chloride

*Stair removal and replacement on Sicheluff Hall*

infiltration. During this process, the limestone steps were removed and stored for reinstallation. These steps were evaluated to determine which stones could be reused and which needed replacement due to deterioration from the elements. After the reinstallation, the replacement stones were stained to provide a color match to the original 80-year-old stone steps.

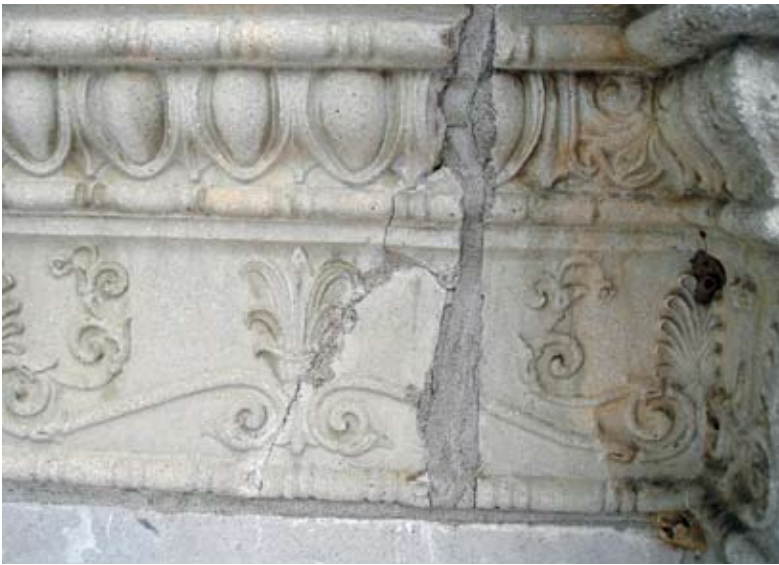
*Cast stone on Carrington Hall prior to repairs*

Carrington Hall, the second phase of this project, showed signs of deterioration from the elements. Mortar joints were deteriorated, cracked, or missing and some of the stone showed signs of general deterioration. At one time, space was added to the building by enclosing open-air entry ways. Stone and cast stone were removed from their original locations and reused to clad the addition. This process was not kind to the stone, damaging it and leaving a multitude of small chips in the face of the stone. In addition, one of the cast stone parapet caps had once been replaced with a very poor match.

To repair the mortar deterioration, the building was tuckpointed and sealant joints were replaced. Damaged stone was patched using a stone patch material that was specially formulated to match the existing stone. The end result was stone and cast stone patching that was virtually undetectable from the ground surface.

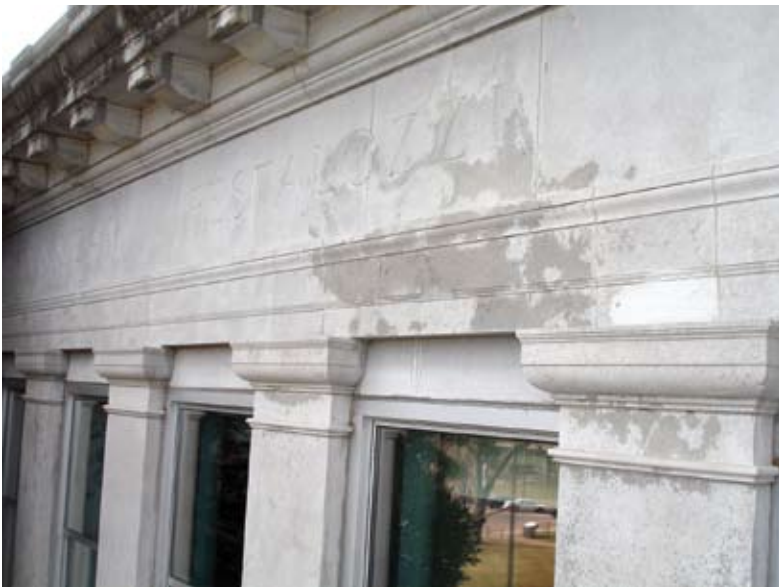
*Deterioration and discoloration of stone on Hill Hall*

Hill Hall was the final phase of the Quad Restoration project. After the initial building investigation, it was clear that the major concern was deterioration of some of the building stone. Signs of moderate deterioration indicated that if steps were not taken, the deterioration, fractures, and spalling could advance to the point where the original beauty of the building could be scarred forever. A stone consolidator was applied to certain portions of the stone that showed deterioration.
