SUNY Health Science Center Brooklyn Parking Structure Strengthening

Brooklyn, NY

Submitted by Carl Walker, Inc.

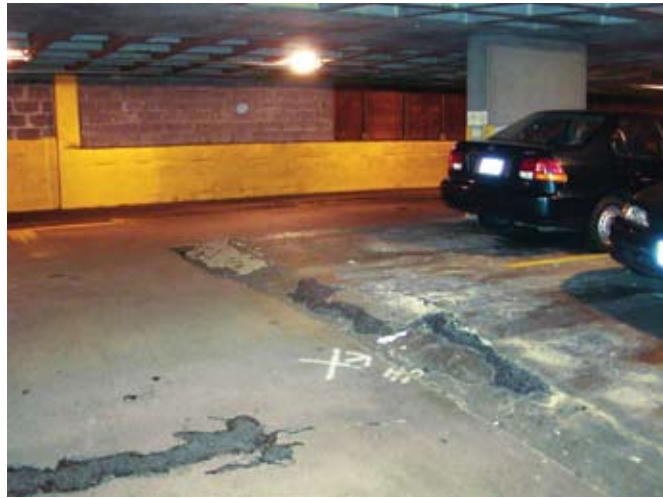
The 6 in. (15 cm) thick concrete overlay located along the interior columns was found to be in poor condition. Numerous areas were observed where the top surface of the concrete had spalled off, leaving reinforcing steel exposed. Open spalls in the overlay area lead to further deterioration and created potential tripping hazards for patrons using the garage structure. It is also evident that in many locations, the concrete overlay was no longer bonded to the structural system below, raising doubts about the effectiveness of the strengthening retrofit. Based on the survey of representative areas on each level, it was estimated that on some levels as much as 70 to 80% of the overlay was either debonded or delaminated.

Deteriorated concrete overlay with trip hazard

In the design stage, it was determined that cutting slots and installing FRP bars was a good solution, the limited cover on the reinforcing steel created a concern of cutting steel. Therefore, the final repair system selected was to shore the floor, remove the concrete overlay, epoxy-inject cracks, apply carbon FRP on the top side of the slab, then install an extra layer of epoxy resin and a urethane traffic bearing membrane.

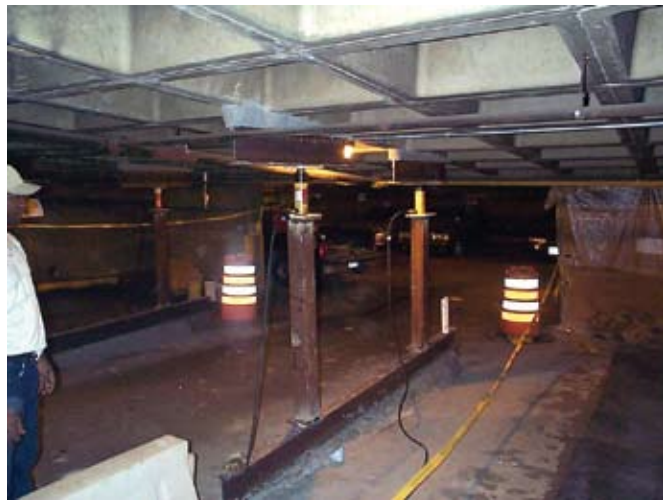
Load test of trial strengthening area

loads without the FRP should a fire occur, or extreme wear/abrasion over time cause damage. It was also determined that two test areas would be completed and load testing of the structure after strengthening be completed to verify capacity. The trial areas and load testing were completed successfully with the final repair program being bid out after 1 year of successful in-place performance.

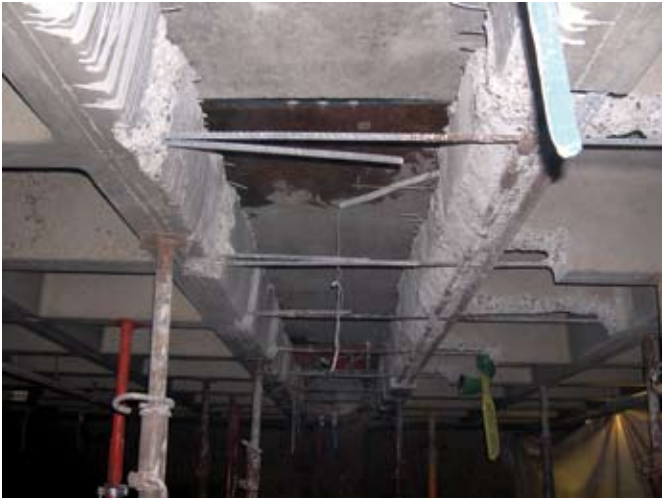
Full-depth concrete repairs

Prior to installation of the FRP strengthening materials, the existing concrete surface was patched in areas of divots, spalls, and the structure long notch created in the slab to tie in the original overlay. The floor surface was shotblasted prior to FRP installation. The main existing crack was epoxy injected.

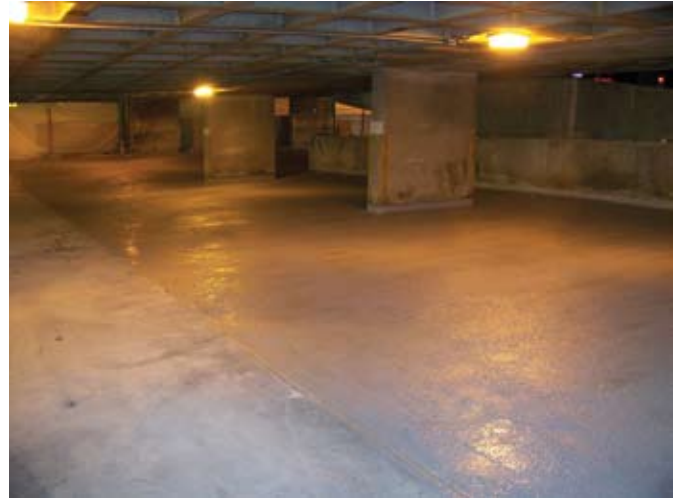
Final surface with vehicular traffic bearing membrane

The surface was primed and then two layers of carbon FRP were installed. A saturator was used to saturate the fabric prior to being applied. To provide a durable wear-resistant protection for the structural FRP, an extra layer of epoxy resin was installed on top of the second layer of FRP. A urethane traffic bearing membrane was then installed over the entire area and adjacent unstrengthened concrete areas to provide a uniform and waterproof coating.

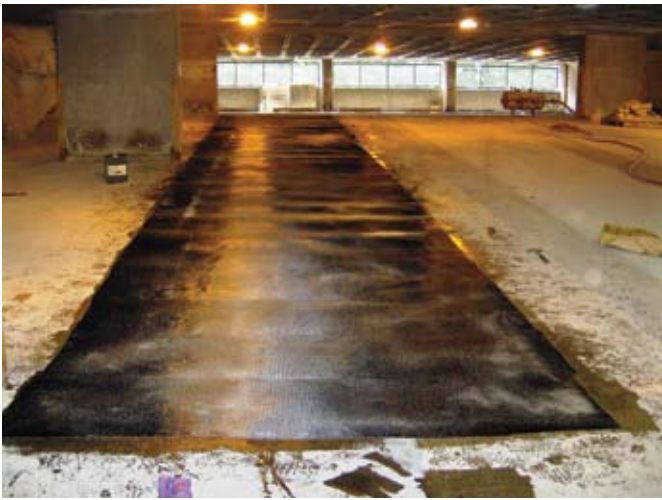
FRP strengthening
