# 440 West Condominium Parking Garage Repairs

Clearwater Beach, Florida

Submitted by The Euclid Chemical Company

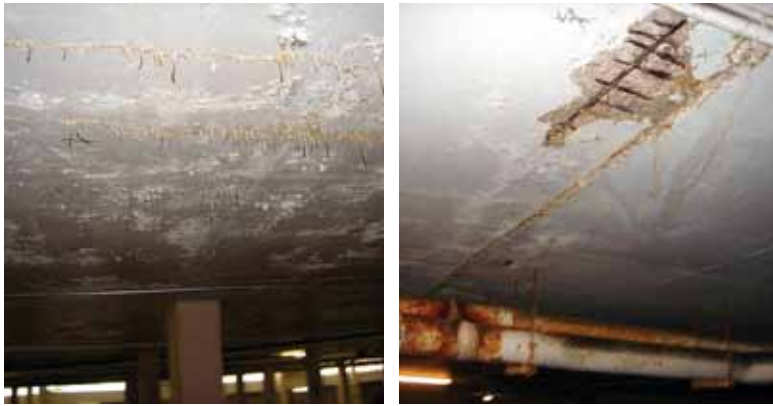
Large scale corrosion damage was obvious throughout the garage; stalactites were growing from some ceiling cracks. Water constantly leaked through the ceiling. The corrosion appeared to have been caused, in part, through exposure to a salt-rich coastal environment, exacerbated by cracking and inadequate coverage over the reinforcing steel. Due to its proximity to salt water, the humidity (moisture availability) within the garage area routinely reached 100%. Small holes and poor consolidation of the concrete were visible everywhere. These conditions suggested elevated porosity and subsequent corrosion risk.

*Deterioration prior to repair*

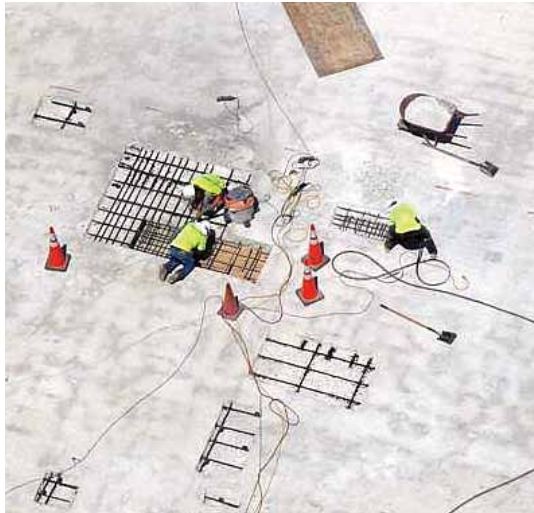
*Repairs to top deck prior to waterproofing*

Prior to the repairs, existing sand-set concrete pavers and a previously installed aliphatic waterproofing membrane were removed. Pavers were removed by hand and the sand was shoveled and swept away. The existing membrane was removed using a combination of shot-blasting and grinding. The top deck was then mechanically sounded with chains to find delaminated concrete. The many facets of surface preparation required were in accordance with ICRI Technical Guidelines.

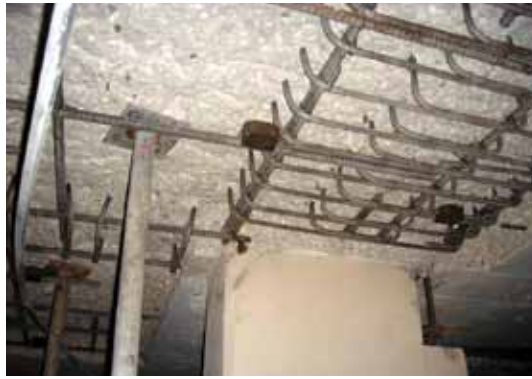
*Sacrificial zinc anodes at repair perimeters*

An overall corrosion management scheme was detailed by the engineer during the bid phase. The plan combined three essential elements: fresh, highly alkaline mortar for the primary repair material; sacrificial zinc anodes at repair perimeters to combat the "anode ring" effect; and an aliphatic, rapid curing, elastomeric waterproofing membrane on top of the slab.

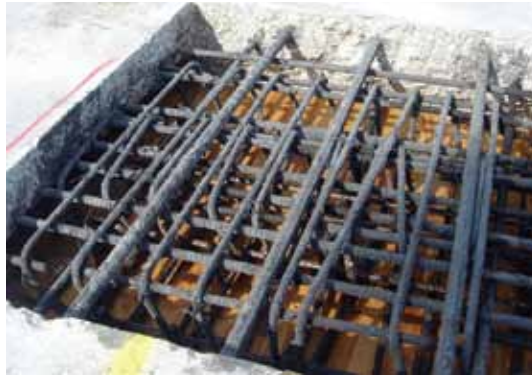
The conservative 1970s design methodology used on the slab resulted in heavily reinforced concrete. The concrete repair crews, therefore, had to take special care to ensure complete encapsulation of the reinforcing steel. At one point, a routine quality control test revealed voids (air pockets) in the repair material on top of the lower reinforcing steel mat. The owner became concerned that all of the repairs in the parking garage might have voids. To save time and expense, the engineer recommended nondestructive testing as a way of locating additional voids in the slab (if any) and determining the extent of the problem.

*Congested steel reinforcement*
