Structural Rehabilitation of a Chloride-Contaminated Concrete Silo

Lagoa, the Azore Islands
Submitted by STAP, SA

Lagoa Concrete Silo

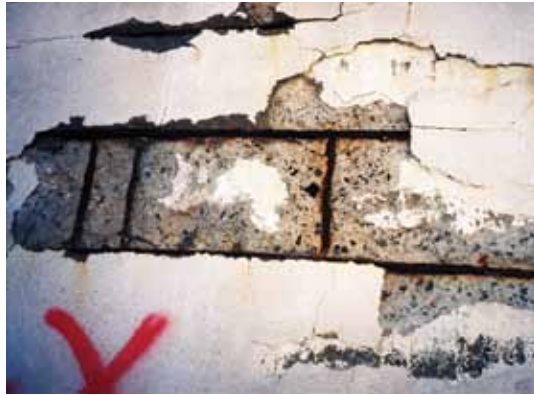
The silo was built by the slipform method, using very porous volcanic aggregates and beach sand. For some years, there were signs of significant deterioration—mainly widespread concrete spalling due to corrosion of reinforcement (Fig. 1).

On the external surfaces, the concrete cover thickness of cover varied significantly. The mean thickness values ranged from 0.6 to 1.3 in. (16 to 35 mm). The depth of carbonation ranged from 0.4 to 2.6 in. (10 to 65 mm). In 75% of the cases where reinforcing was exposed, the carbonation depth was found to equal or exceed the thickness of the cover.

Chloride content was also high—0.6 to 1% of cement mass at reinforcement depth—and showed

Fig. 1: Area showing severe deterioration, marked for concrete removal

that the high chloride content on the external surfaces was mainly due to the diffusion of the airborne chlorides.

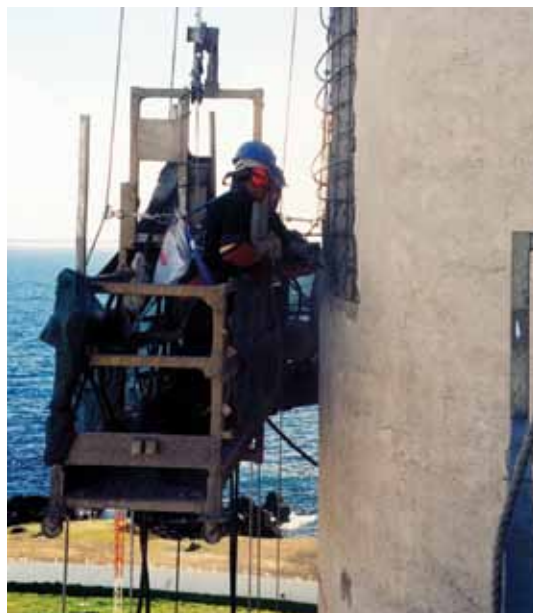
Fig. 2: Removal of deteriorated concrete

- a) Removal of deteriorated concrete using light pneumatic hammers (Fig. 2), with care being taken to avoid formation of thin scales at the repairs' boundaries during the ensuing spraying of repair concrete;
- b) Cleaning of the exposed reinforcement to remove all corrosion products;

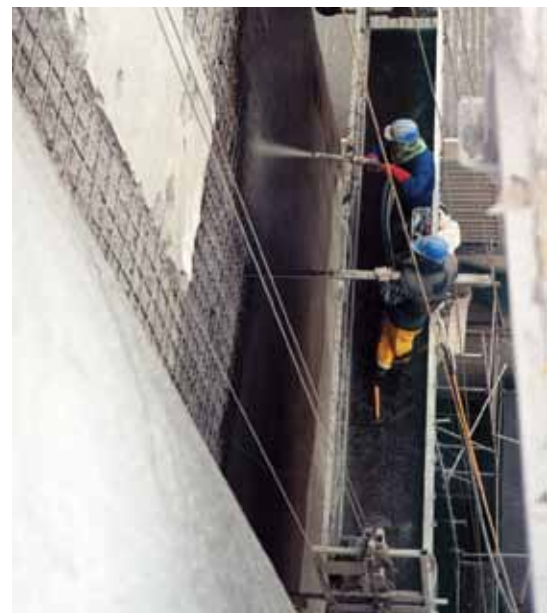
Fig. 3: Concrete spraying

- c) Dry-mix shotcreting using double-chamber machines, assuring a concrete cover of 1.6 in. (40 mm) minimum (Fig. 3);
- d) Spraying of the migrating corrosion inhibitor; and
- e) Application of acrylic paint on all external concrete surfaces, of a coat with dry total thickness of 6 mils (150 micron).

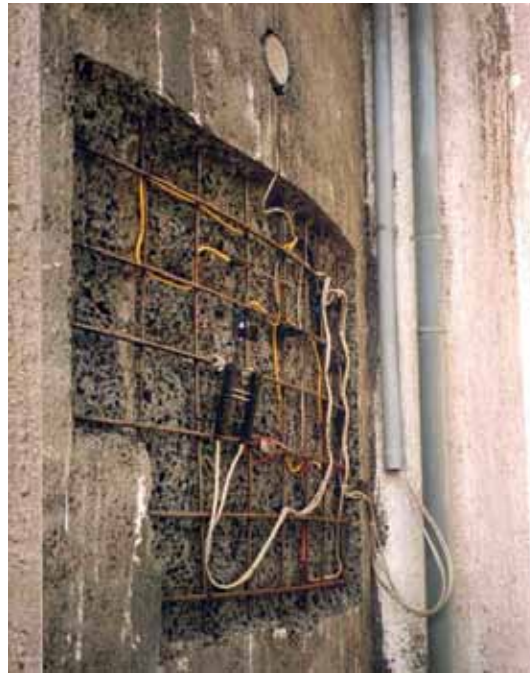
On the repaired surfaces, four areas of 10.8 ft² (1 m²) each were chosen (Fig. 4). Close to each monitored area, a sensor was placed in the original nonrepaired concrete (top of Fig. 4).

The values of the potential in the repaired areas were initially very negative. After 2 years, however, they were shifting to less negative values, a trend compatible with the repassivation of the reinforcing steel. In these areas, the macrocell current values obtained during the 8 years up to 2008 have been very low, indicating low corrosion activity. The agreement between the values of the macrocell current with the values of the potential measurements indicates that the reinforcing steel has been maintained in the passive state and is, therefore, free of corrosion. This demonstrates the effectiveness of the repair method for the monitoring period.

In the areas where the concrete was not replaced, the values of the macrocell current initially obtained were also high, indicating some corrosion activity. Again, the values decreased with time to levels of the same order of magnitude of those measured in the repaired areas. This indicates a reduction of the corrosion activity and its absence because the rehabilitation works, in spite of the concrete still being contaminated with chlorides.

Fig. 4: Monitoring system—sensors to be embedded in the new concrete and inserted in the existing concrete (top)

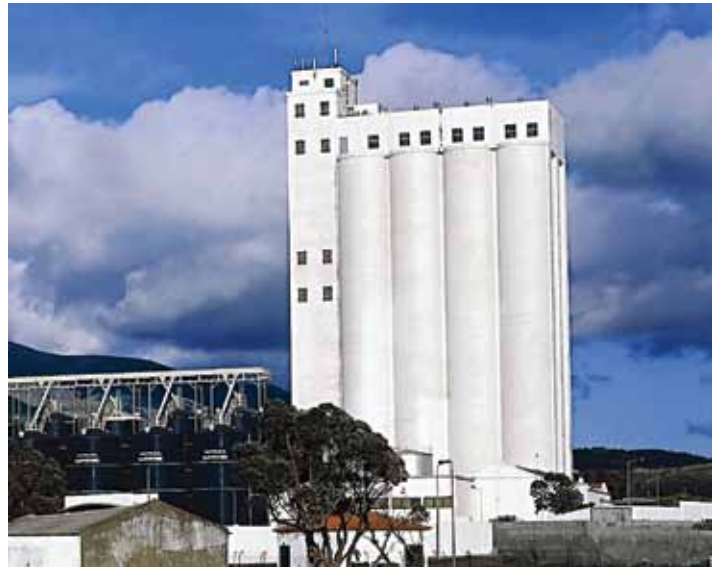
The rehabilitation of the Lagoa Silo (Fig. 5) presented various challenges: design and construction deficiencies, budget limitations, operational constraints, and an adverse job site environment. The project success can be credited to the excellent partnership developed between owner, designer, and contractor, enabling a strict compliance with the appropriate methodology of structural concrete rehabilitation throughout the intervention and beyond. The project is now nearing the term of its 10-year warranty. Monitoring will continue to enable timely maintenance and to make sure that the silo goes on fulfilling its role in satisfactory safety and operational conditions.

Fig. 5: Recent view of the rehabilitated Lagoa Silo
