# The Solomon R. Guggenheim Museum Exterior Restoration and Building Enhancement

New York, New York

Submitted by WASA/Studio A

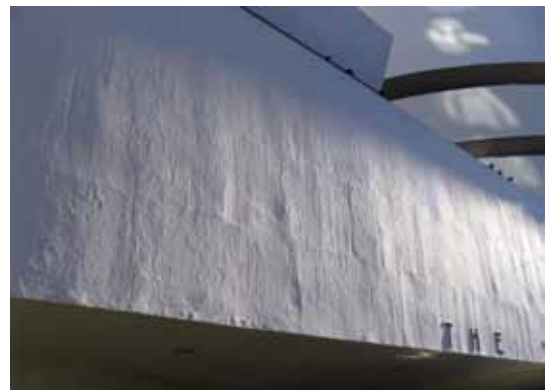
*Guggenheim Museum's Fifth Avenue façade showing coating failures before repair work*

sculpted in its green and cured stages for accurate textural matching of adjacent surfaces, particularly the original board-form marks, which were deliberately retained as evidence of authenticity of craftsmanship. A highly-elastic, shape-retentive acrylic filler was installed in cracks and a flexible cementitious mortar was used on concrete surfaces for protection against water, salts, and carbon dioxide penetration. A state-of-the-art opaque coating, which mimicked and enhanced the quality and properties of the original “cocoon” finish, an early version of elastomeric paint, was applied to protect the concrete and repair system.

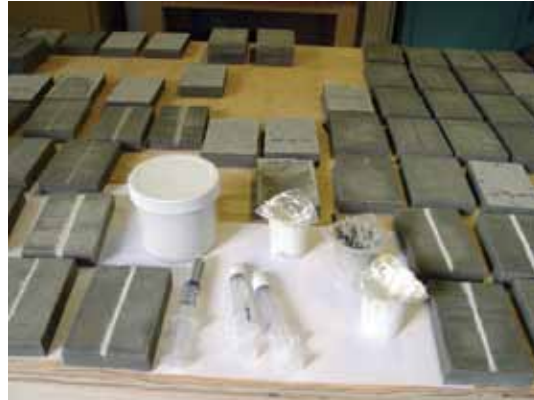
*Replicas of existing shotcrete and selected repair systems at the project's architectural conservator's laboratory*

Along with materials analyses, a detailed testing program was implemented to choose the most appropriate repair system, including crack fillers, patching materials, and protective coatings. This work was carried out in the laboratory and in the field. Laboratory studies of proposed conservation products were done on test panels that replicated the composition and properties of the original gunite, the primary exterior material. The testing included accelerated weathering in an ultraviolet light chamber (QUV) by freezing and thawing, water-vapor transmission rate measurement, and adhesion and color change assessment before and after QUV exposure. The field work consisted of two rounds of mock-ups at different locations on the building with the limited number of repair systems that had performed well in the laboratory test program. These mock-ups were monitored over a 1-year period.

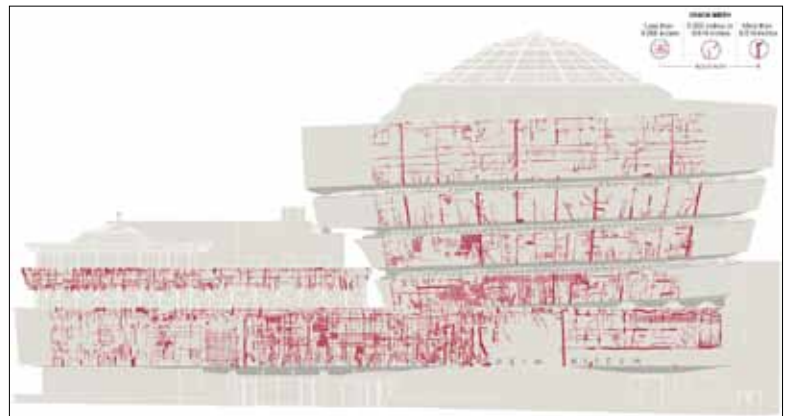
*Fifth avenue façade elevation and crack documentation (blue print)*

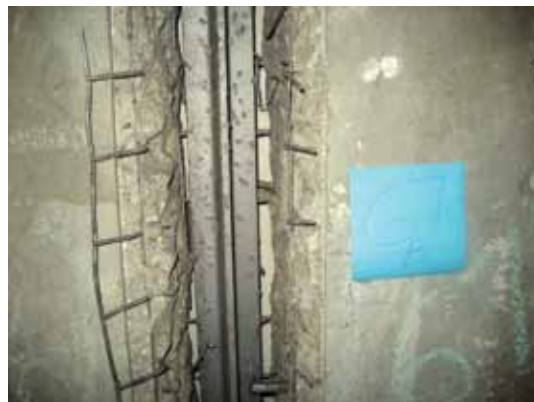
wall, the horizontal reinforcing was found to be discontinuous due to embedded vertical steel elements spaced approximately every 10 ft (3 m) along the ramp. The top ramp wall is double the height of the other ramp walls so a larger steel element was used in the original construction, leaving insufficient space for the reinforcing to be continuous. Deficiencies were also identified at the connection of this exterior top wall to the ramp slab and to the main load-bearing walls.

*Exposed sixth floor 2-1/2 x 2-1/2 in. (63.5 x 63.5 mm) steel tee after abrasive cleaning*

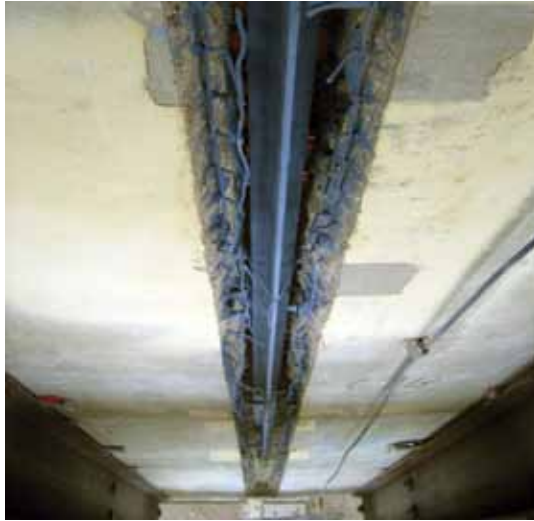
*Remedial control joint at sixth floor tee location*
