Camp Verde Wastewater Treatment Plant Repair

Camp Verde, Arizona

Submitted by Truesdell Corporation

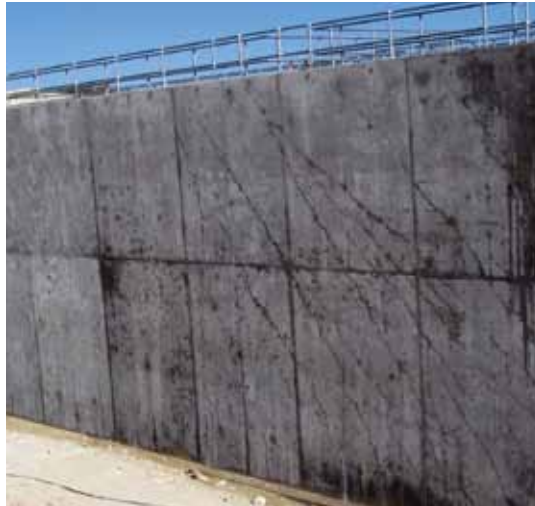
Extensive visible cracking in concrete walls

Cracks in the tank walls that developed during the filling for the leak testing were epoxy injected. Cracks, measuring over 3000 lineal ft (914.4 m), developed in two walls and were repaired using high-pressure, two-component epoxy injection.

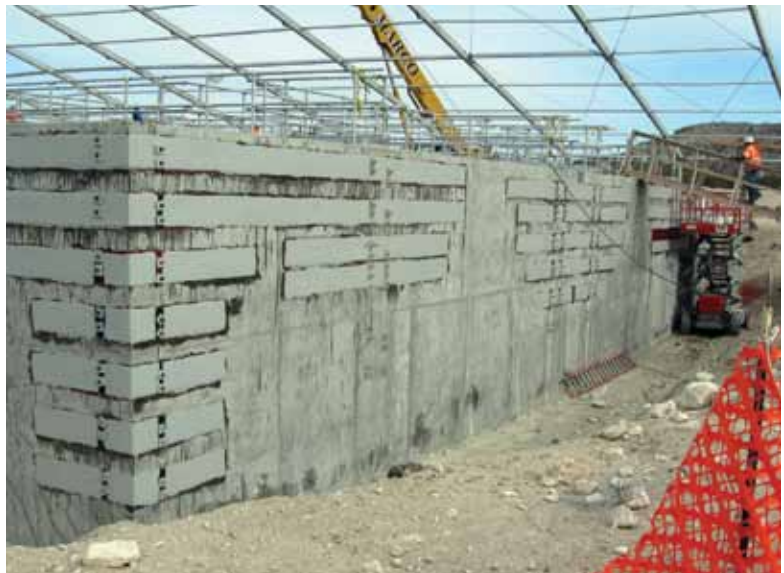
External corner of structure showing CFRP, anchorage, and temporary tent erection

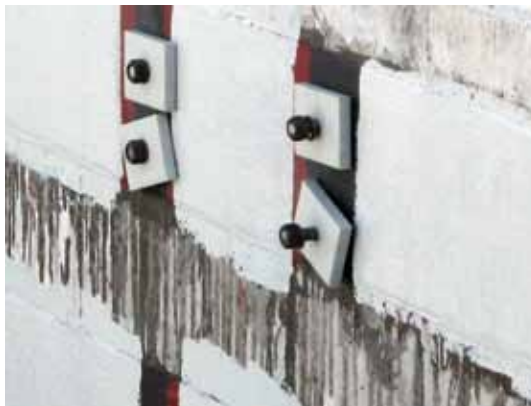
Bolts and plates at wall intersection (opposite side of wall pictured)

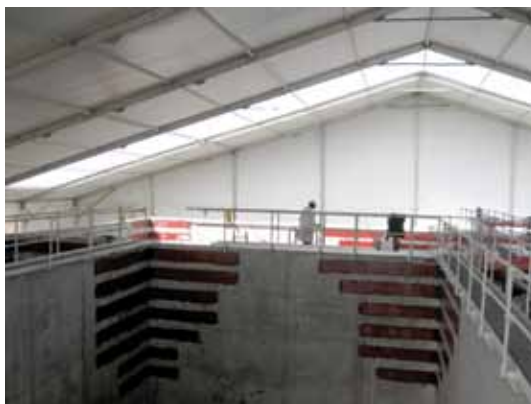
Ambient winter conditions required temporary heat and tenting of entire structure

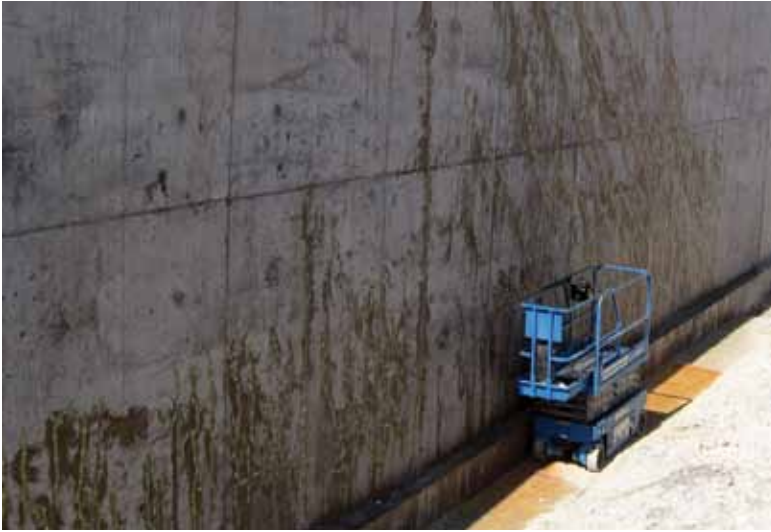
High-pressure epoxy injection of cracking

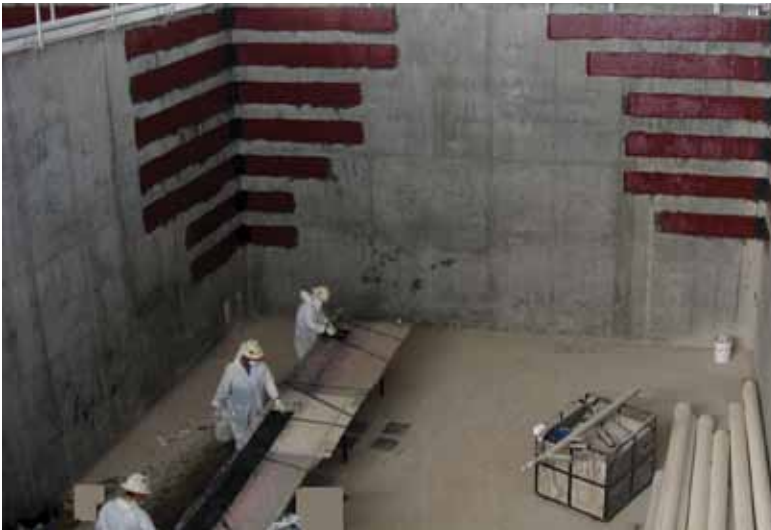
Saturating station in a single cell

A central mixing and carbon-fiber cutting and saturating station was created in one of the central cells. The mixing station was able to simultaneously accommodate up to four installation crews all requiring specific individual material lengths in specific order. The wall surfaces were primed with impregnating resin. Unidirectional carbon fiber was installed by wet layup method at all locations. Over 8500 ft² (789.6 m²) of carbon fiber was installed in 4 days.
