Parking Structures Category

Detroit Metropolitan Airport Blue Deck Parking Structure Restoration

Romulus, Michigan

Submitted by Carl Walker, Inc.

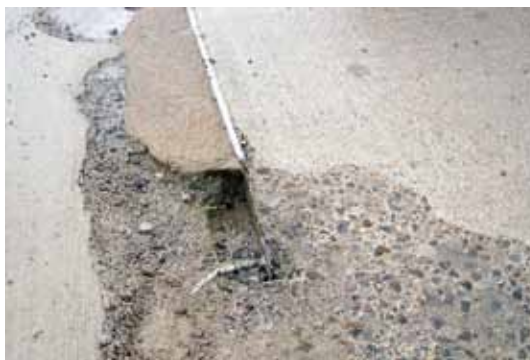
The deck surface experienced significant failure of connectors, causing movement of double-tee elements throughout the structure. Original connectors experienced problems associated with original construction methods, tolerances, and welding procedures and operationally with exposure to abnormal snowplow loads.

Significant failure of connectors causing movement of double-tee elements throughout the structure

The flange-to-flange connector failures were restored by monolithic bonding of the new overlay with a wire mesh-reinforcing layer. Shear-wall rooftop connectors were reinforced during the

Widespread failures of existing connectors required reconstitution and supplanting them with additional reinforcing. The design detailing integrated these procedures with overlay installation. Drain basin reconstitution, which involved strengthening the concrete around the drain, was also performed. Special supplemental reinforcing reconnected shear walls to the structural tee system.

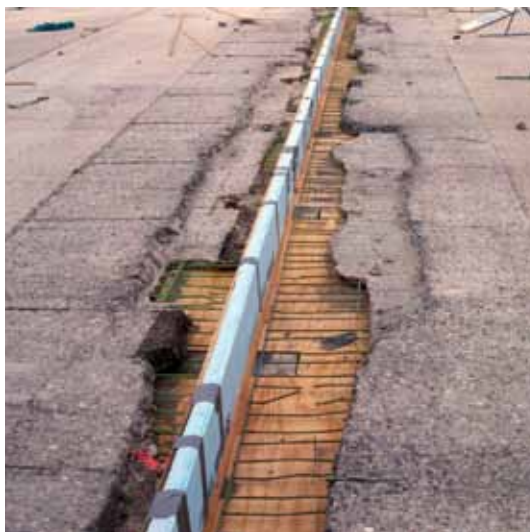
Structural repairs to the concrete tees were completed before the overlay and deck coating were installed

both localized along expansion joints and targeted around drains, were completed before the overlay and deck coating were installed. Additional shear transfer beams were also installed (beneath roof level expansion joints) to replace original devices.

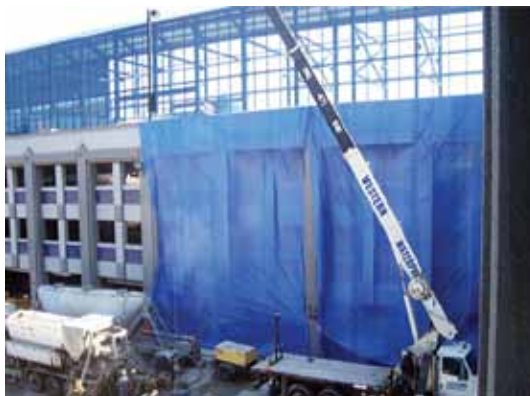
Special steps were taken during surface grinding to minimize dust spread by using tarps

Special steps were taken during surface grinding to limit dust migration by using fogging and to minimize dust spread by using tarps or limiting sandblasting operations. Water jetting was used as a supplement to sandblasting, either for the removal operation or for the final surface preparation.

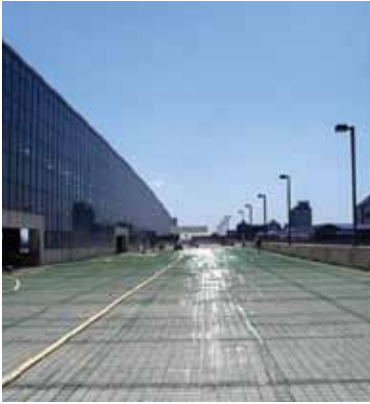
Roof deck with reinforcement in place and overlay to be installed

Supplemental reinforcing, in the form of stitch rods along with additional mesh reinforcing, was used to provide extra strength at those locations where the original connectors could not be repaired. New combined drains were reconfigured and installed to promote better drainage.

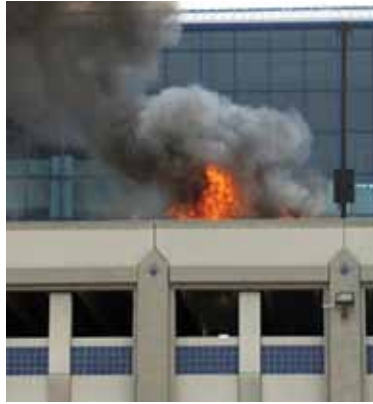
Car fire on the roof of the repaired structure in November 2006

Of special interest was the car fire on the roof of the repaired structure in November 2006. The overlay design limited flame spread in the structure and limited damage to the total structure to less than \$10,000.
