# SCDNR Marine Resources Research Institute Corrosion Mitigation

Columbia, South Carolina  
Submitted by Sika Corporation

South Carolina Department of Natural Resources  
Marine Resources Research Institute

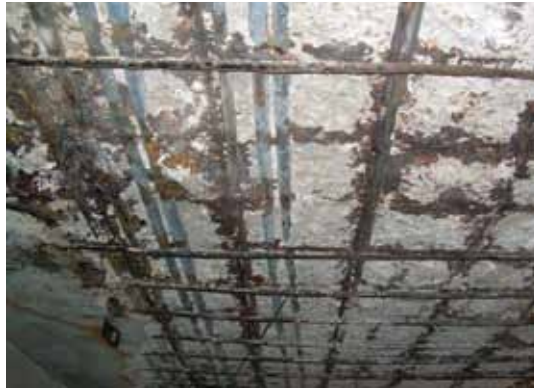
Underside of wet labs show spalling and steel corrosion

It was determined that the root cause of the steel corrosion and resulting spalling was due to high chlorides and, in some cases, insufficient cover. This situation was exacerbated by the marine environment in which the building is situated, as well as the saltwater tanks within the building and the routine washing of various areas throughout the lab.

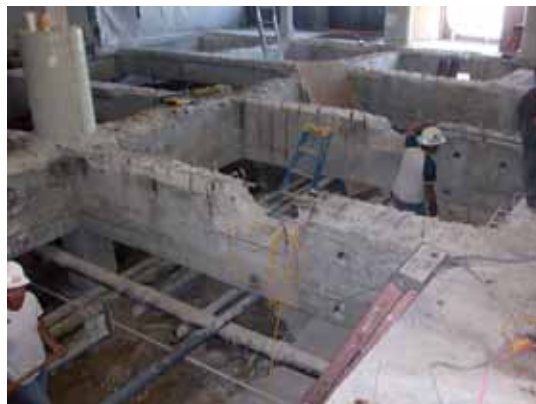
*Demolition at Wet Lab A*

The Wet Lab A area required complete removal of the concrete slab and removal of the upper 5 in. (127 mm) of the beams and girders. Due to the connection of the new floor slab reinforcing being tied to existing beam reinforcing, 100 sacrificial galvanic anodes were installed to reduce the effects of incipient anode corrosion.

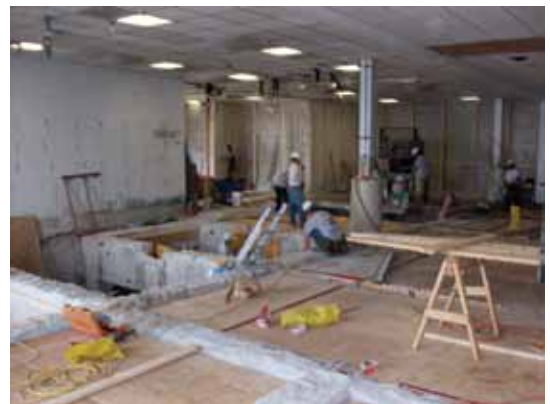
*Demolition and forming*

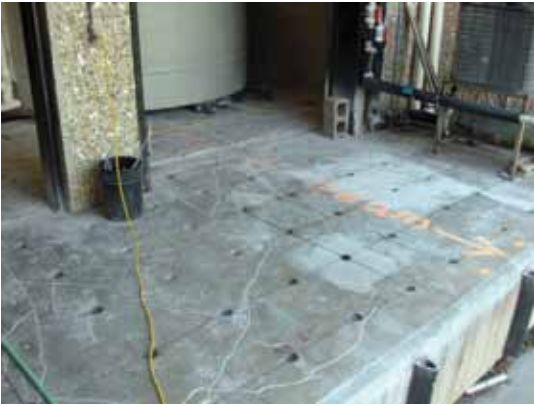
*Cored holes and slots for galvanic protection*

It was determined that the Wet Lab B area did not require complete floor slab removal, but long-term corrosion protection was required. Due to the high levels of chlorides found in the concrete, another system of sacrificial anodes (634 in total) was installed.

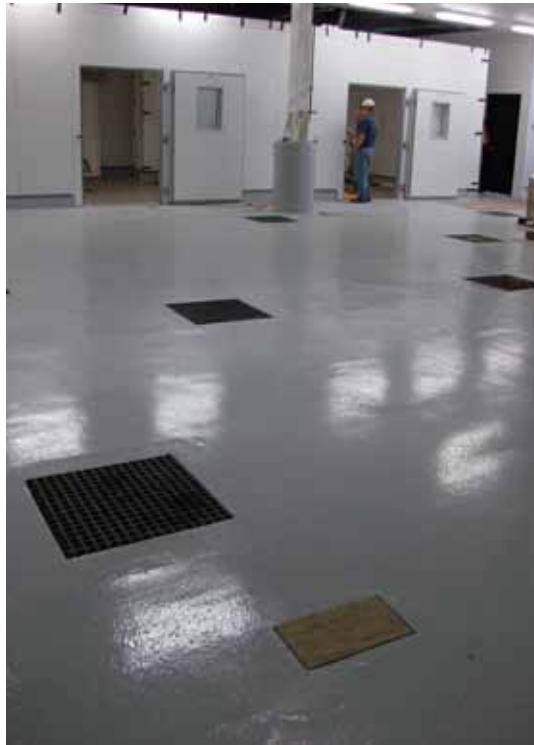
*Completing lab finishes*

The Wet Lab B area received a cementitious overlay to provide better pitch to drains and improve the floor finish. Finally, all wet lab floor slabs (8000 ft<sup>2</sup> [743 m<sup>2</sup>]) were coated with a high-build epoxy floor-coating system.
