St. Louis Union Station Headhouse Façade Restoration

St. Louis, Missouri

Submitted by Walter P Moore

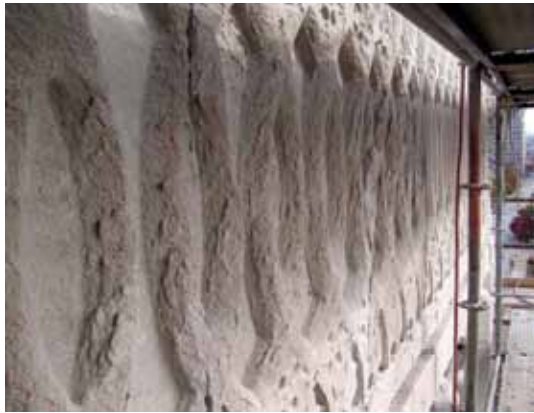
Fig. 2: Surface deterioration of carved elements

Although the Indiana limestone was typically in good condition, certain areas were experiencing significant surface exfoliation, such as vulnerable corners and carved details, as well as areas along public sidewalks where deicing salts were used. Other locations were experiencing deep deterioration that penetrated the entire depth of the stone unit. When possible, the original stone was maintained, and damage was patched to match the surrounding masonry (Fig. 2 and 3).

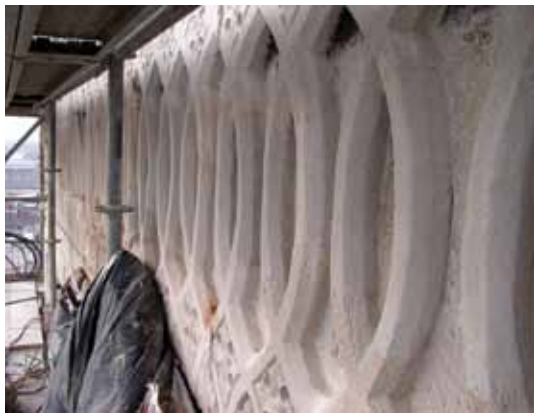
Fig. 3: Same area of carvings after patching repairs

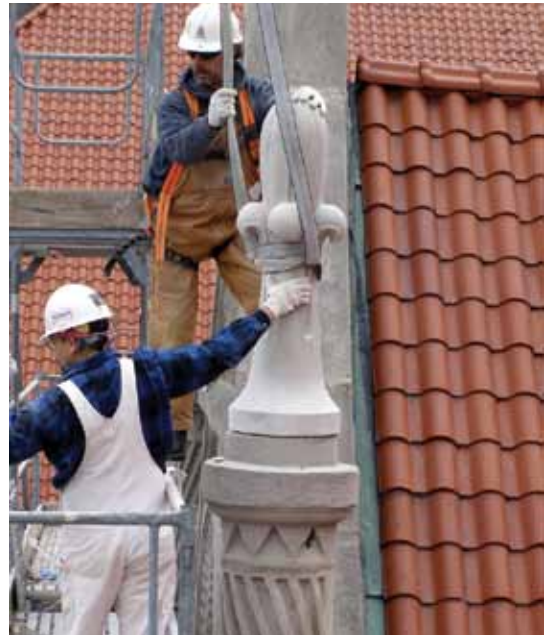
Fig. 4: Installation of new limestone finials to match the originals

During the project, repair masons developed a fondness for the artistic side of stone patching and successfully produced repairs that closely matched the adjacent existing stone. In locations where stone deterioration was too severe to salvage the original units, replacement units were hand-carved to match the intricate surface tooling and ornament created by the nineteenth-century artisans. Lifting the new stone units (each weighing several hundred pounds or more) into locations like pedestals above the roof line and ornamental balconies high on the clock tower required intense coordination between the repair masons and the crane operator (Fig. 4). In addition to patching and replacement of damaged and deteriorated limestone units, mortar joints across all limestone façades of the headhouse were repointed.

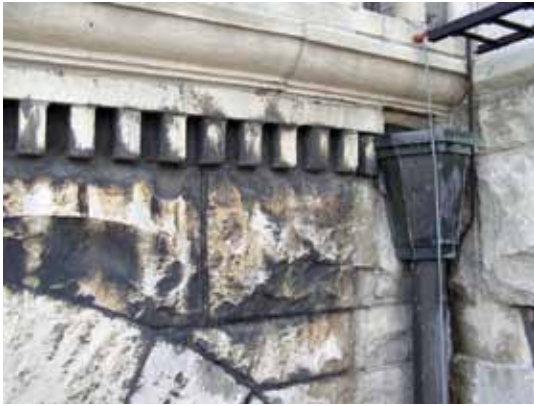
Fig. 5: Heavy gypsum crusts resistant to water spray and chemical cleaning

obscuring the intricate carvings and ornamental detail carved into the limestone with heavy black crusts in many places. Gentle water mist spray was successfully used to remove soiling in most locations, although the heaviest of the encrustations, especially at protected areas such as window arches and under projecting elements, resisted removal by water spray (Fig. 5). These heavy crusts proved resistant to chemical cleaning methods as well. After careful consideration of a number of abrasive cleaning methods, dry soda blasting at low pressure, a cleaning method that uses sodium bicarbonate as the abrasive media, was selected. Petrographic analysis was performed on both cleaned and uncleaned samples of limestone taken from the building, and no adverse effects from the soda abrasive were found. Concerns about residual salts and staining from the soda abrasive were mitigated by providing thorough rinsing with potable water after the cleaning was complete.

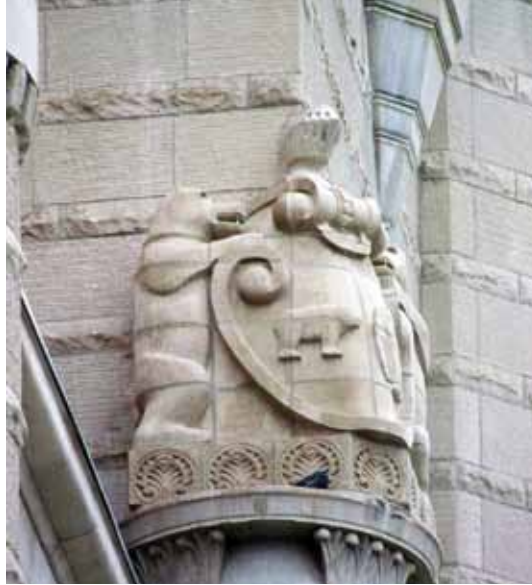
Equally impressive, in terms of the restoration of the building as a whole, was the restoration of the large crest of the Seal of Missouri on the clock tower. From the start of the project, it was the intent of the design team to maintain the original crest and perform patching repairs only as needed. Unfortunately, hands-on examination of the crest revealed extensive deterioration of the limestone, and inappropriate former repairs made with an unknown patching mortar had exacerbated the limestone's deterioration. Cores taken through the thickness of the existing crest revealed stone that was unsound and heavily fractured through its entire depth.

Fig. 6: Installation of the replacement crest is nearly complete

Using photographs to recreate lost detail and to artistically recreate the life-sized bears that flank a massive escutcheon, the new crest was carved from blocks of solid limestone. Design quirks of the original crest, such as the slight projection of the crest over its pediment base, were replicated in the new crest to maintain as much historical authenticity as possible (Fig. 6).

Installation of the new crest was in itself very challenging. Positioned at nearly half the height of the clock tower and above a steeply hipped roof, the crest was well over 100 ft (30.4 m) in the air. Scaffolding had to be cantilevered to access the crest pedestal, and the new stone blocks were slowly lifted into position just a few units at a time to prevent overloading of the scaffold.
