# Terminal Tower Façade Repairs

Cleveland, Ohio

Submitted by Sika Corporation

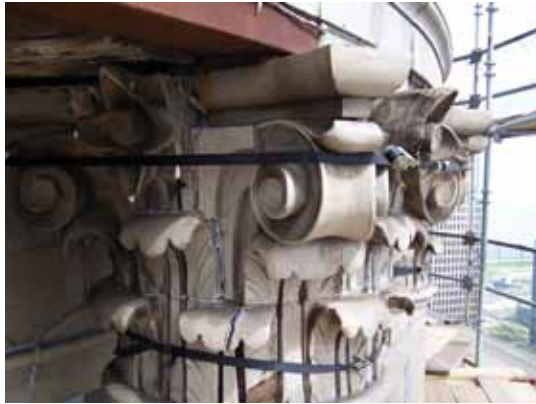
by slowing the evaporation of water. Steel flanges rusted and expanded, causing pieces of terra cotta to loosen and fall and resulting in cornices that needed to be strapped into place.

*Falling pieces of terra cotta needed to be secured with straps*

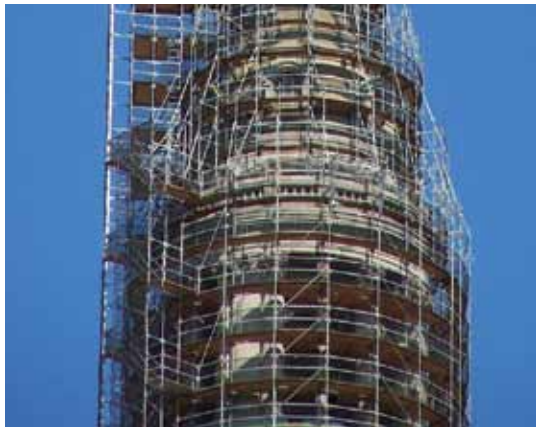
*Scaffolding around the entire 37th to 52nd floors allowed engineers to inspect every square foot (meter) of the façade*

The project started with scaffolding being erected around the entire 37th to 52nd floors. It allowed engineers to inspect every square foot (meter) of the façade. To expose the cause of deterioration at specific sites, selective demolition was used. Repairs were then designed and competitively bid out for that section, with the process repeated for each section as the project moved from floor to floor.

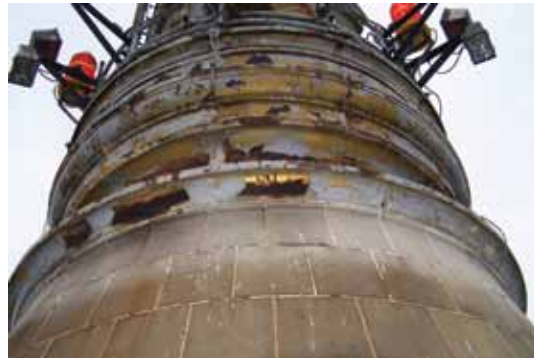
One of the first renovation tasks involved repairs on the cast-iron cupola at the base of the flagpole. Originally, the cast iron served as a form for poured concrete. Over the years, the cast iron had cracked and reinforcing bar in the concrete had rusted. Workers removed all loose and split cast-iron cornices and replaced them with new steel, duplicating the shape of the original. Handrails and windows were replaced, and the area including the existing metal deck was cleaned and coated with a fiberglass-reinforced polyurethane liquid-applied membrane system manufactured to match the original.

*Cracked and rusted cast-iron cornices were replaced with new steel, duplicating the shape of the original*

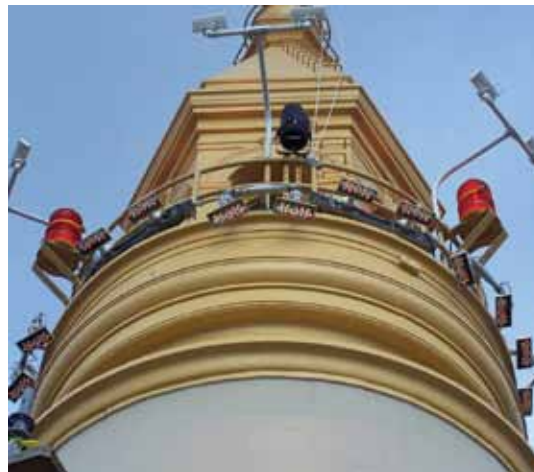
*Fiberglass-reinforced polyurethane liquid-applied membrane in custom gold to match the original*

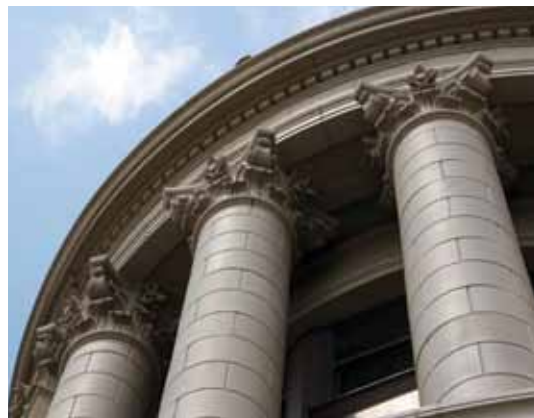
*A total of 32 fiberglass columns replaced the originals*

As the project moved to the 51st floor and below, a method of repair for unsalvageable terra cotta was developed. All loose and broken cornices and rusting and expanding steel lintels that were splitting apart the façade were removed. The framework was replaced with stainless steel and aluminum, and the terra cotta was replaced with fiberglass molded from original pieces. Fiberglass units replaced hundreds of lineal feet of specialized cornice as well as thousands of square feet of terra cotta, including 32 columns, each 40 in. (1016 mm) in diameter and 30 ft (9 m) tall.
