# Upper Perry Arch Bridge Repairs

La Grande, Oregon

Submitted by The Euclid Chemical Company

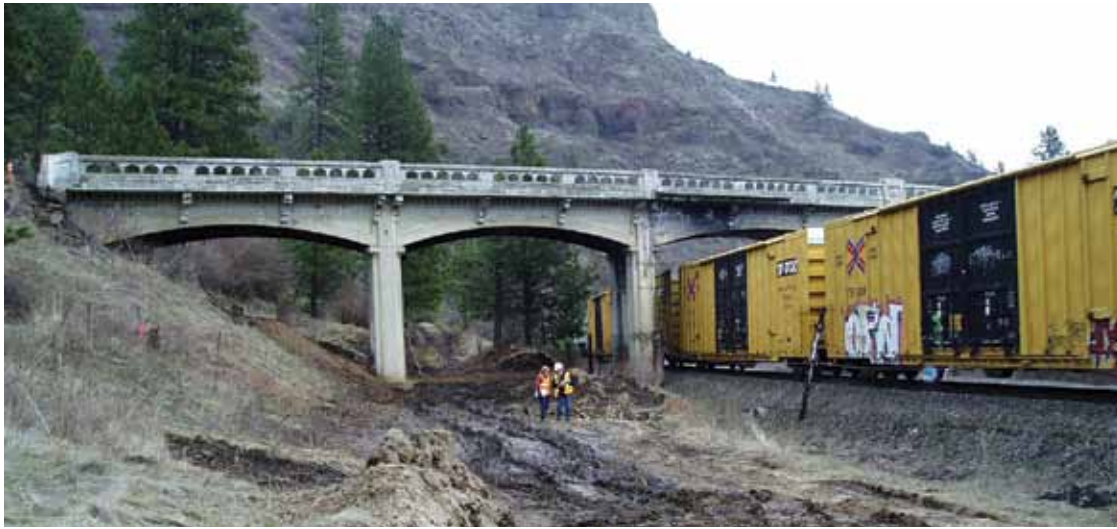
*80 years of deterioration*

The ODOT considered demolishing the bridge, but after further inspection and input from an architectural committee, determined that rehabilitation was a viable option. The bridge was in very poor condition, and the deck was riddled with cracks and spalls, crumbling rails, and exposed reinforcing bars in numerous locations.

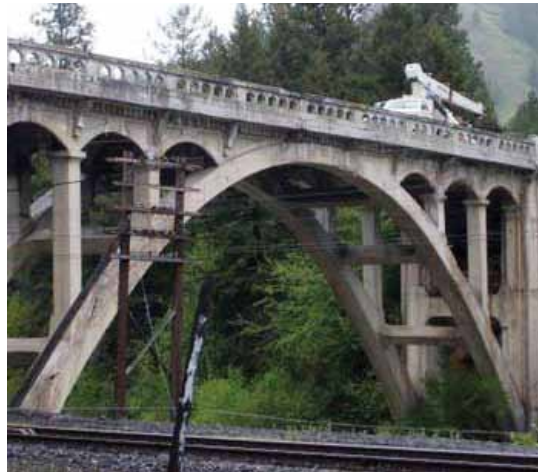
*Upper Perry Arch Bridge prior to restoration*

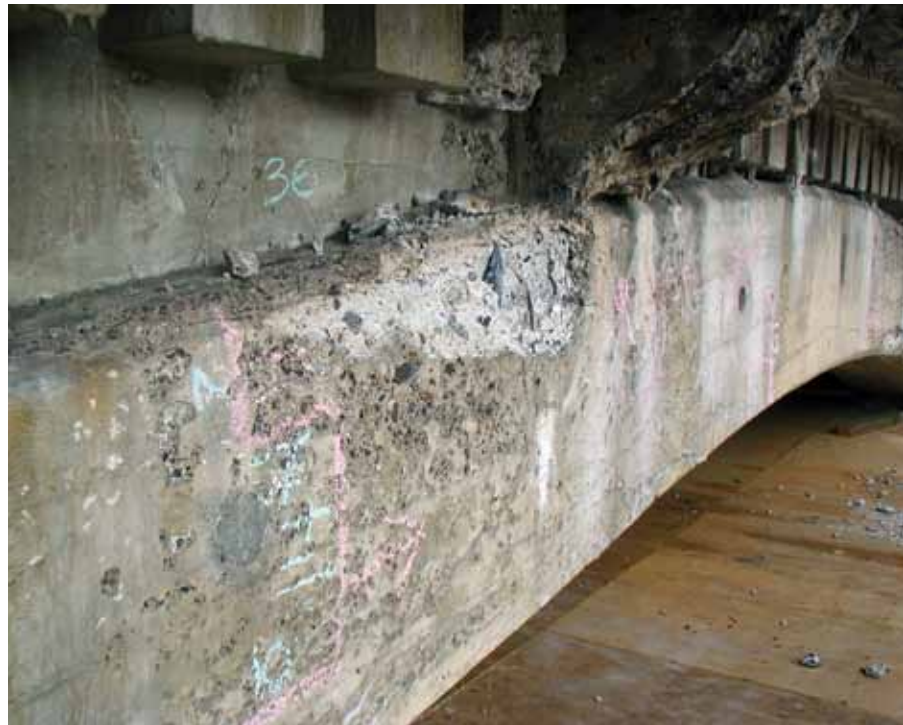
*Arch deterioration*

This work included rehabilitating four approach spans and complete replacement of the span supported by the main arches. All bridge rails, cross-beams, decks, spandrel posts, sidewalk brackets, and corbels were demolished and replaced. The arches and bents were salvaged; the cracks were injected with epoxy; and the unsound, deteriorated concrete was removed and repoured in place.

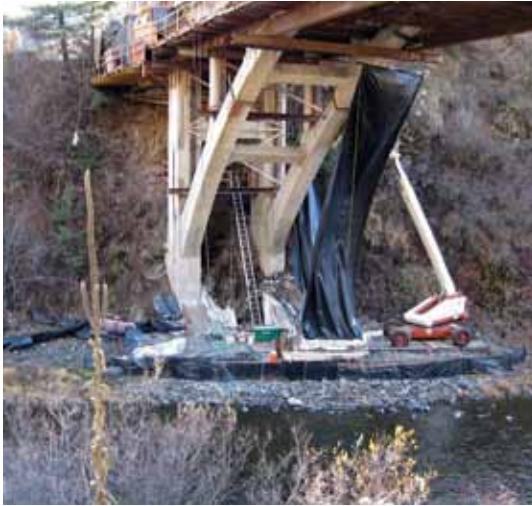
*Work performed from man-lifts and netting used to contain concrete debris during surface preparation*

Deteriorated concrete had to be removed using handheld jackhammers and replaced with repair grout before other work could begin.

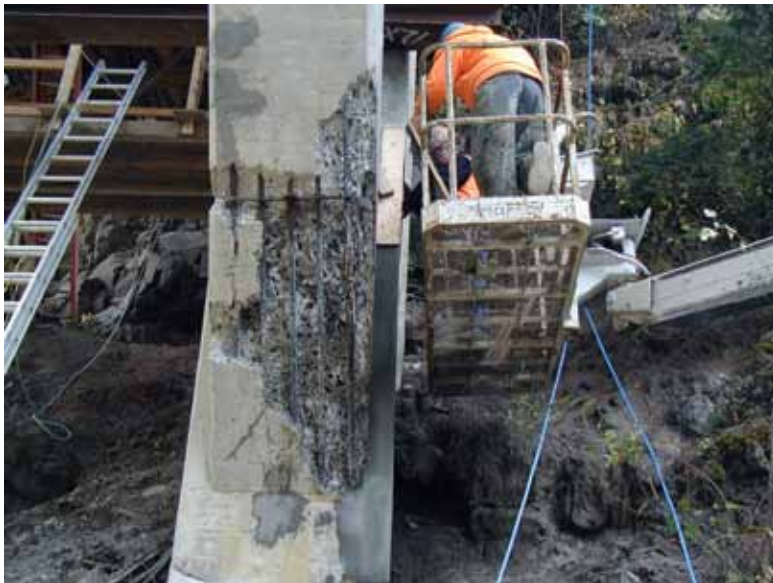
*Arch deterioration accessible by man-lift*

blankets. Due to the poor condition of the concrete, only 10 ft (3.05 m) sections of each arch could be repaired at a time.

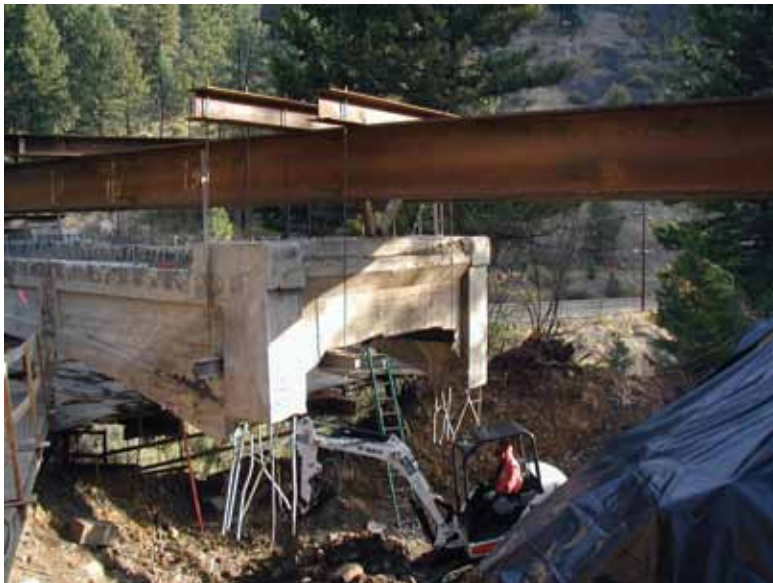
As is quite common with concrete restoration projects, once demolition began, the deterioration was worse than originally thought. During renovation, it was discovered that both of the foundation columns at one end of the bridge were completely sheared. The entire bridge was demolished, except for parts of the columns and the repaired arches, which were used to support the new cast-in-place concrete. The entire span was temporarily suspended with false work and the columns and footings were removed and replaced with new cast-in-place concrete.

*Suspended arch while footing and columns replaced in one section*

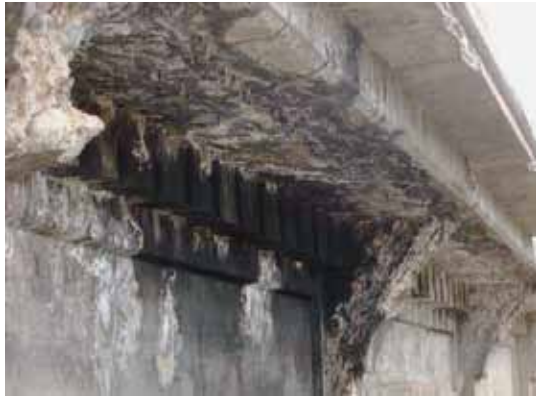
*Extensive deterioration to corbels and dentils*

A total of 306 dentils and 68 sidewalk brackets (corbels) were demolished, meticulously formed, and cast in place.
