# 906 Grand Building Masonry Repairs

Kansas City, MO

Submitted by Structural Engineering Associates

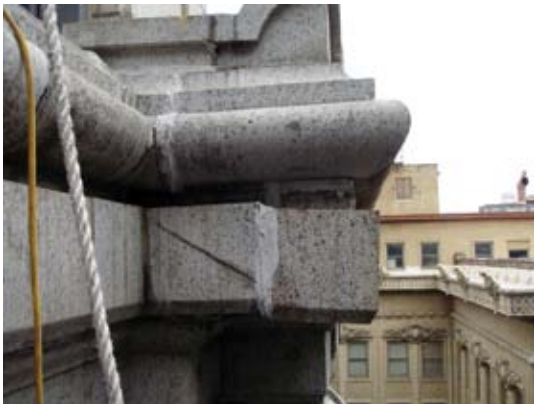
Years of water infiltration through deteriorated mortar joints progressively attacked the structural steel framing. As the steel corroded, it expanded and cracked the brittle terra cotta, allowing more moisture to enter. This created a cyclical process, which led to more destruction and other deterioration mechanisms, such as freezing and thawing. Conditions observed included cracking and displacement in the terra cotta at many locations on the north and east faces of the building. The mortar joints were open and the brick was showing signs of deterioration.

Fractured and dislodged terra cotta

Individual deteriorated units of terra cotta in the main field of the building were identified, removed, and replaced with architectural cast stone. Forms were fabricated to match the original broom finish and a coating was applied to match the existing terra cotta appearance.

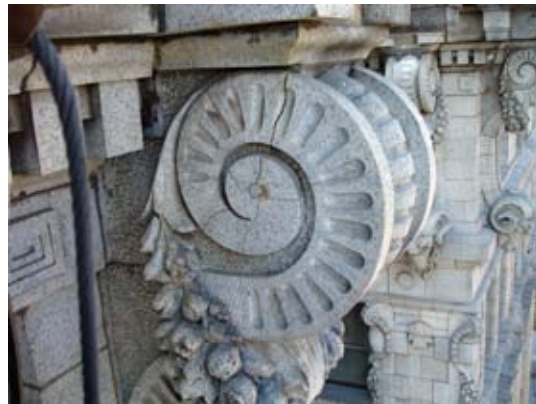
Fractured terra cotta

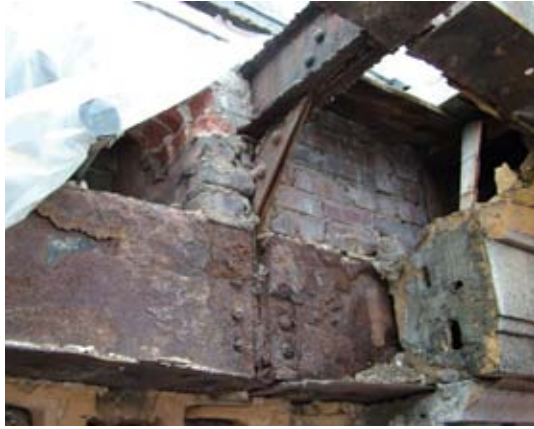
*Corroded steel and cornice framing*

The condition of the cornice was problematic. At the four exploratory demolition areas, the deterioration of the structural steel framing inside the terra cotta cornice ranged from severely deteriorated with significant cross-sectional loss to

no corrosion or loss of cross section. A majority of the terra cotta surrounding the steel framing of the cornice was either cracked or fractured. In many locations, the existing terra cotta appeared to be held in place simply from friction caused by coursing and stacking of the units. The cracking and movement was due to either severely corroded hangers from the structural steel framing or the framing itself lacking the ability to support the terra cotta. Steel pins holding large "scroll" pieces of terra cotta had corroded and expanded, resulting in radial fractures through the terra cotta. Hangers had rusted entirely in half. This created a very unsafe condition for pedestrians below.

Deteriorated structural steel was identified by the engineer as demolition proceeded. Repairs were analyzed and consisted of full replacement or

strengthening. In some cases, new members were added to provide a new load path past severely deteriorated members that could not be replaced.

New drain lines and waterproofing were installed in the gutters of the cornice to prevent further water intrusion into the cornice. Because the FRP system was modular and could be molded to any shape, this created a unique opportunity to create a new gutter system and drain lines that would better prevent rainwater from entering the cavity. The remaining structural steel was sandblasted to bare metal. To fight against corrosion, a new high-performance coating was applied to the structural steel members.

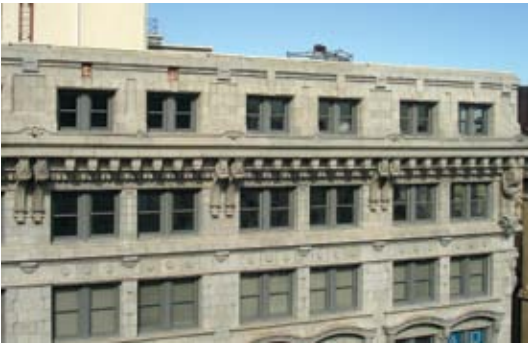
Completed FRP cornice

The FRP manufacturer made latex forms on the existing terra cotta pieces of the cornice 12 stories above street level. FRP panels were manufactured with special attention paid to dimensions, texture, and color. Construction consisted of approximately eight pieces of FRP per column bay in lieu of approximately 110 pieces of individual terra cotta units.

In total, 300 ft (91 m) of terra cotta cornice was removed and replaced with FRP panels. Two hundred thirty-three individual units of terra cotta were removed and replaced with new coated cast stone units. Around the windows, 12,000 linear ft (3658 linear m) of sealant was removed and replaced. The unique cantilevered scaffolding system was dismantled and re-erected eight times as work progressed.

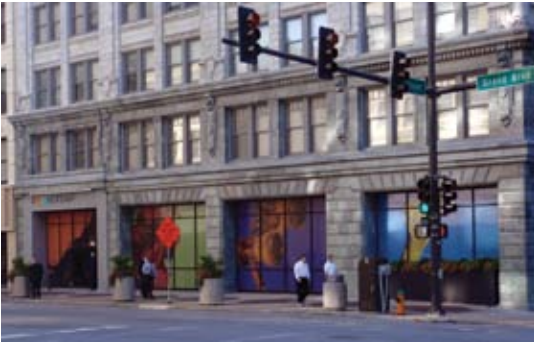
Front entry after completion

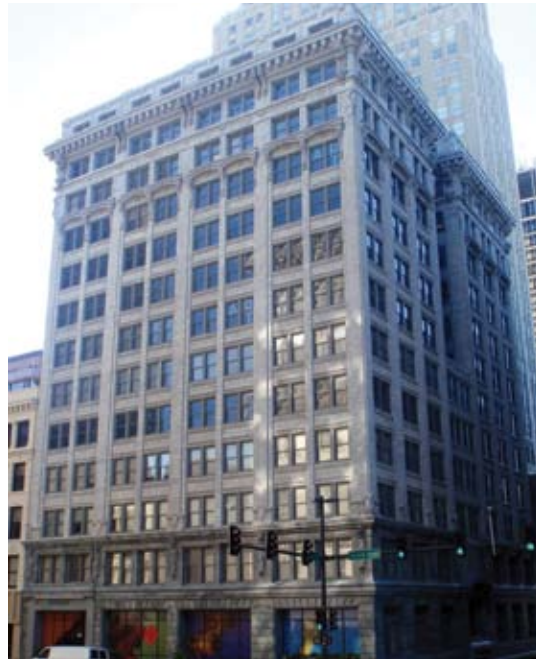
Completed project after repairs

All mortar joints were repointed, the entire building was cleaned with chemical cleaners, and penetrating water repellent was applied to the brick surfaces.
