# Bellaire Tower— The Jewel of Russian Hill

San Francisco, CA

Submitted by Sika Corporation

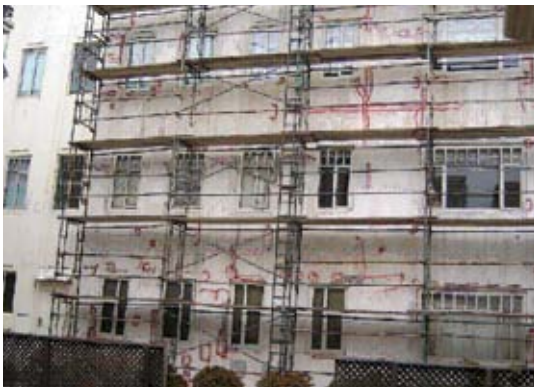
- Sounding was conducted after the coatings were removed for accurate delamination mapping;
- Much of the spalled concrete was at the windows, where leakage had occurred;
- Spalling was due to corrosion of the steel window flanges embedded in the surrounding concrete;

*Mockup phase, coating removed, and delamination and cracks identified*

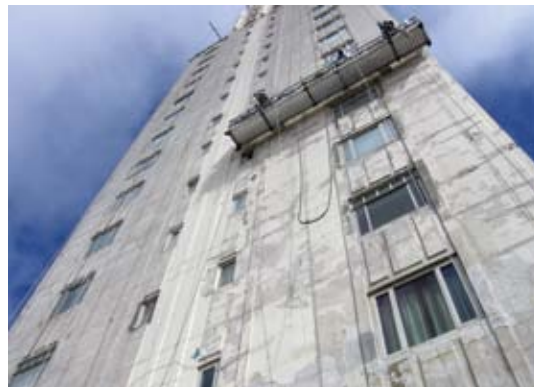
*Coating removal required several passes using different methods to complete*

The removal and abatement of all existing coatings on the concrete used a labor-intensive “tomahawk” method, which entailed delicately chopping away at the coating with small axes. Grinders were used to remove the coating on the steel windows.

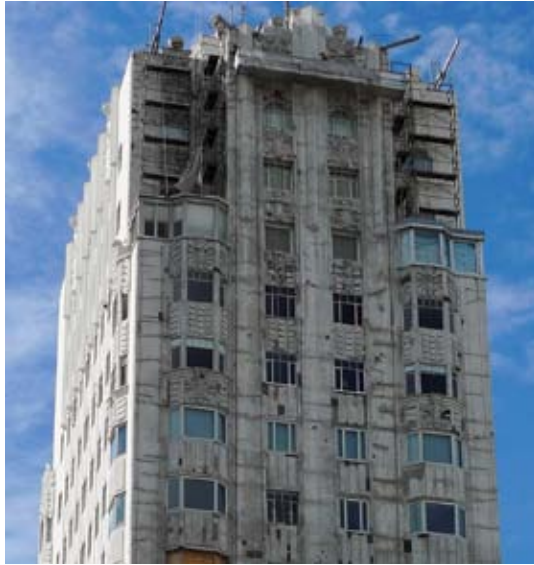
*North façade with coating removed and crack and concrete repair in progress*

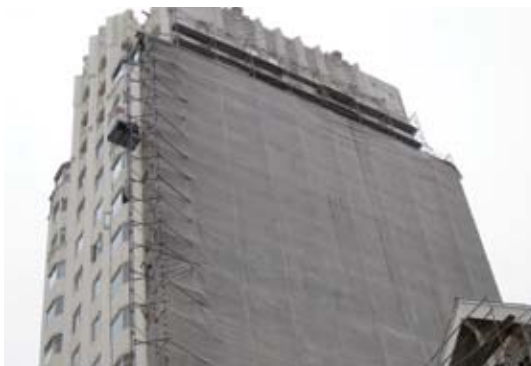
*Twenty-story scaffolding erected on the west wall, fully enclosed*

A combination of 20-story frame scaffolding and swing stages was used to access the entire exterior wall. The scaffolding and swing stages required suitable enclosures to contain all construction debris, dust, and lead-based coating abatement. Enclosures with windows were built in each unit during window refurbishment.

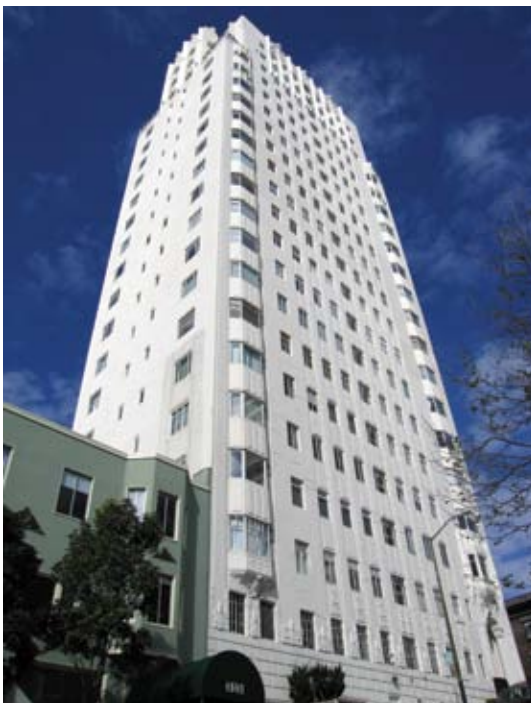
*Restoration complete*
