A Job That Nobody Wanted

San Francisco, CA

Submitted by John F. Maillard, CSI-CDT

2011 AWARD OF EXCELLENCE

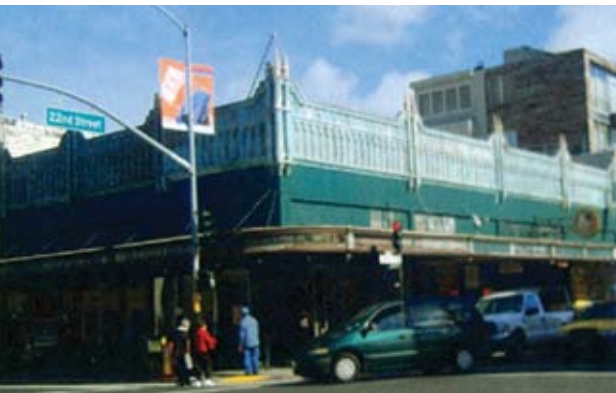
Project before repair work

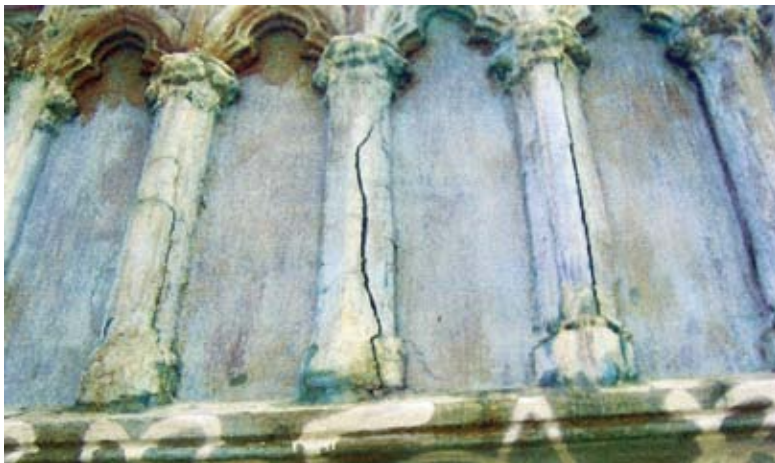
Water intrusion from the parapet behind the ornamental concrete units had rusted the reinforcing steel. This created the expansion of the reinforcing steel and the spalling of the units. There were several cracks, especially at the parapet and upper section of the structure. The 1989 earthquake did not damage this building. The parging did not address the source

The spalled ornamental units created a dangerous condition

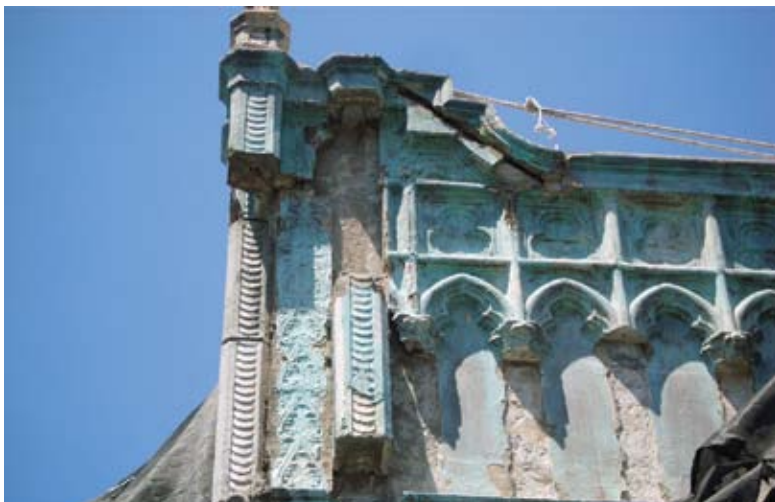
Demolition to remove unsound concrete

The demolition was strictly hand demolition, removing all unsound concrete units below 3000 psi (20.7 MPa). Precaution was taken to protect adjacent sound units.

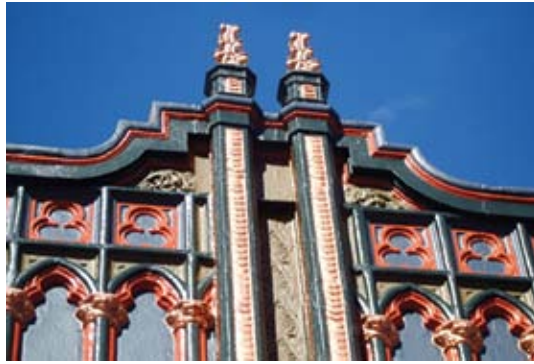
Close-up of completed repair

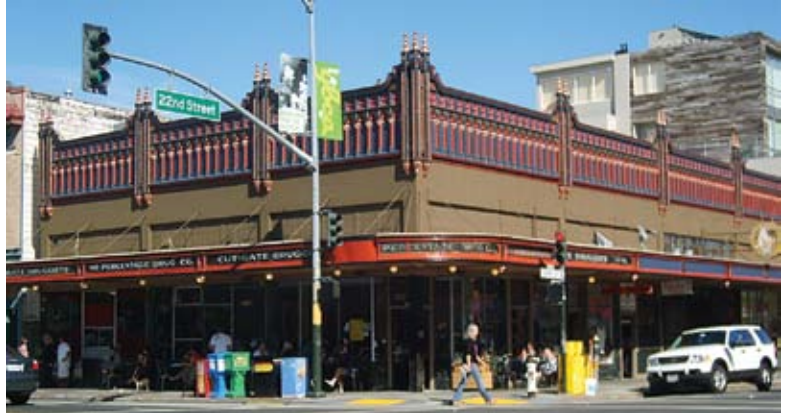
Project completed on schedule and within budget
