Royal Floridian Resort

Ormand Beach, FL

Submitted by ConTech Construction, LLC

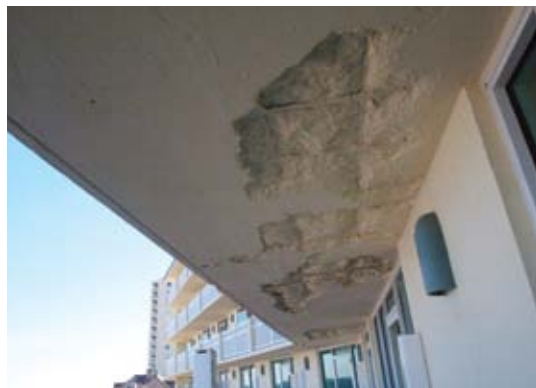
The balconies had visible underside and topside spalling throughout. Reinforcing steel was exposed in many large areas and was obviously corroded. Water had been penetrating into the units during typical rainstorms. Cracks were visible in balcony edges and at the base of columns. The underground garage suffered water leaching in, creating stalactites hanging from the ceiling, because the waterproofing membrane on the pool deck above had failed. The north and south ends of the structure had cracks and large areas of disbonded stucco. The air-conditioning units on the balconies had rusted and corroded, leaving piles of rust on the floors and orange streaks running down the building. Pavers on the pool deck were efflorescing and discolored.

Severe underside spalling of balconies

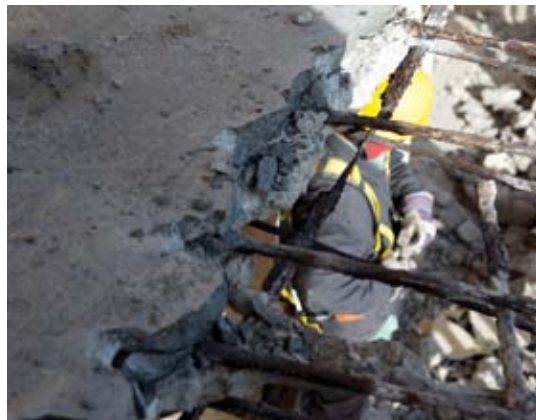
Reinforcing steel was extensively corroded

indicated a pH below 9 at the base of the spalls. Concrete and steel damage was extensive on the balconies and walkways. Moderate damage was observed on the columns, seawall garage, and front porte cochere ceiling. Reinforcing steel corrosion was common and generally severe under and along the aluminum storefronts and the concrete spalling extended into the unit interiors. Extensive damage was caused by the aluminum electrical conduit that was in contact with the reinforcing steel. The steel corrosion in these areas was caused by a reaction caused by the galvanic voltage difference between the aluminum (-0.604 volts) and ferric steel (-0.207 volts) embedded in a conductive electrolytic solution-wet concrete.

and transported to large dumpsters on the ground. The existing steel was cut out and removed, except for the lap length, which was sandblasted and augmented with additional bars where it had lost 30% of its cross-sectional area. All the old concrete and steel was recycled. The speed of removal was striking—2400 linear ft (731.5 linear m) of balcony was removed in 3 weeks.

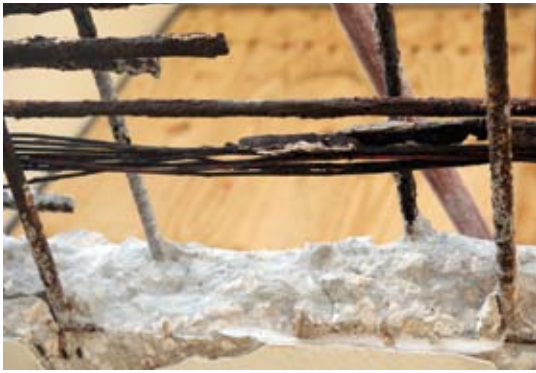
Close-up view of corroded reinforcing steel

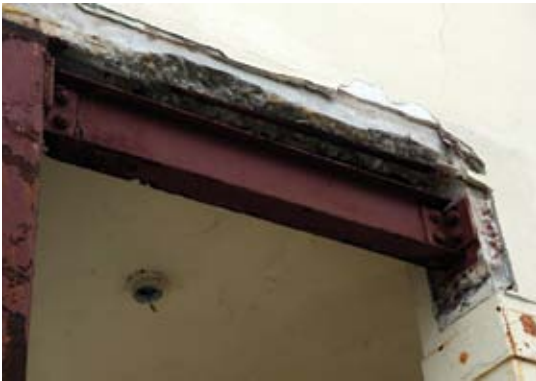
Corroded beams and columns were not capable of supporting loads much longer

The plan review showed a disturbing item. The north and south ends were originally designed to be 5 ft (1.5 m) cantilevered elevated slabs, but the top reinforcing had been left out of all these cantilevered areas back in the 1970s during the original concrete placement. Much cracking followed, and the steel beams and columns were added soon after the problem had been discovered. These beams and columns were now corroded and not capable of supporting the loads much longer.

It was in the beginning of the structural steel replacement that another obstacle presented itself. It was discovered that when the beams and columns were added back in the 1970s, they were placed on footings that were grossly undersized for the loads imposed by the seven-floor structure. Several of the columns had no footing at all, but instead were resting on the original concrete pavement and concrete stairway. The adjacent concrete columns had severe cracking and bulging as the load shifted to these columns from the steel columns. It appeared that the containment steel ties were failing. To fix the problem, the engineer designed enlarged footings and new footings as required. The existing concrete columns would be removed and enlarged as well.

The contractor excavated around the existing footings, dowelled and epoxied new reinforcing, and poured the enlarged and new footings. The replacement of the structural steel beams and columns went exactly as planned, with no movement or settlement of the building when the supports were removed.

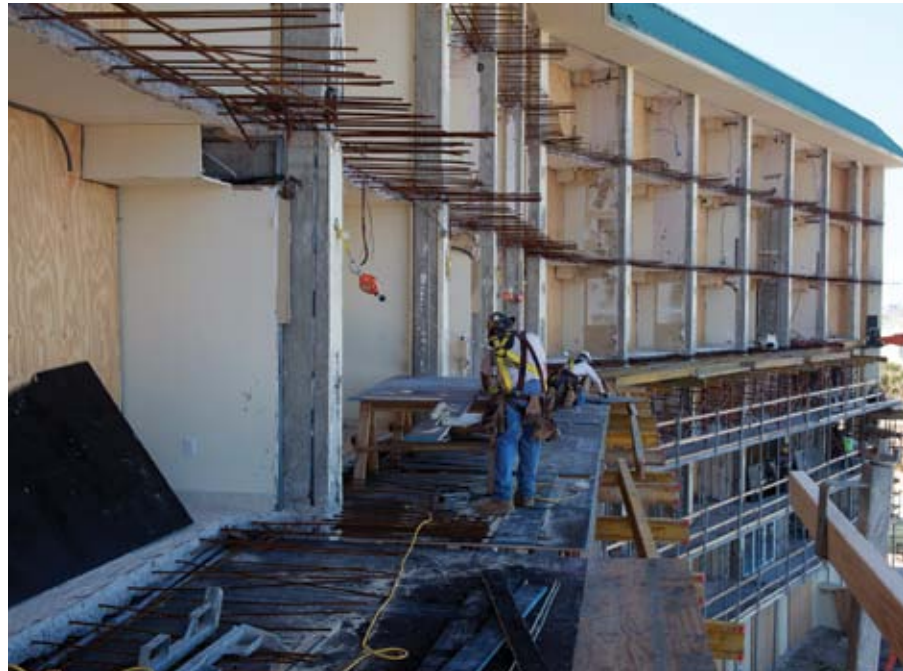
Work proceeding on balconies

Twenty jackhammers were used to remove the balconies to a line 24 in. (610 mm) inside each unit. The broken concrete fell to the balcony below, from which it was then deposited into small dumpsters

The rebuild forming process started from the second floor to the seventh. The formwork was reused on each floor, reducing cost and increasing efficiency. As each 200 linear ft (61 linear m) section of decking was completed, new steel was installed and lapped to the cleaned reinforcing bar. The engineer inspected each area before the steel was covered by concrete. In many areas, the existing steel had been placed irregularly, both in spacing and in the height of the concrete. Many additional bars were drilled and epoxied into place to correct these deficiencies. A corrosion inhibitor was sprayed on the existing concrete to avoid creating a battery effect with the differential between the old and new concrete. The new concrete was a 5000 psi (34.5 MPa) concrete with a water-cement ratio (*w/c*) of 0.40. All slabs were finished with a light broom to allow for good adherence with coatings that would be applied later.

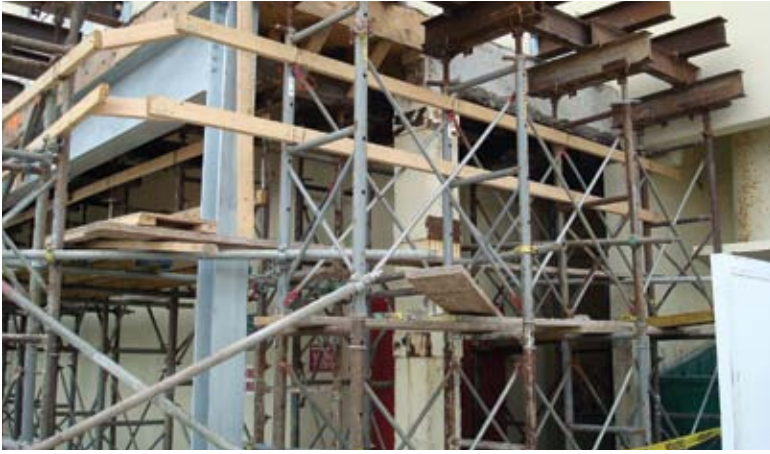
Replacement structural steel columns and beams

Engineered shoring with needle beams was installed in preparation of removing and replacing the structural steel on the cantilevered ends of the building. This was the most challenging and daunting part of the project. A failure here could be catastrophic.

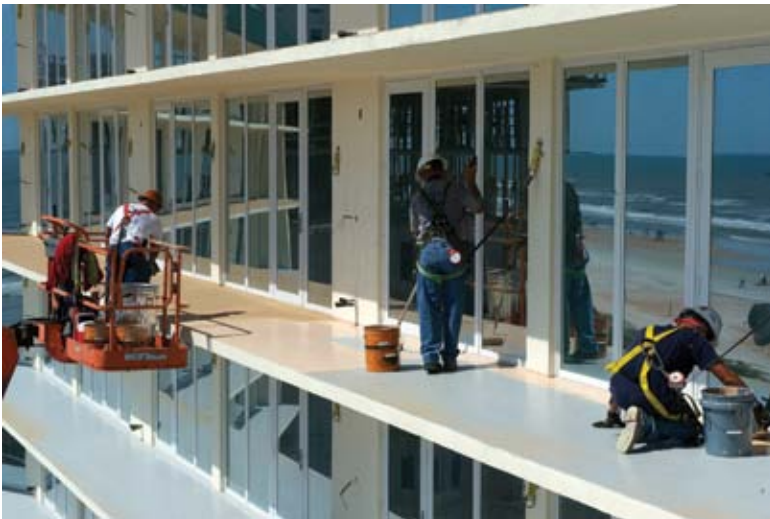
Coating being applied to new balconies

As the concrete proceeded upward floor by floor, the window installation crew followed from the ground upward as well. All fasteners used were stainless steel and were embedded in a sealant to minimize potential corrosion. All the sealants, coatings, and paints were from the same manufacturer to ensure compatibility between all of the components. Temporary handrails were clamped to the edges of the new concrete, giving workers safe access to every floor after it was poured.

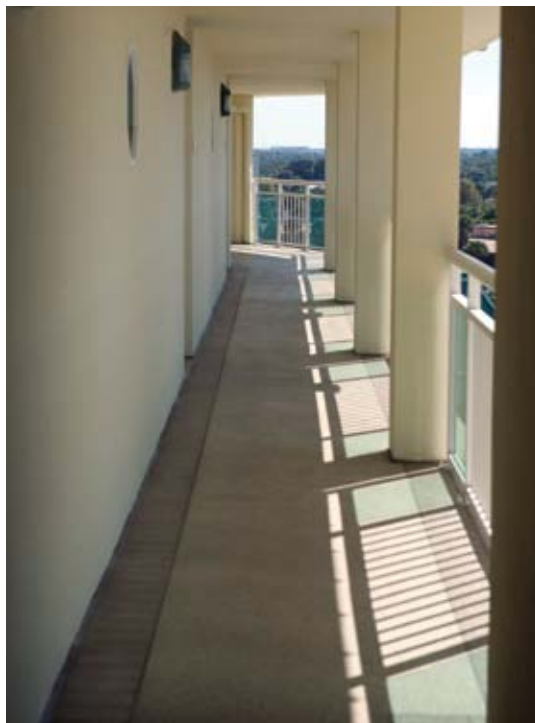
Finished balcony with new railing

these surprises included standard picket railings that were replaced with a modern-style guardrail with glass inserts; waterproof deck walkways with intricate paver details; a new energetic color palette throughout the property; modern window systems tinted the color of sea glass; and a complete renovation of the porte cochere entry, which included new lighting fixtures, cast-in-place stamped concrete ornamentation, and a sleek minimalist entryway free of the previous clutter.

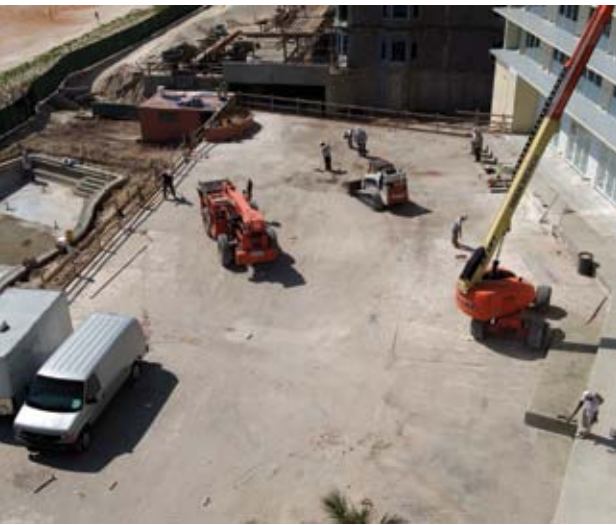
Work proceeding on new deck and pool area

The biggest hurdle thrown at the construction team occurred when the owners announced in March that they wanted to demolish the existing pools and pour three new pools. This was to be done concurrently with the rest of the project, with no time added to the schedule. Just getting the permit from the Department of Environmental Protection, which authorizes all construction in the tidal zone (which this was), took 2 months.

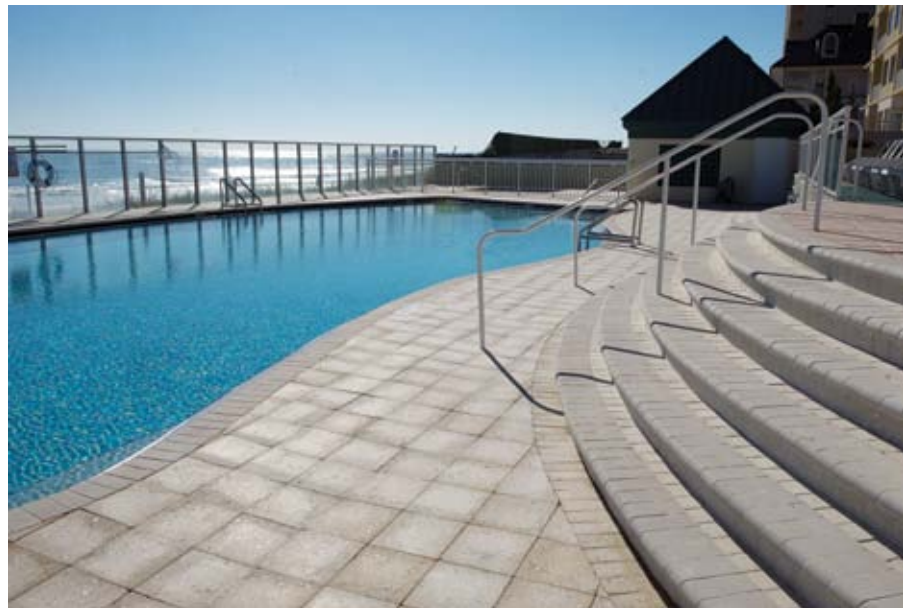
New deck and pool area

existing deck had an interesting layout of paving and curvilinear planters, the pavers were outdated, and the raised planters were difficult to maintain and allowed water infiltration into the garage below. The architect used this opportunity to delete the existing planters and create additional deck space with a circular paver pattern with a palette of colors that accentuated the building's new color scheme. The new deck and pool renovation creates a spectacular foreground for the ocean view from the unit balconies above.

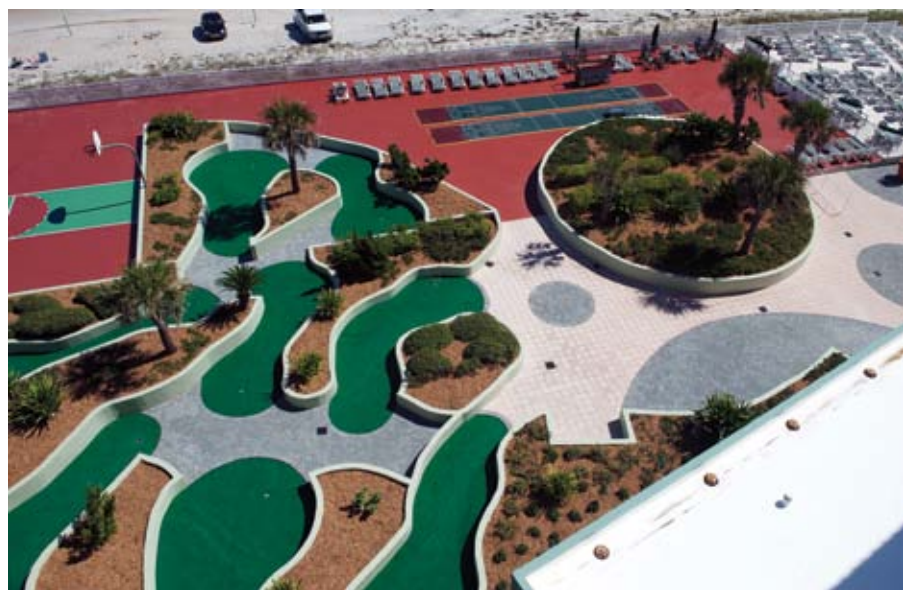
New recreation deck area

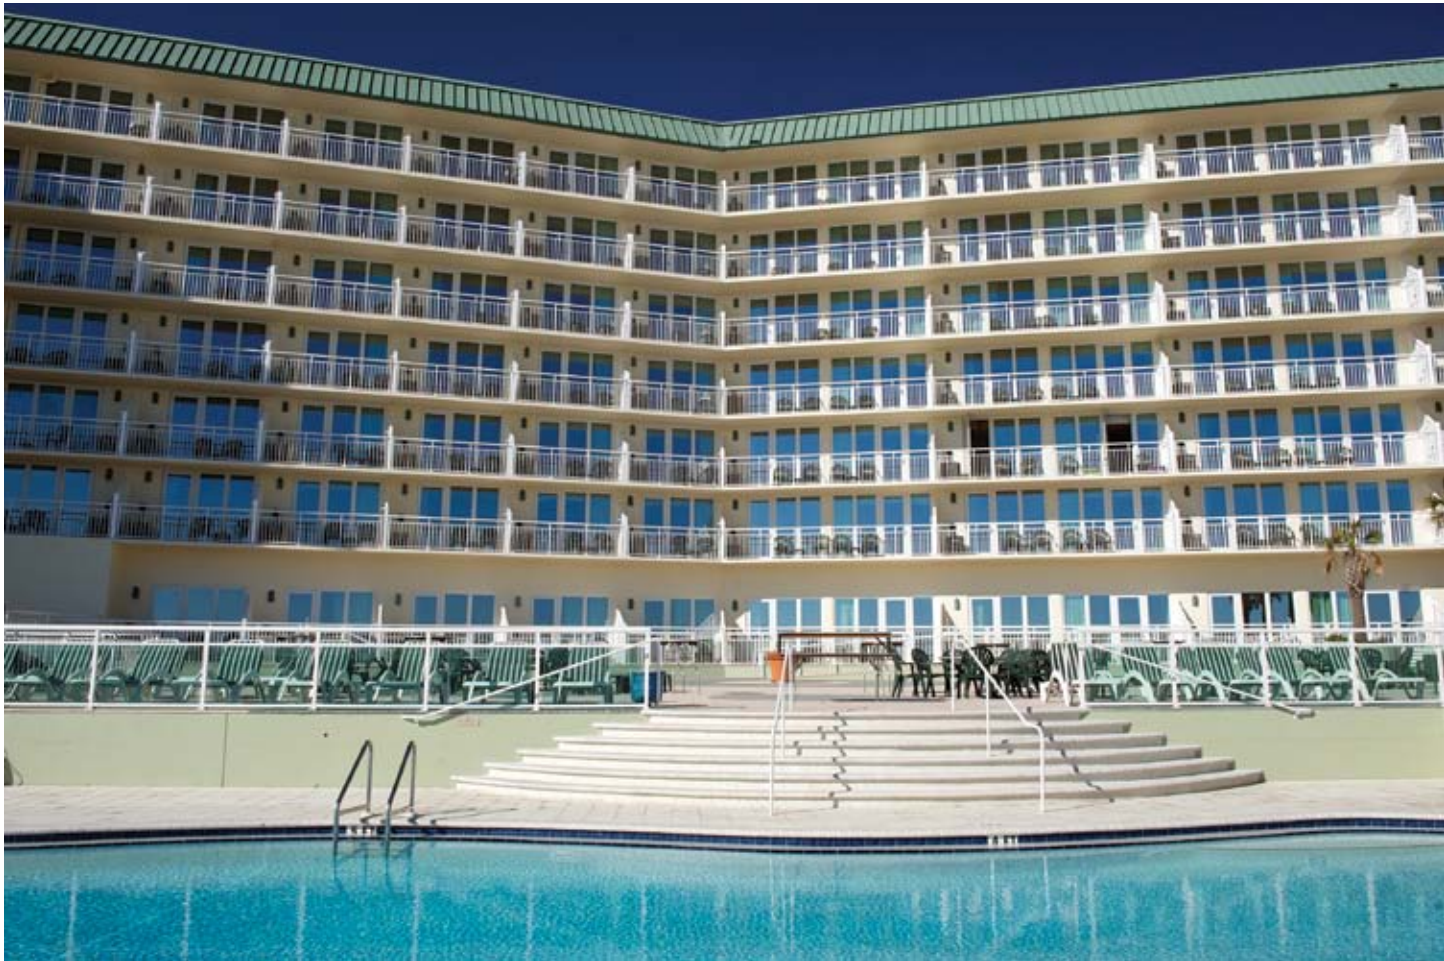
Completed Royal Floridian Resort renovation
