East House Underground Garage Rehabilitation

Washington, DC

Submitted by Restoration East, LLC

2012 Award of Excellence

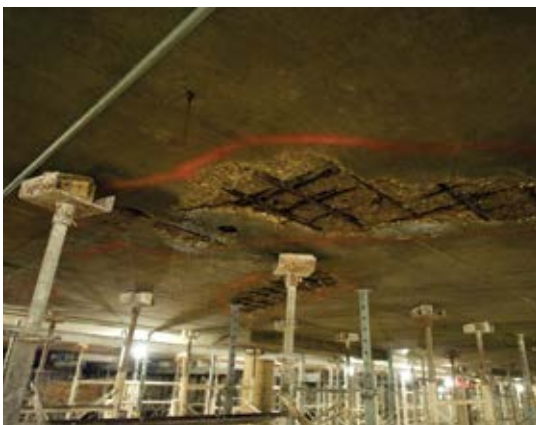
Deteriorated soffit areas identified for repair

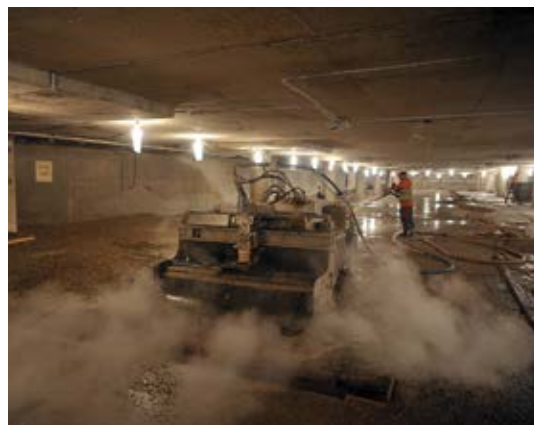
Hydrodemolition of deteriorated floor area

- 172,000 ft² (15,980 m²) of wall-to-wall hydro-demolition of the top 5 in. (127 mm) of the elevated slabs with the incorporation of a graded concrete overlay to provide superior drainage to a revitalized storm sewer design;

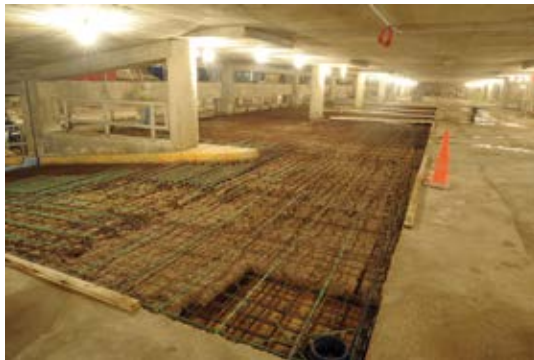
Prepared repair area with steel replacements

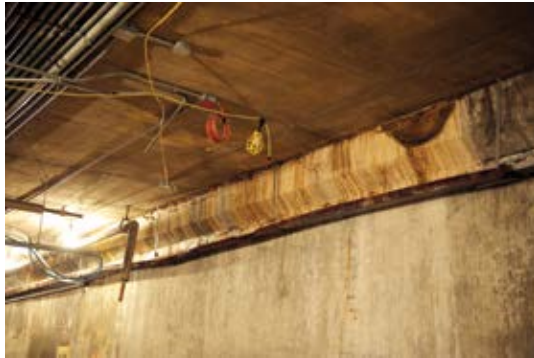
Deteriorated corbel area

2. **Repair of the corbel supports**—The original design for the corbel repair included spot removal of deteriorated areas of the corbel and slab edge. Demolition revealed that proper thermal movement was inhibited and the structure had not been erected per the original design. Uneven slide-bearing surfaces created a restriction, which amplified deterioration with mechanical friction. Additionally, the slab edge was poured short in some areas, providing less than 2 in. (50 mm) of bearing contact with the haunch, which was inadequate for the spans and loads present. Further complicating this portion of the restoration, the corbel and slab edges were on the critical path. Supplementary shoring was shipped in so loading could be transferred down each level to grade. Therefore, complex sequencing was developed to ensure that the large amount of slab repairs could commence and continue while the supporting structure was being restored. After review by the engineer, a revised detail was implemented. The concrete corbels were completely removed and large galvanized steel angles with a slip-bearing surface were bolted to the foundation walls. This provided a faster repair and additional bearing length and allowed for compensation of the existing conditions.

- 41,000 ft² (3809 m²) of full-depth, 10 to 12 in. (254 to 305 mm) thick slab repairs;
- Repair and modification of the foundation wall corbels that bear the elevated slab perimeters;

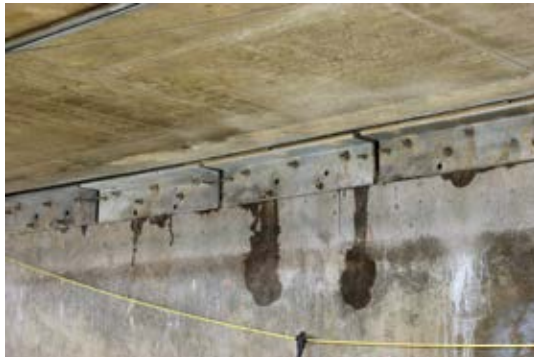
Installed steel support angles

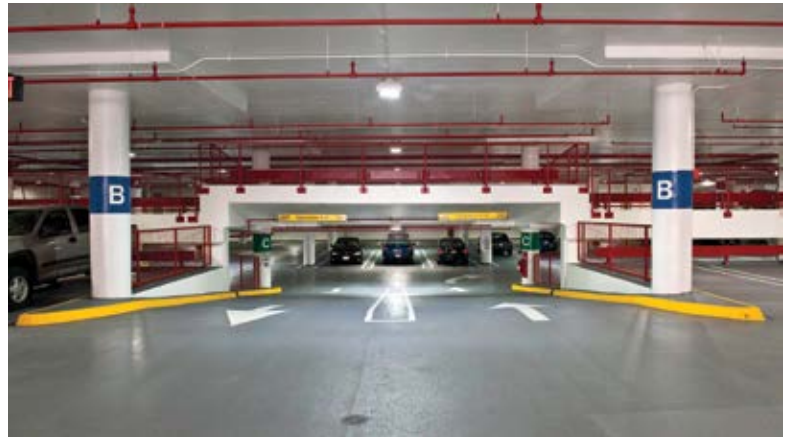
Completed parking garage interior
