Saskatoon City Hospital Repairs

Saskatoon, SK, Canada
Submitted by Walter P Moore

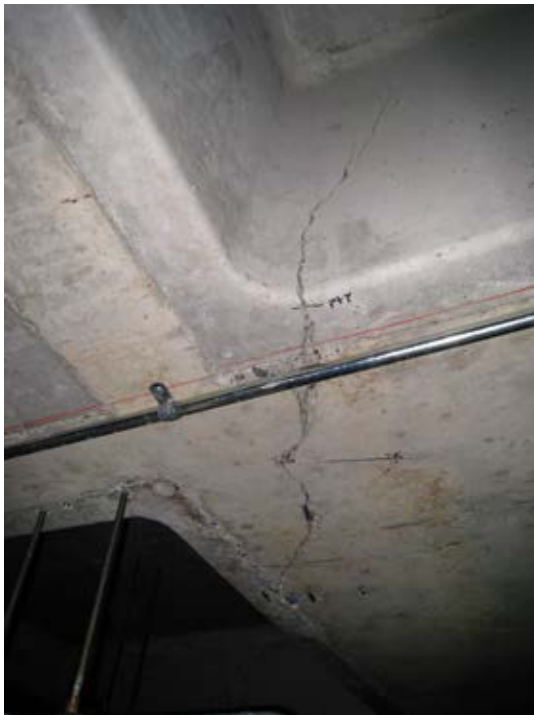
Although cracking was visibly apparent at the surface of the various waffle-slab components, the depth of cracking and condition of the post-tensioning reinforcement was unknown. Crack mapping was conducted to establish patterns and typical occurrences of cracking. Nondestructive testing established the crack depths, the profile of the post-tensioning tendons, and locations of other reinforcement. The investigation showed cracking predominantly along the column gridlines and around

Typical cracking in waffle slab

through slab drop panels. Cracking was found to be full-depth at portions of the waffle slab and the crack widths were found to vary with seasonal temperature exposure at the roof level.

Concrete repair work began with epoxy injection of waffle-slab cracks. Due to heightened dust control concerns, the surface seals that were installed were left in place (with a neat appearance) after injection. Approximately 1500 ft (457 m) of cracks were injected during this phase.

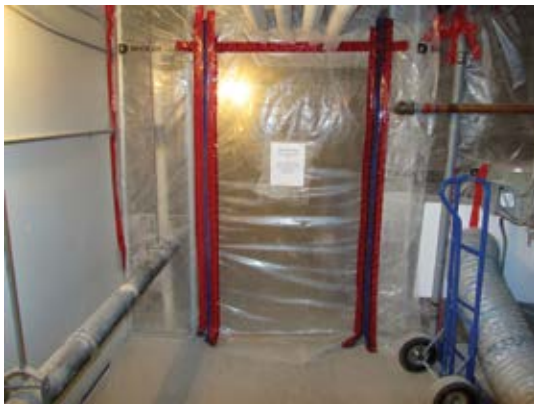
Infection containment system in work area

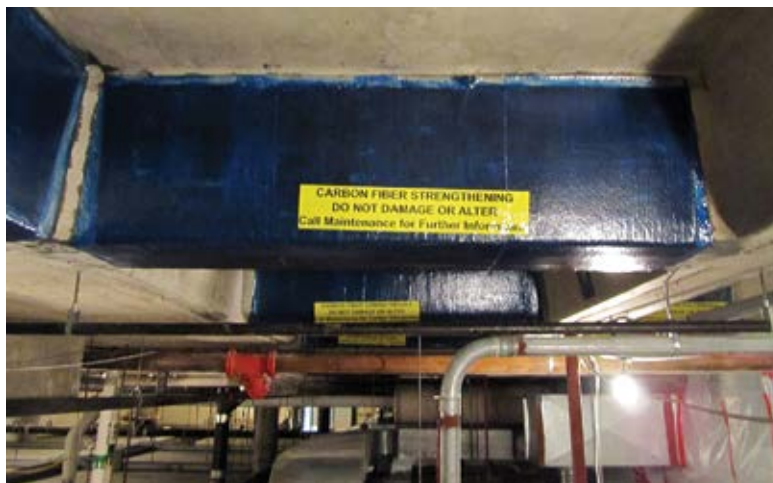
Carbon-fiber reinforcing of beam section

The CFRP reinforcement was then installed to strengthen the cracked and structurally deficient waffle-slab joists and ribs. Concrete surface preparation was undertaken by applying HEPA filter vacuum attachments to concrete removal equipment to minimize dust. Imperfections in the waffle slab were smoothed with epoxy repair mortars prior to the CFRP application. CFRP U-wraps were installed to strengthen the waffle slab for shear near the columns using one or two plies, depending on the strengthening requirements. Cautionary stickers were placed on the CFRP applications to prevent damage from possible future equipment hanger installations. Approximately 100 waffle-slab joists were wrapped with approximately 3000 ft² (280 m²) of CFRP material.

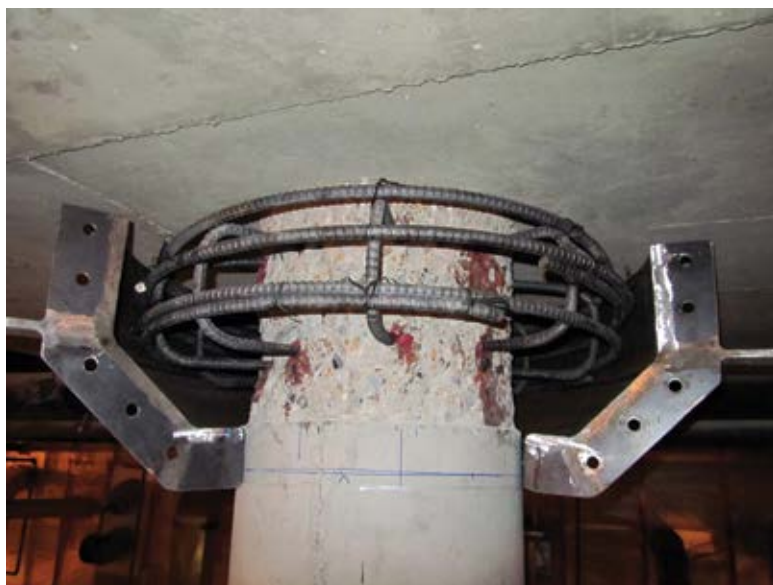
Formwork and reinforcement for column strengthening

The final concrete repair work involved the installation of concrete column collars to strengthen the waffle slabs for punching shear deficiencies. While carefully complying with infection control requirements, the contractor roughened the concrete surface of the columns and installed reinforcing steel for the collar installation. The contractor fabricated steel forms to facilitate the placement of the repair material and used a self-consolidating concrete mixture to minimize vibrations. The interface between the concrete collars and slab soffit was then filled with dry-pack grout for uniform bearing with the waffle slab. A total of six column-to-waffle-slab joints were strengthened for punching shear.
