# Reincarnation: The NYLO South Side Hotel

Dallas, TX

Submitted by JQ

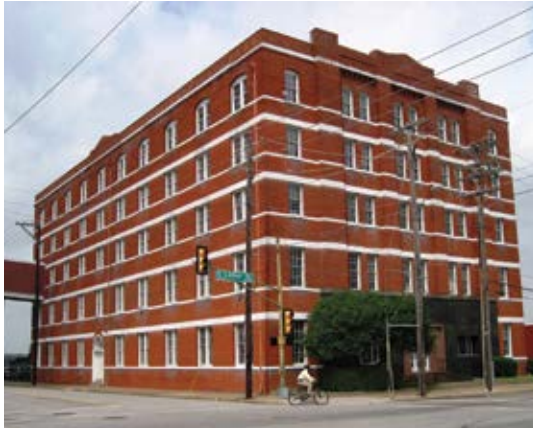
Fig. 1: Building in original condition before "reincarnation"

The NYLO South Side Hotel, located south of downtown Dallas, was constructed in 1911 for the Dallas Coffin Company (DCC) to house their offices and manufacturing center (Fig. 1). The DCC operated at this location until the 1950s and was then taken over by Sears & Roebuck from 1960 to 1993. The building sat vacant until a local development group purchased the property in 2005, with aspirations of converting the historic structure into a boutique hotel.

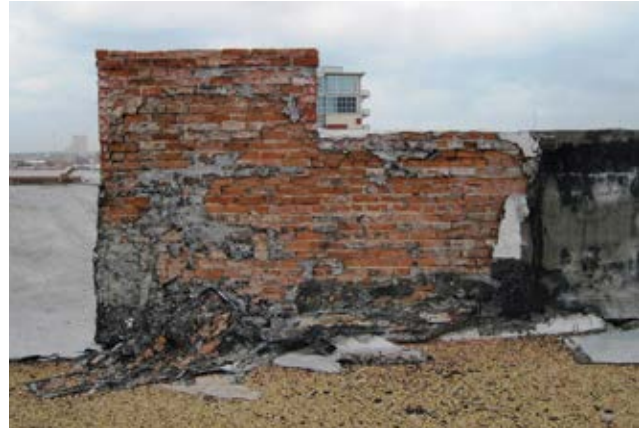
Fig. 2: Roof wall prior to rehabilitation

The scope of the renovation work consisted of evaluation of the existing structure, retrofit and repair of structural deficiencies, design of new components, and upgrades to the structure to support the new building program (Fig. 2). The new building program called for a new rooftop amenities deck containing a swimming pool, fully enclosed bar and lounge area, and exterior seating areas; mechanical spaces; new vertical circulation; an exterior entrance to the basement level; and miscellaneous floor infills, exterior entrance canopies, and new site structures.

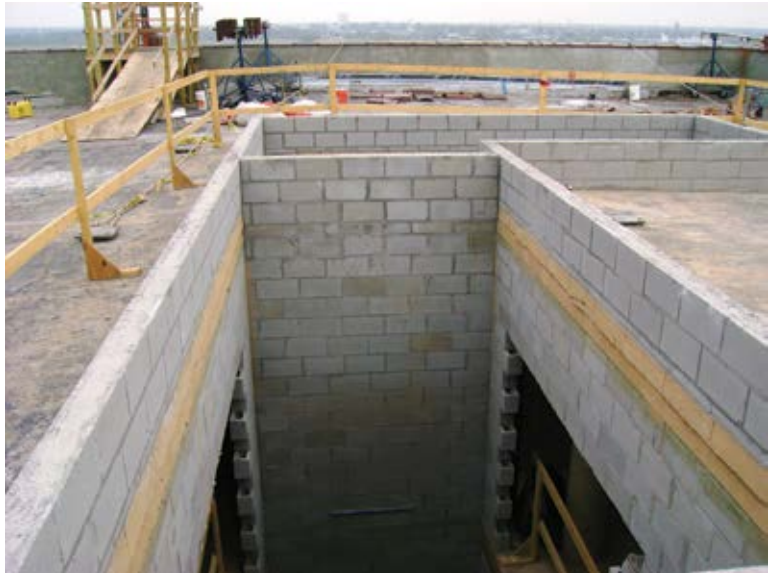
Fig. 3: At new service core openings, supplemental support for the slab was provided by new 6 in. (152 mm) load-bearing masonry walls around the perimeter of the shaft(s)

Much like other historic buildings, existing building systems and paths of egress did not meet current building code requirements. Therefore, new service cores were required to extend from the basement to the new rooftop deck. At these new openings, supplemental support for the slab was provided by new 6 in. (152 mm) load-bearing masonry walls around the perimeter of the shaft(s) (Fig. 3). In addition to supporting the new cores, the shaft walls were designed to take a portion of the lateral loads at each existing level due to the discontinuities in the floor diaphragm created by the new shafts. Foundation support for the new service cores was provided by a mat slab supported by helical screw piles.

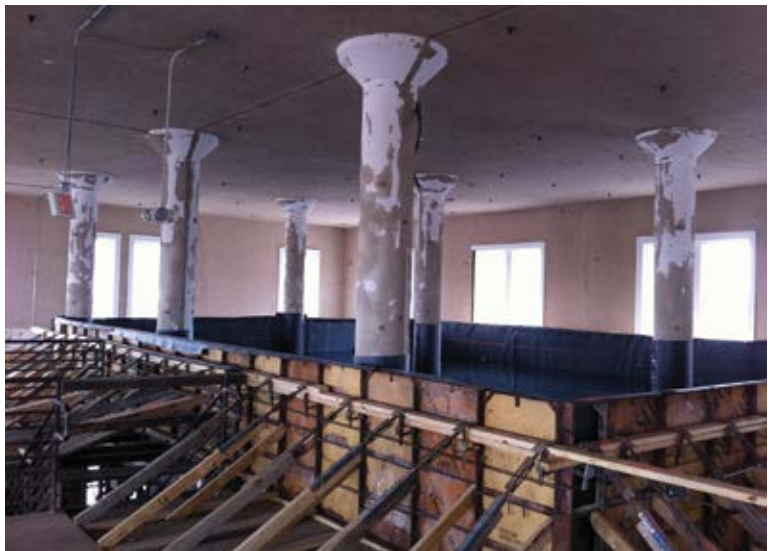
Fig. 4: Load test being performed in accordance with ACI 318-05

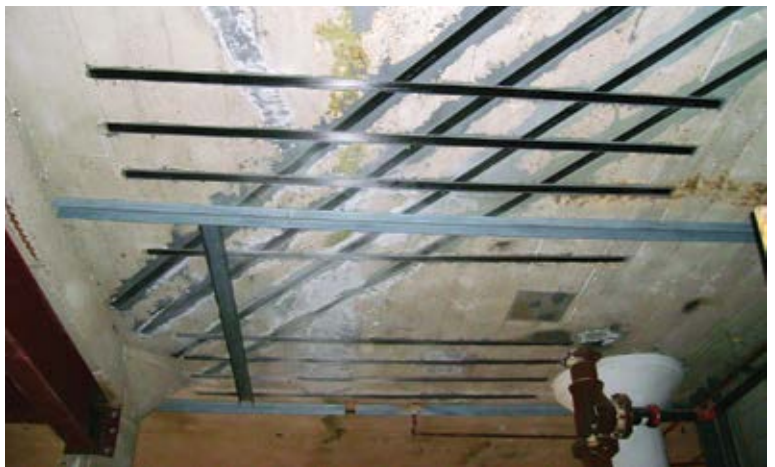
At the service floor openings, a finite element model (FEM) was created to analyze the slab and to determine the required area of steel for each section. A baseline model was established by modeling the original slab without openings using the assumed loading for the original building use. This model was compared to a second model with the openings included, using current code-stipulated design loading (Fig. 4). Locations where original stresses were exceeded were reinforced with carbon-fiber reinforced polymer (CFRP) strips externally bonded to the slab with epoxy (Fig. 5).

Fig. 5: Locations where original stresses were exceeded were reinforced with carbon fiber-reinforced polymer (CFRP) strips externally bonded to the slab with epoxy

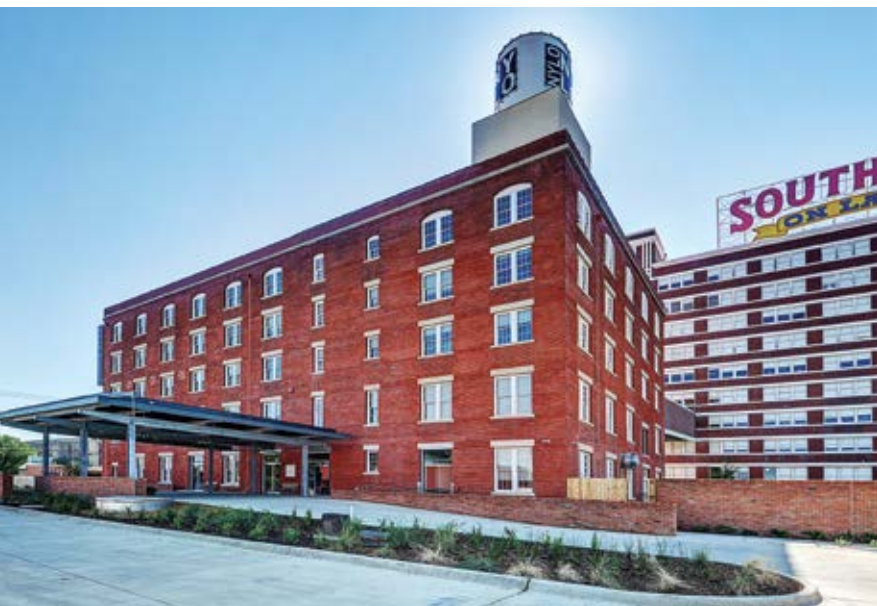
The owner and architect worked closely with Preservation Dallas, a nonprofit organization focused on historic building preservation, to ensure that the historic integrity of the structure remained intact. The historic façade was largely untouched, and mainly consisted of repointing mortar joints and cleaning of the brick. However, the exterior granite façade not original to the building was removed and crushed to be used in landscaping. Site improvements included retaining walls, screen walls around the dumpster and mechanical units, flagpoles, entry canopy and porte-cochere, and a cistern for rainwater collection to handle site irrigation needs. To reduce the amount of new construction materials, the guestrooms feature exposed masonry walls and original exposed concrete floors, columns, and ceilings. This project was designed to achieve LEED Gold and has already received Certified Rehabilitation status from the National Park Service and won a Preservation Award from Preservation Dallas (Fig. 6).

Fig. 6: Historic NYLO South Side Hotel after “reincarnation”
