# One Biscayne Tower Façade Restoration and Repair

Miami, FL

Submitted by STRUCTURAL

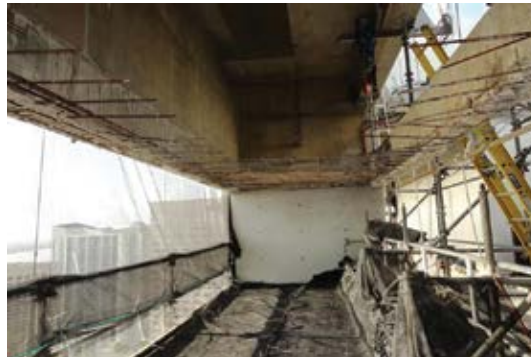
*Overhang slab after demolition and “dance floor” with debris protection installed*

The first major repairs to be performed were the replacement of the two overhang slabs that were severely deteriorated. Demolition was performed using electric chipping hammers with debris falling into netting installed below the slabs. Existing reinforcing steel coverage was minimal with steel areas exposed before demolition. Upon demolition, it was discovered that the supporting soffit beams were also deteriorated and needed repair.

After demolishing the slabs, shoring was installed. Steel truss joists supported by triangular brackets were attached to the columns on either side of the overhang slabs. This required that a beam and pulley system

be devised so as not to overload the “dance floor.” Next, new reinforcing steel was placed and doweled into the adjacent columns and support beams. The steel was coated with corrosion inhibitor and then placed back with high-strength concrete containing corrosion inhibitor for further protection.

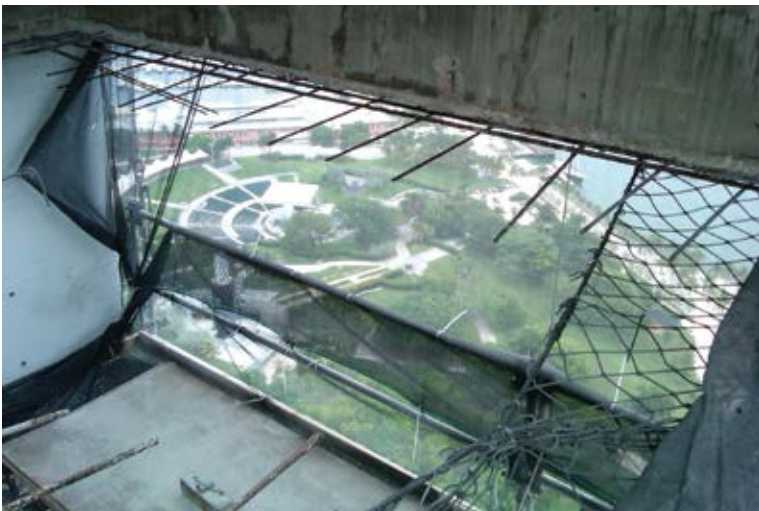
*Cantilevered soffit slab after demolition, looking down to Bayfront Park and the bay*

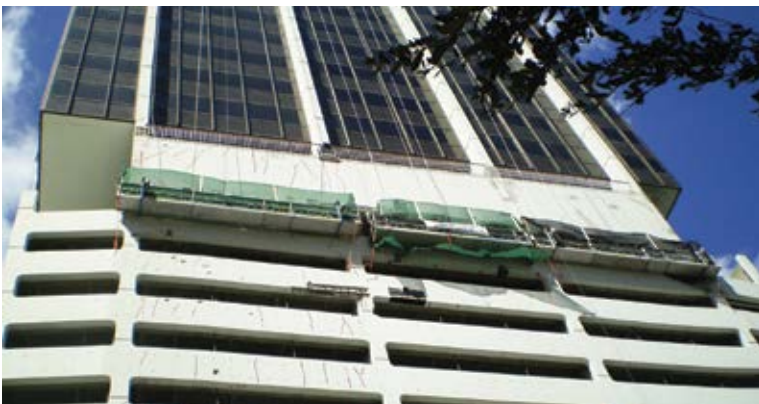
*Repairing the south elevation using swing stages*

The façade repairs were performed with electric chipping hammers on the swing stages and rigid platforms. The steel was wire-brushed clean and painted with corrosion inhibitor. Smaller repairs were placed back with hand-packed material, while larger repairs were formed and placed; both materials contained corrosion inhibitor. Crack epoxy injection was performed with pneumatic injection guns attached to a small compressor on the swing stage and used cartridges, which proved to be very efficient and effective.

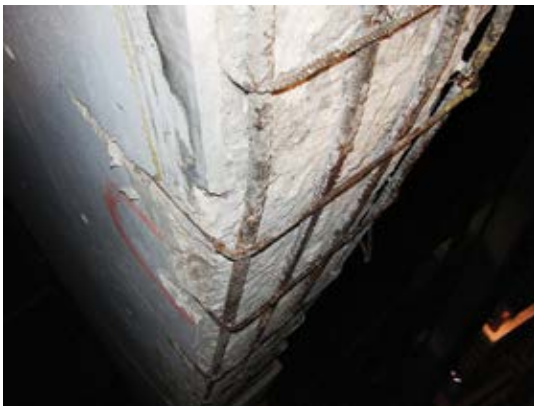
- A large section of column on the north façade exhibited severe deterioration and unconventional reinforcing with minimal concrete coverage. A design was created to build out the column and install additional reinforcing; and
- A large section of column on the east façade at the 37th to 39th levels exhibited severe deterioration with loose concrete, posing a safety hazard to Biscayne Boulevard below. A custom repair design was created and protection measures were immediately installed to contain any falling debris. Logistics were very challenging and required the use of three independent swing stages

Column repair at 39th level during demolition, looking down at night

working in tandem to access all sides of the column. The final repair included building out the column using SCC and wrapping it with CFRP.

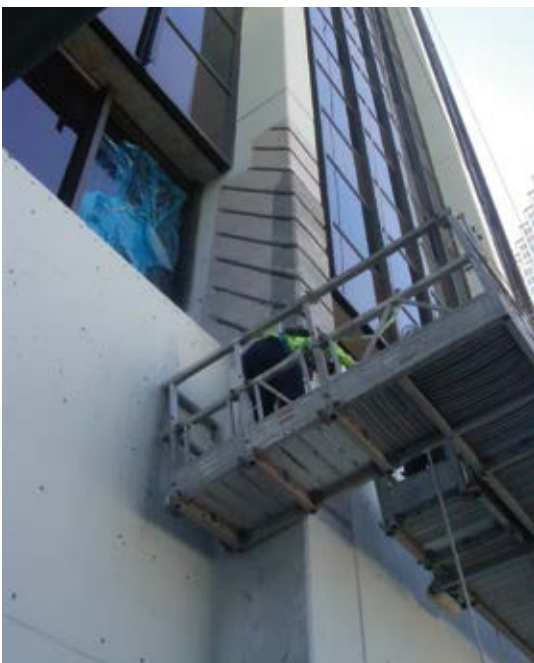
Column build-out and additional reinforcing slots

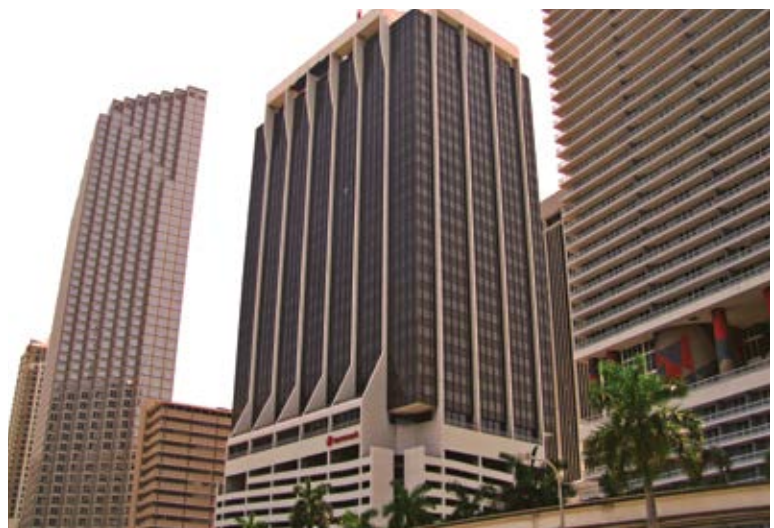
Completed repairs to One Biscayne Tower
