Restoration of 945 Green Street

San Francisco, CA

Submitted by Sika Corporation

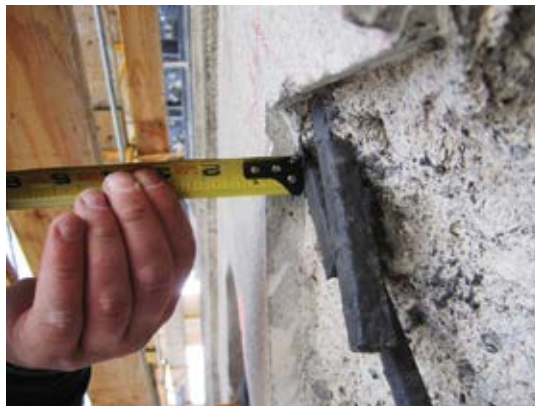
Concrete cover was also measured, and much of the coverage depths were between 1.5 and 3 in. (38 and 76 mm) with only a few areas tested found to be less than 1 in. (25 mm). These low-coverage areas were typically concentrated where the reinforcement hooked over the top of the structural steel I-beams.

Concrete cover

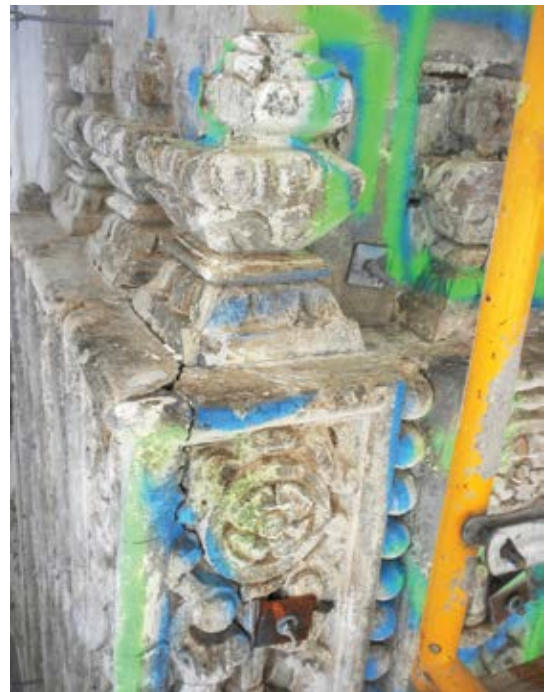
In November 2012, a corrosion evaluation of the north face of the building was performed. The concrete was sounded and many large areas were marked as delaminations. Electrical continuity was then tested to determine the corrosion mitigation methods to apply. Holes were drilled in multiple locations and physical connections were made to the existing reinforcement. A high-impedance multimeter was used to test continuity, and if the difference in potential was less than 1 mV, the steel was deemed electrically continuous. All reinforcing steel tested was found to be continuous; therefore, cathodic protection was considered a suitable method of mitigation.

Evaluation testing

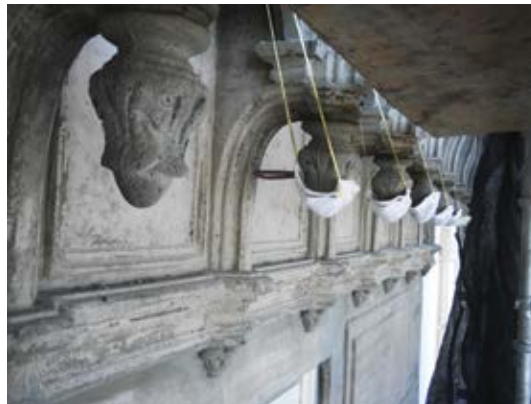
Restoration of decoration flower detail

corrosion inhibitor. As the patching mortar was being applied, the contractor was also overseeing the repair and replacement of the architectural details. The first area to be restored was the line of 20 decorative columns between the 11th and 12th floor panels. Only one column had a capital and footer, so a foam mold was created with a profile of the detail. The mold was then used to recreate this detail for the other 19 columns. Around the outside of the building there had been busts of a woman's head and, like the panels/columns, most were missing. One bust was found in decent condition so, after minor repairs to the original, a mold was created and the remaining busts were cast using a pre-bagged, self-consolidating concrete mixture.

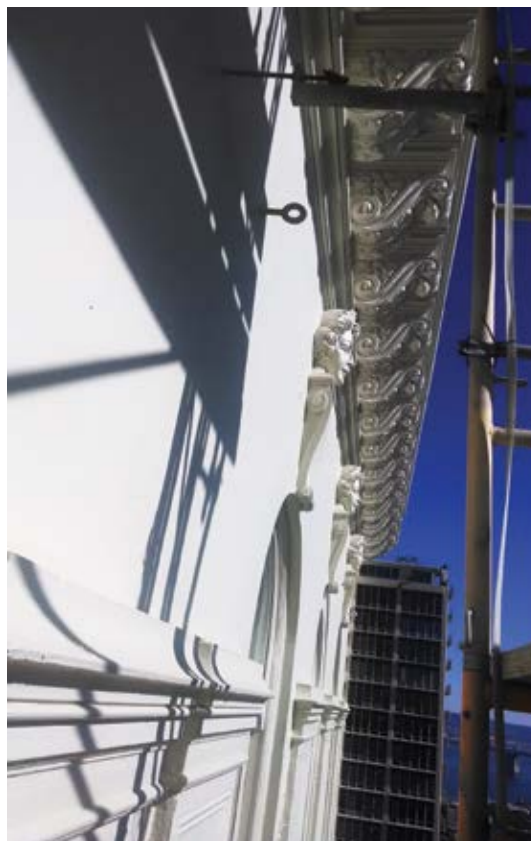
Restoration of architectural details

These decorative elements were then reattached. Many of the decorative panels surrounding the façade were badly damaged or missing, so a similar procedure was used to restore these as well.

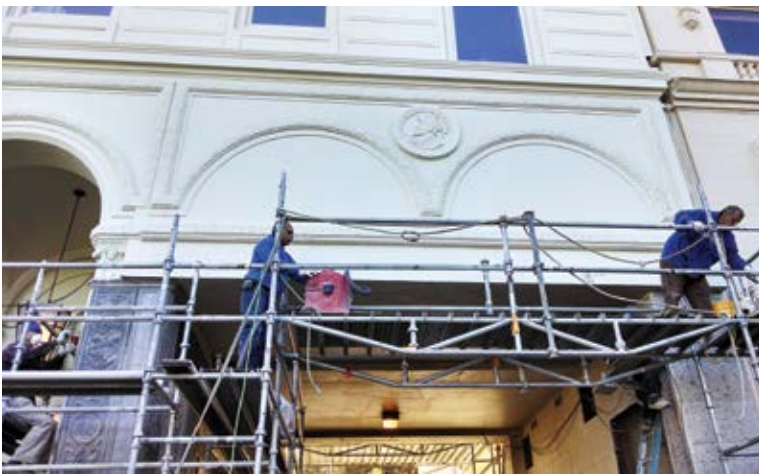
As the workers made their way to the ground level, they began work on the breezeway, which had been altered over the years due to changes in modes of transportation. An entire row of columns had been removed to make way for wider vehicles to pass through, and to make up for the missing support system, beams were put in place to carry the load. This replacement meant that many of the original decorative arches had been removed. The existing arches were modeled along with the medalion and decorative trim surrounding them. As for the arches, to fill in the gap left by the removed

Arch restorations

columns and to keep the radius consistent across the span, the contractor created a vertical element. This eliminated the gap and created a full half circle.

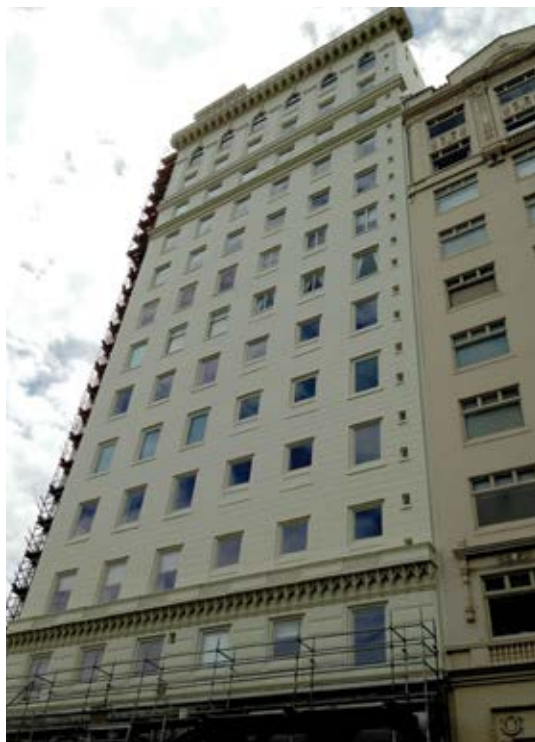
Completed restoration

The building received a topically applied penetrating corrosion inhibitor on all bare concrete. After allowing the inhibitor to penetrate the surface and onto the steel, the remaining surfactant was removed using a power washer. Finally, for added waterproofing and long-term protection, the entire building was coated with a high-performance elastomeric wall coating system.
