# Baltimore Design School

Baltimore, MD

Submitted by Sika Corporation

2014 Project of the Year

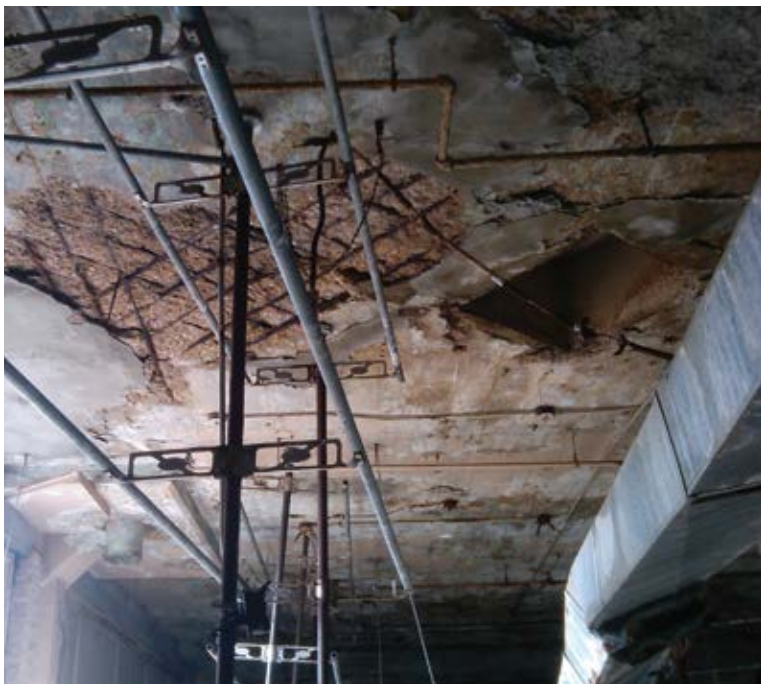
*Spalling ceiling*

Once the decision was made regarding the site selection, a design and construction team was assembled to perform condition assessments of what would be required to make this grand vision a practical reality. Unoccupied and lacking maintenance for over a quarter of a century, the building was in extreme disrepair. Due to the lack of concrete cover, lower-quality concrete, and advanced carbonation, corrosion had spread throughout the exterior reinforced elements and interior columns. Ceilings and spandrel beams were especially heavily damaged from accelerated corrosion. Testing revealed that the concrete was 2000 psi (13.8 MPa) in compressive strength, low for today’s standards but consistent with building codes of that era. The steel reinforcement was smooth and uncommonly placed diagonally to column alignment. The severe corrosion diminished the capacity

of the reinforcement, making it necessary to use structural strengthening in addition to the repair and protection work.

All major methods of concrete repair techniques were incorporated into the overall strategy. This included hand-applied, machine-applied, form-and-pour, and form-and-pump applications. The method of installation was selected based on the orientation, the size of the repair, and the predicted productivity of the technique. Materials were selected based on the ability to bond to the original concrete, resist corrosion with minimum cover, and provide the workability benefits associated with the application method.

- 
2. The hand-applied method was chosen for both the smaller, more isolated repairs on columns and ceilings, and for the more complicated architectural features, such as with the exterior arches.

3. Machine-applied repair mortar was used to repair some large ceiling sections. This method was selected to greatly improve production while providing a very dense material.

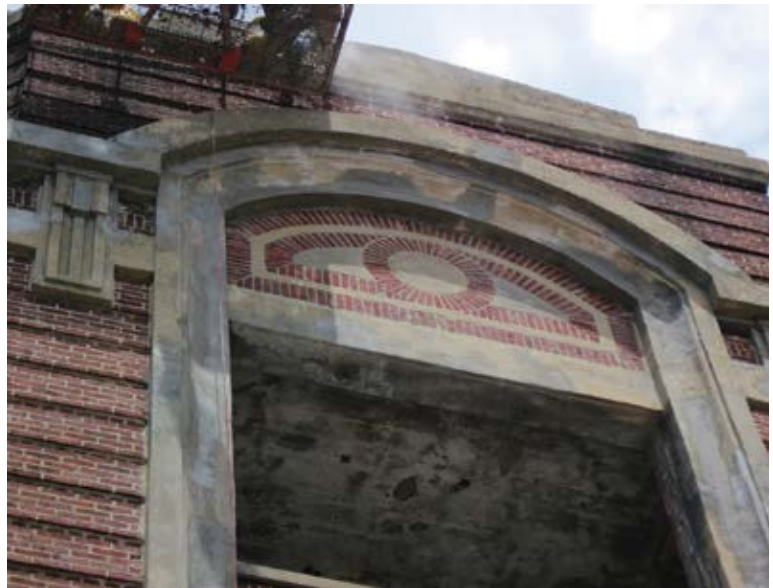
*Hand-applied mortar*

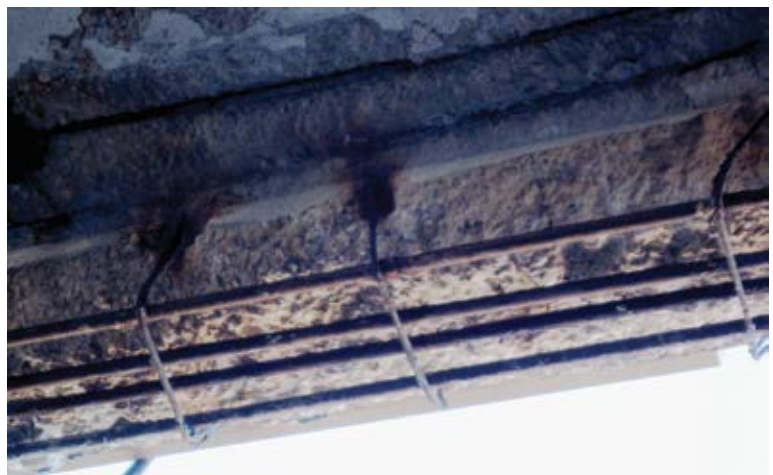
*Close-up of spandrel beam repair*

1. Any surviving smooth reinforcing steel in the repairs was thoroughly cleaned and coated with a corrosion-resistant primer that also increased adhesion with the repair material. However, much of the reinforcement throughout the structure was terminally corroded and had to be replaced with new reinforcing steel or complemented with additional strengthening. New reinforcement was required for all the spandrel beam repairs.

5. Prepackaged self-consolidating concrete was used to repair the vast volume of spandrel beams at all the windows. The limited width and depth of the repair, combined with the quantity and size of the required reinforcement, plus the expansive length of spandrel beams, dictated special consideration to the application and material. Working time, flow, segregation concern, and consolidation in addition to adhesion, durability, and shrinkage properties all had to converge for a successful installation. This required the expertise in pumping supplied by the installing subcontractor

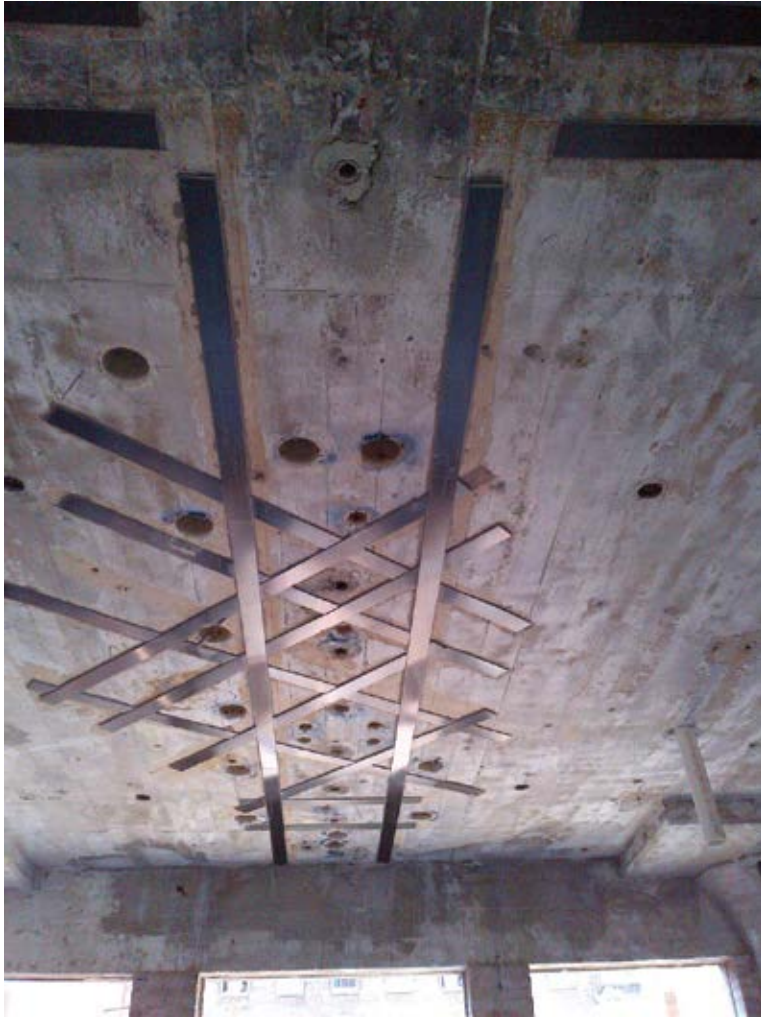
Carbon-fiber plates

Roof slabs of the building had extreme section loss requiring new reinforcement. Supplemental reinforcement was also used to bring slabs back to their safe load-bearing capacity. Carbon-fiber plates were installed for strengthening these areas along with strengthening locations of new cutouts for conduits, pipes, ducts, and vents and for the new HVAC system.
