# Bethel Park Restoration

Houston, TX

Submitted by Walter P Moore

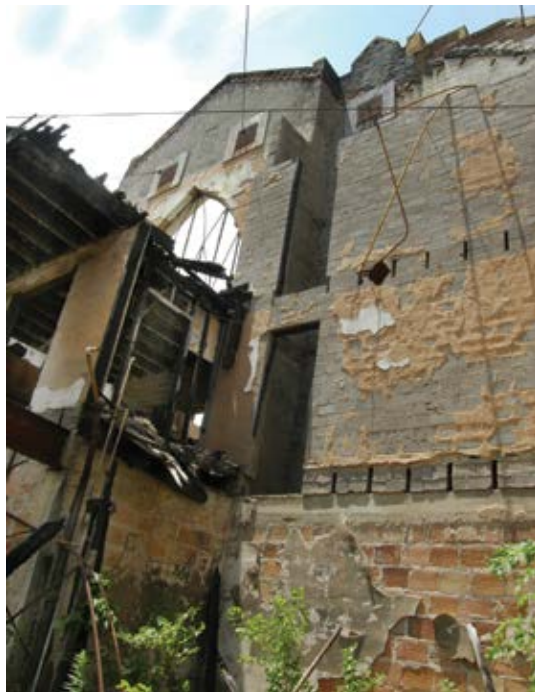
Fig. 1: Masonry wall prior to restoration

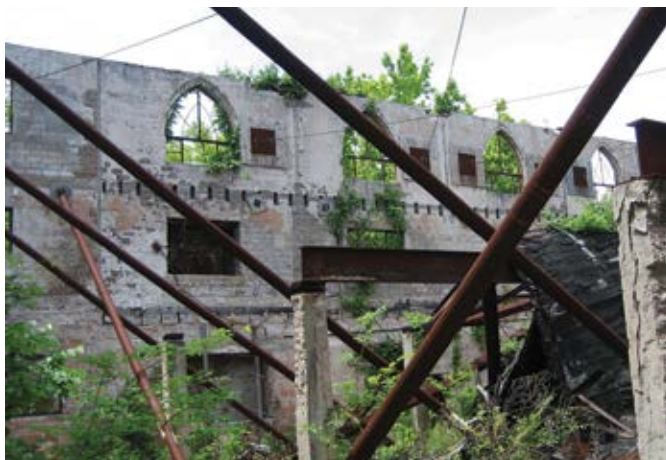
Fig. 2: Interior of gutted church

After the first two church buildings were destroyed, a third, single-floor church building was erected in 1923. Second and third floors were added in a 1950 renovation. The sanctuary was designed by James M. Thomas, a prominent architect of African-American churches. In January 2005, a fire gutted the interior of the historic structure, collapsing the interior framing and roof, leaving only the exterior masonry walls in place. The structure sat exposed and abandoned until 2009, when the City of Houston purchased the property to convert the former church into a community park (Fig. 1 and 2).

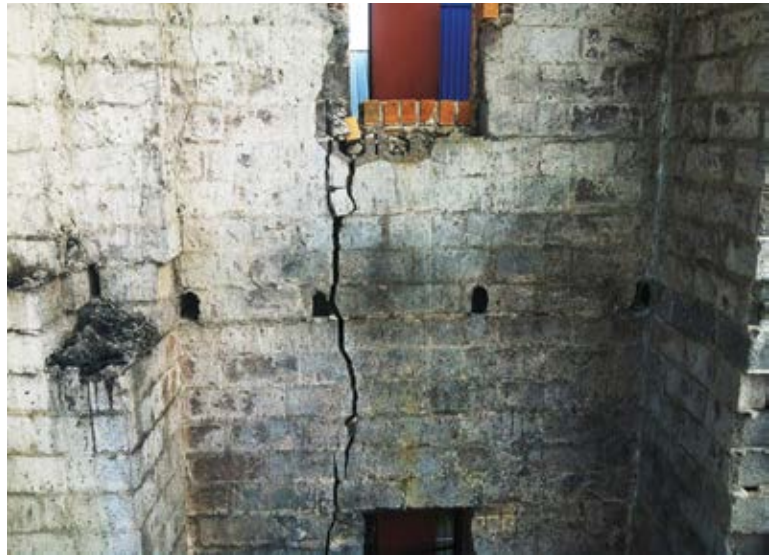
- Difficult site access and possibly dangerous conditions due to collapsed framing and debris that remained from the 2005 fire; and
- Public safety risk due to deteriorating conditions—a large crack that ran from the base to the top of the 50 ft (15 m) brick veneer façade (adjacent to pedestrian sidewalk) indicated imminent collapse (Fig. 3).

Fig. 3: A large crack that ran from the base to the top of the 50 ft (15 m) brick veneer façade (adjacent to the pedestrian sidewalk) indicated imminent collapse

Before any evaluations could be performed, the engineering team made recommendations to the City to immediately close the street to traffic and temporarily brace the existing walls. Emergency shoring and bracing was designed and installed within a 24-hour period to protect the public and the structure (Fig. 4).

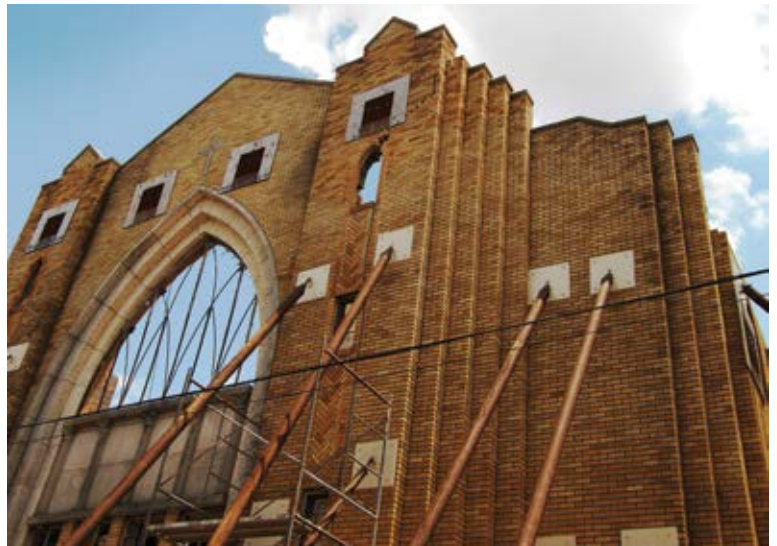
Fig. 4: Emergency shoring and bracing

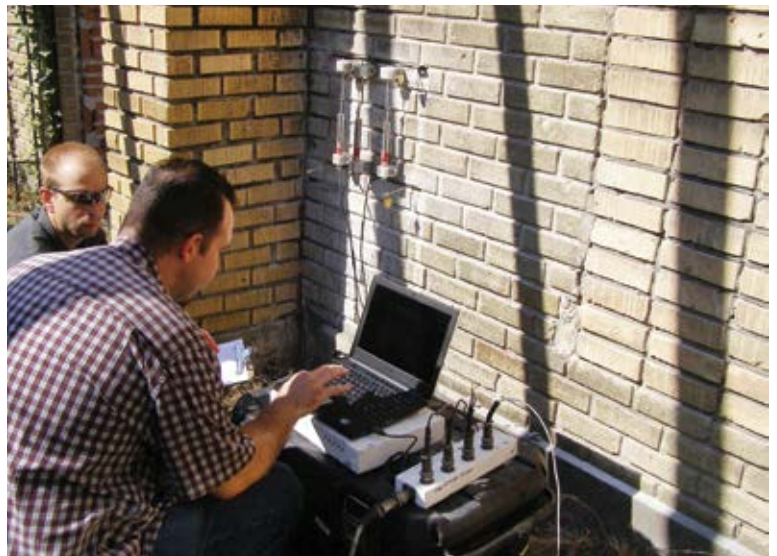
Once the walls were stabilized, the engineers devised a plan to provide safe site access to evaluate the building. The south wall, portions of which had collapsed, was demolished and the interior of the site was cleared. The design team was then able to enter the facility to perform a condition assessment program of the existing walls. This program included ground-penetrating radar (GPR) scans to assess the wall reinforcement, flat-jack testing to develop information for design, and a visual assessment to document distress conditions for repair (Fig. 5).

The assessment program determined that the CMU backup walls and structural clay tiles were in poor condition, contributing to dangerous conditions. Significant cracking was evident throughout the backup wall system, and large portions of the wall were unreinforced, including the 50 ft (15 m) north wall. At several locations, the brick ties installed during the 1950 construction had corroded and failed, and the veneer was deflecting away from the backup.

Fig. 5: Part of condition assessment program on existing walls

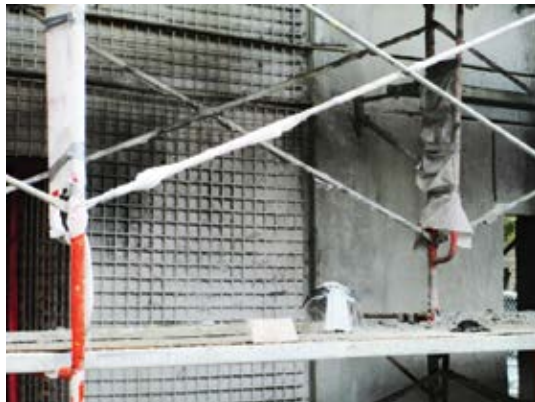
*Fig. 6: A ferrocement coating provided lateral reinforcement to the CMU backup wall and provided a uniform finish to the interior of the park walls*

A ferrocement coating provided lateral reinforcement to the CMU backup wall and provided a uniform finish to the interior of the park walls (Fig. 6). Galvanized welded wire reinforcement was pinned to the interior faces of the walls, and a 2 in. (51 mm) thick shotcrete coating was applied. The ferrocement coating extended around the edges of window openings and at the tops of walls to provide clean, aesthetically pleasing terminations. It was then given a drag finish for a relatively smooth wall surface that resembled a stucco finish. A cream-colored elastomeric coating was then specified to brighten the interior finish and contrast against the new multicolored fenestrations (Fig. 7).

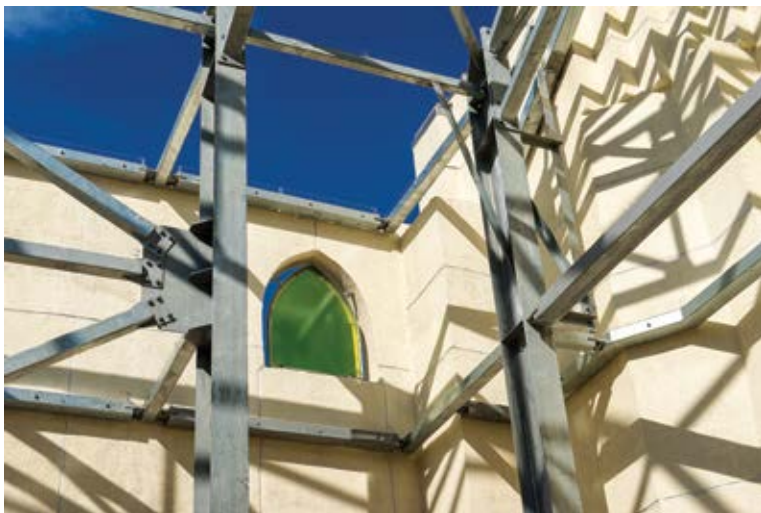
*Fig. 7: A cream-colored elastomeric coating brightened the interior finish*

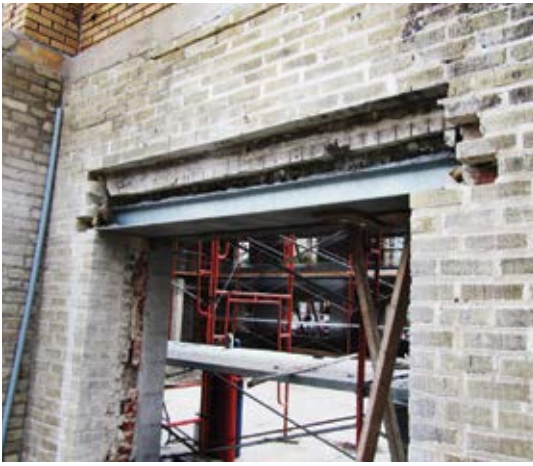
While this strengthening ensured that the historic walls would withstand hurricanes common to the area, a number of other details were required to enhance the appearance of the park and preserve key architectural elements of the walls. Cast stone panels installed in the north wall required patches to repair spalls and restore these panels. Existing lintels over door and window openings in the 1923-era construction were removed and replaced because corrosion of the original lintels had resulted in rust-jacking and cracking (Fig. 8).

Fig. 8: Existing lintels over door and window openings in the 1923-era construction were removed and replaced

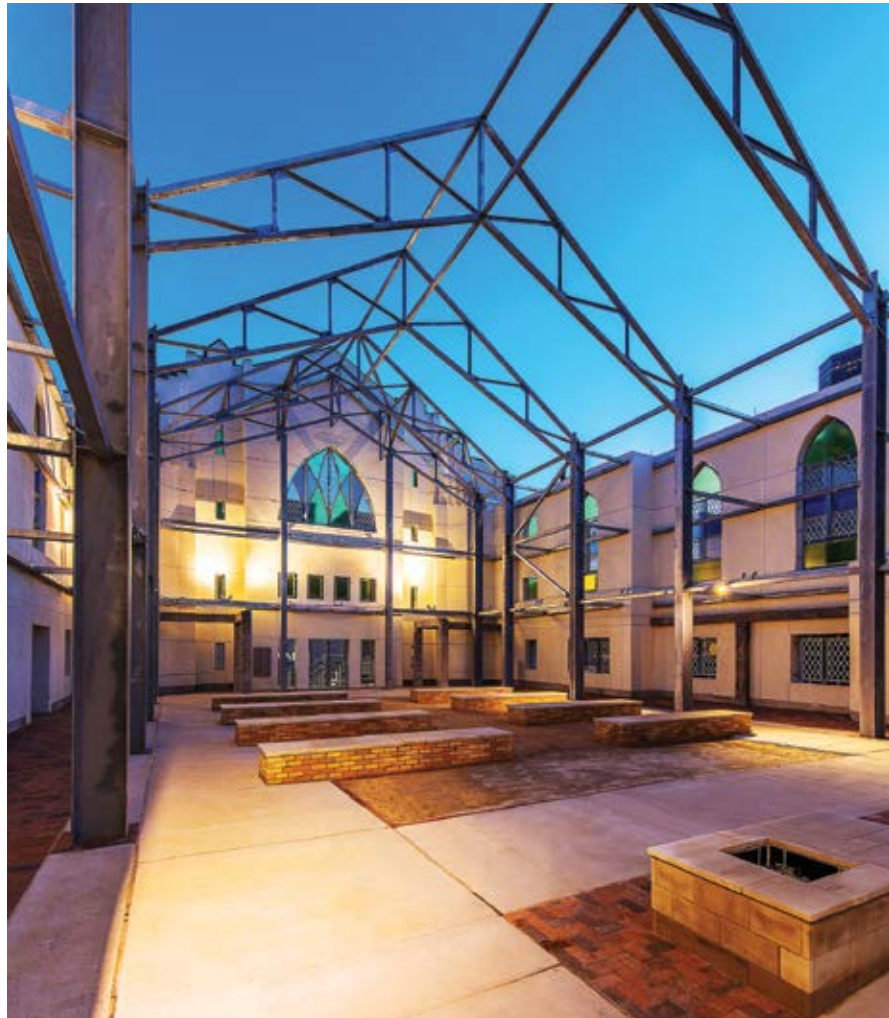
Fig. 9: Interior of finished project

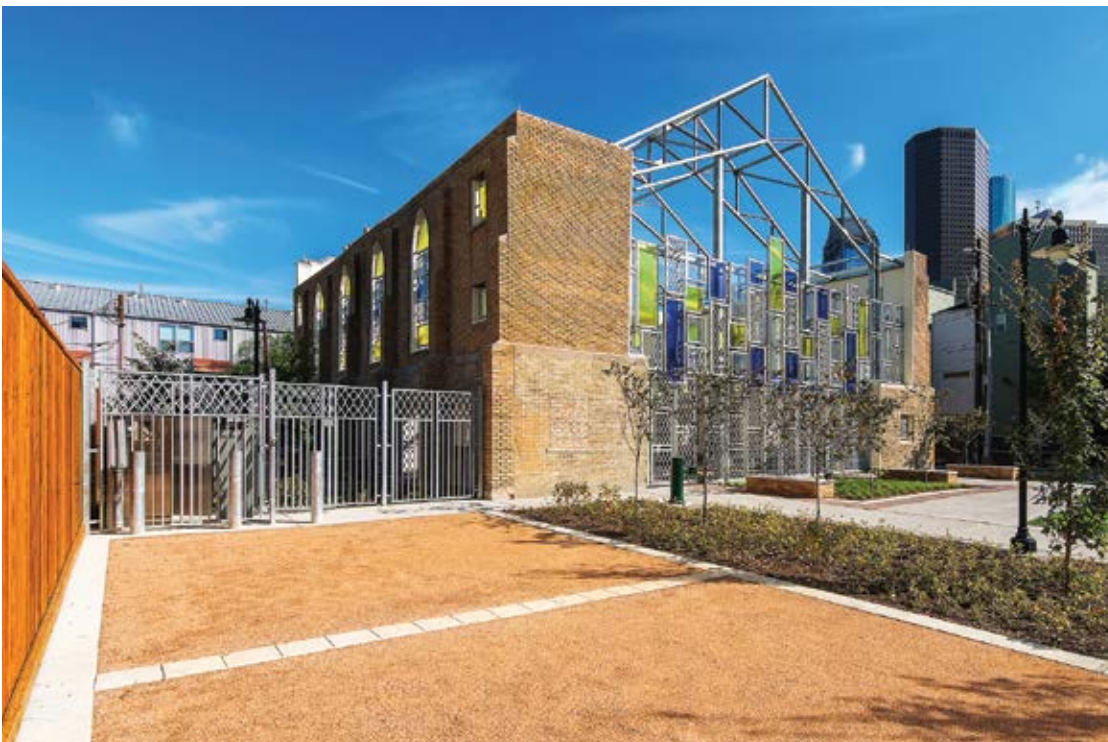
Fig. 10: Rear of finished project and park
