Repairs to Paulina Street Parking Structure

Chicago, IL

Submitted by CTLGroup

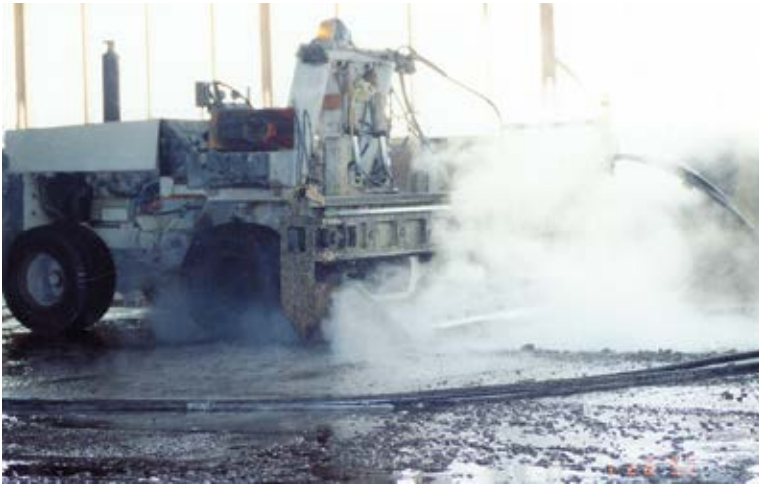
Hydrodemolition in progress

1. Removal of deteriorated deck concrete would be performed by hydrodemolition. In this way, the potential for tendons damaged by chipping hammers would be minimized. Moreover, the resulting surface profile of the substrate would be conducive to achieving high bond strengths.

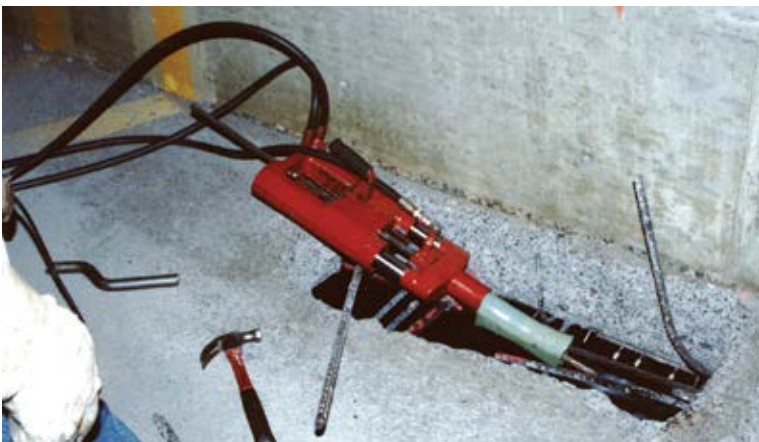
Post-tensioning tendon repair

Pitted strand segments were replaced. In most instances, replacement was performed by rethreading new, greased strand into existing sheathing and splicing to existing strands. In a few instances, replacement required trenching of the slab followed by installation of new sheathed strand and anchorages.

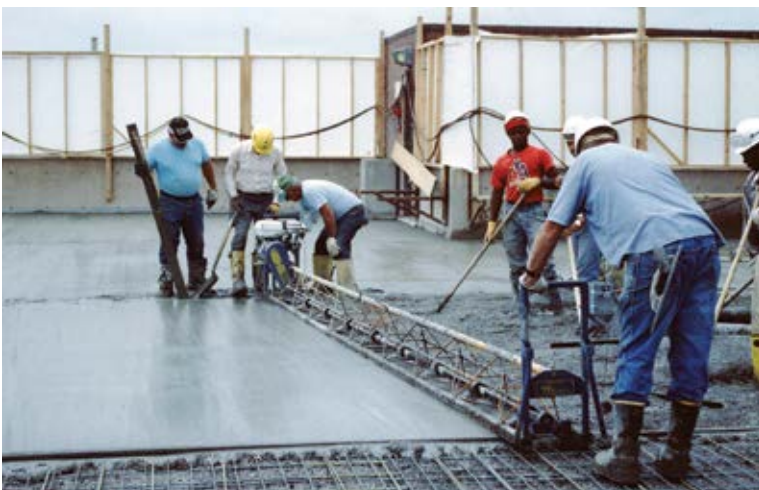
Placement of concrete overlay

4. Repair methods were developed to correct detensioned and significantly corroded post-tensioning tendons.
5. Microsilica concrete was chosen as the overlay material due to its relatively high strength, low permeability, and low maintenance requirements. Reinforcing steel for the overlays consisted of epoxy-coated welded wire reinforcement and some supplemental reinforcing bars.

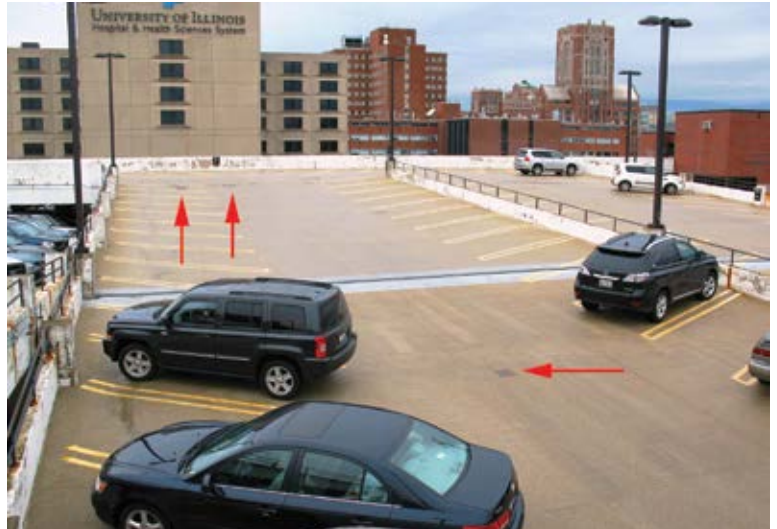
Based on a 2013 inspection and discussions with the university, the garage has required minimal maintenance over the past 21 years. It appeared that two repair programs have been performed since 1993 repairs. The repair programs consisted of only isolated patch repairs, routing and sealing of some slab topside cracks, and some joint maintenance. The total area of patch repairs reflects significantly less than 5% of the total surface area of the 1993 overlay. No soffit deterioration was observed. Isolated topside delaminations were identified during the inspection; delaminations sounded relatively shallow and appeared to be located in areas where cover over overlay reinforcing was locally shallow.

Overlay and localized repairs

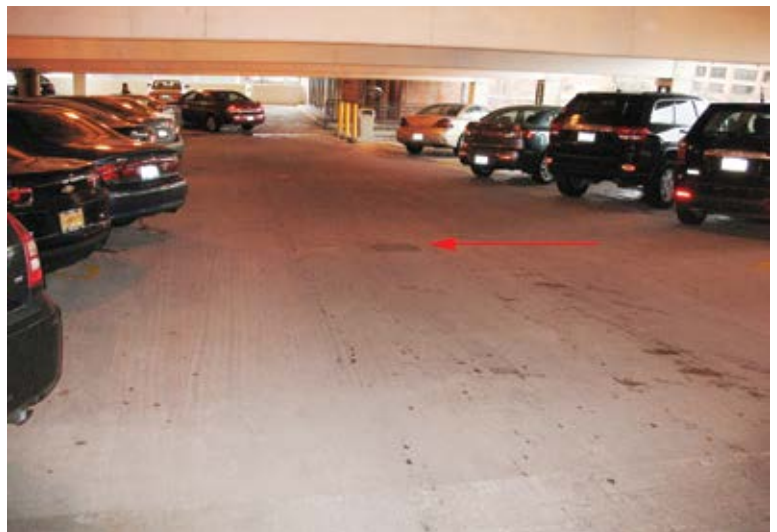
Overlay and localized repairs
