# What's on Tap? Structuring Water Quality

Denton, TX

## Lake Lewisville Water Treatment Plant

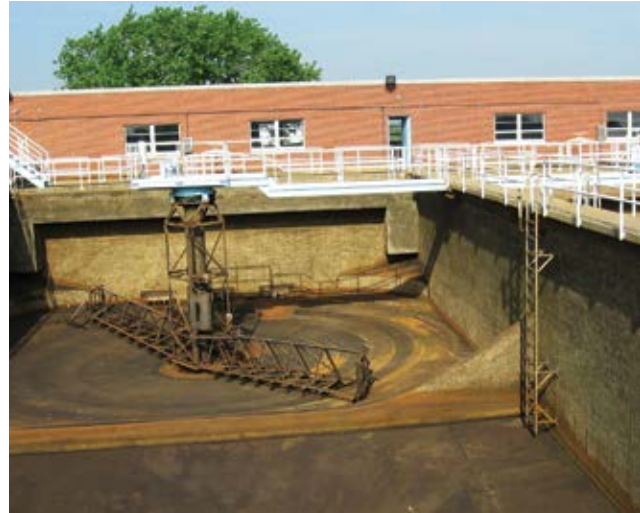
A major capital investment was required to increase plant capacities and obtain the water quality requirements mandated by changes in federal and state water regulations. Process changes enacted in the early 1990s in response to the EPA Safe Drinking Water Act resulted in a much lower pH in the floc/sed basins and filters. The widespread pitting of the concrete surfaces was a direct result of the low-pH, acidic process water. This posed water quality issues, as the pitting holds debris, bacteria, and other contaminants.

*A general view of the original floc/sed basin conditions*

The primary cause of the observed matrix loss, surface pitting, and embedded metal corrosion was determined to be the highly acidic process fluids in the floc/sed basins and filters, which have a pH in the range of 6.3. Isolated instances of exposed and rusting reinforcing steel and metal assemblies are a result of the aggressive service environment. Widespread isolated concrete cracking and spalling existed throughout the complex. Expansion joint material at multiple locations was in a state of disrepair and had failed due to age and exposure.

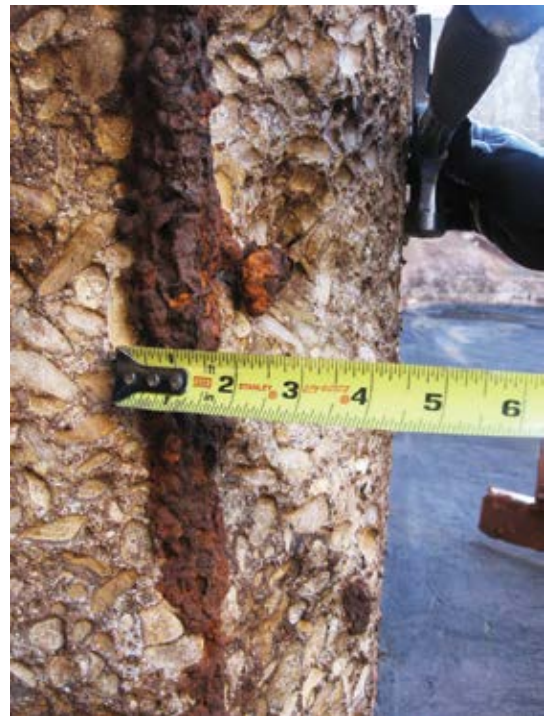
A complete evaluation of the existing facilities was performed which showed the embedded metal components, such as ladder rungs and pipe supports, exhibited severe corrosion and posed risk for further damage of the surrounding concrete. The concrete walls in the primary containing structures exhibited matrix loss up to 1/2 in. (13 mm) and subsequent aggregate loss causing severe surface pitting. To accurately determine the depth of deterioration at the wall surface and obtain the data necessary in evaluating various repair methods, petrographic and pH testing were performed at several locations throughout the basin complex.

*A typical view of embedded metal corrosion*

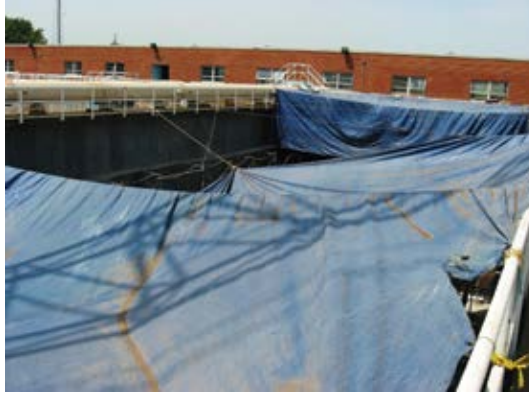
*Temporary shading during repair*

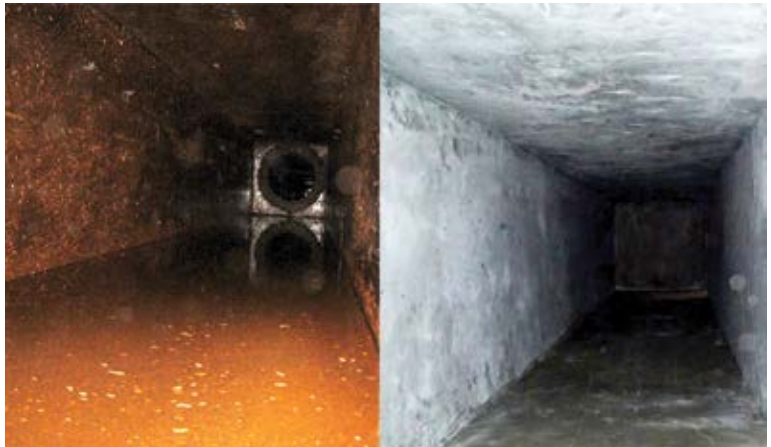
*Confined space wall repairs before and after*

pulloff tests of the existing concrete substrate, the field criteria for an acceptable mortar application were established. The contractor employed several means for surface preparations, including hydro-blasting and mechanical abrasion. The rigorous field quality assurance program implemented on the project to ensure proper surface preparation played a key role in the subsequent successful bonding of the repair mortar system.

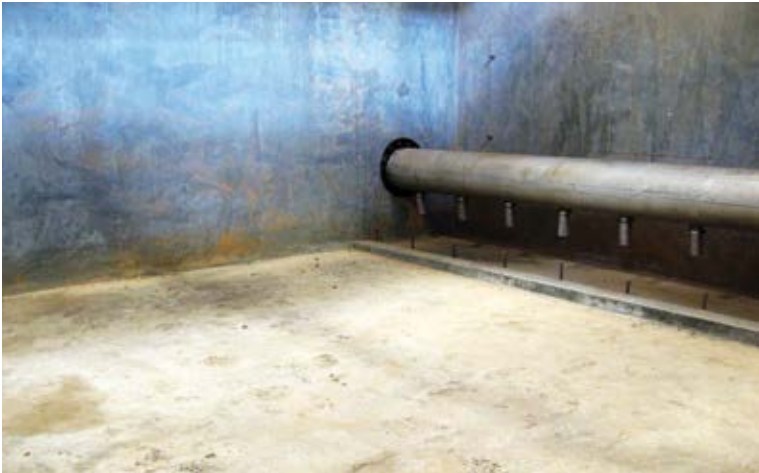
Finalized repairs

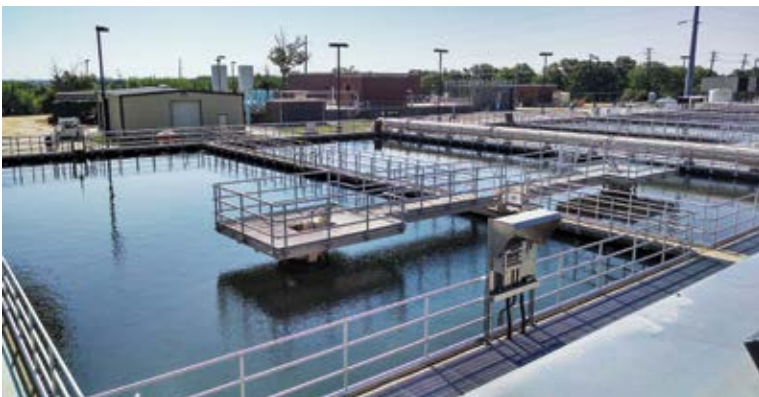
Completed project
