Windsor Suites Hotel Parking Garage Restoration

Philadelphia, PA

Submitted by Carl Walker, Inc.

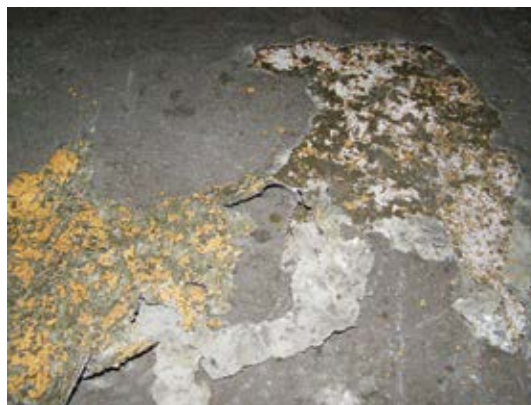
Failed coating and concrete

- **Defects:** Inadequate drainage; previous slab repairs found unbonded to substrate; extensive corrosion of reinforcing steel at previous slab repairs; deck coating system terminated at vertical surfaces of columns, allowing chloride-laden moisture to wick into slab; evidence of trapped moisture at failed deck waterproofing, restricting moisture evaporation; and no drainage provided on south and west sides of garage; and
- **Deterioration:** Concrete freezing-and-thawing damage below failed deck waterproofing; severe corrosion of top/bottom reinforcing steel of slab system, resulting in large areas of concrete delaminations; section loss of reinforcing steel reducing the capacity of slab; excessive deflections occurred; and beginning of punching shear failure at columns, noted patterned cracking, vertical displacement one side of crack to the other.

To prevent future deterioration of repaired floors and ramps, methyl methacrylate deck coating system was provided. This was selected because the relative stiffness of the floor would allow for the less flexible material and the material could be applied and repaired in cold weather.

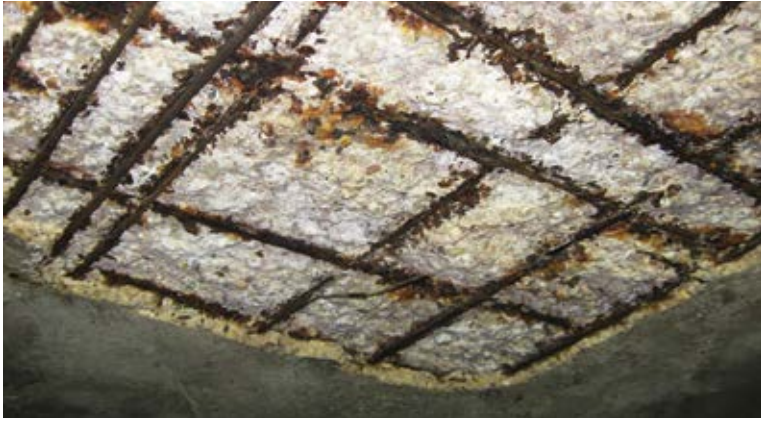
Once areas exhibiting potential failure were safe, the investigation of garage slabs commenced. Visual observations of spalls and exploratory excavations at top/bottom of slabs revealed critical section loss on reinforcing steel. Horizontal cracks extending into the bottom of the slab at the line of reinforcing steel indicated that corrosion continued after previous repairs. Sounding of the top side of the slab revealed delaminations at each column.

Overhead spall and corroded reinforcing steel

Based on investigation findings, partial area repairs were no longer viable. The most effective repair was to replace 3 in. (76 mm) of the top of the slab, including replacement of the top reinforcing bars at each level. Where corrosion extended to the bottom reinforcing bars, full slab replacement was required.

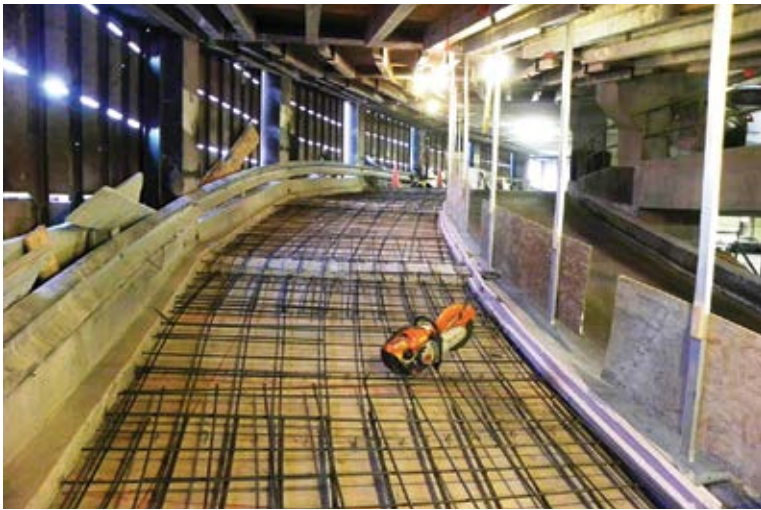
Ramp restoration

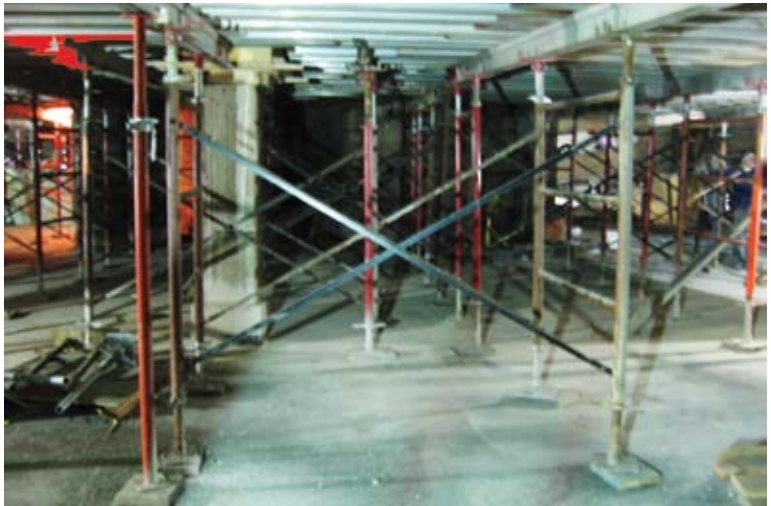
Underside shoring

Prior to beginning saw-cut operations, shoring was installed, consisting of aluminum beams and plywood covered with a layer of foam insulation. Upon removal of the concrete and foam insulation, shoring towers were adjusted, raising the plywood layer into position as the formwork for the new slab.

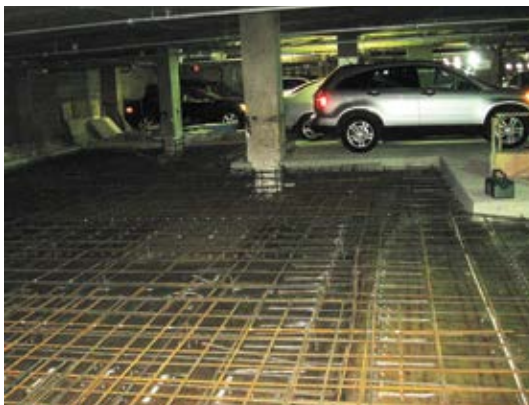
Close coordinated parking and construction
