# Cement Silo Repair and Upgrade

2000  
Award of  
Excellence Winner,  
Industrial Category

## Cement Silo

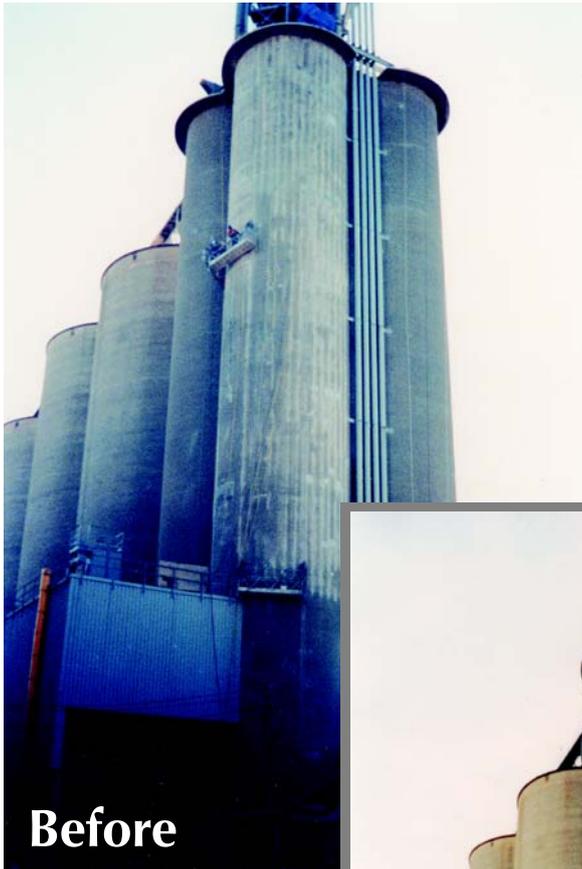
*Top left, initial survey and inspection of silos (4-cluster configuration)*

An initial inspection revealed cracking patterns indicative of concrete spalls as well as radial and circumferential cracking that could have been structural in nature. A structural analysis determined that the latter were indeed structural cracks caused by lack of both vertical and circumferential hoop steel. Over 30% of the required steel was missing due to design and construction oversights when the silos were originally installed. As a result, and at the recommendation of the engineer, the owner was limited to partially filling the silos (approximately  $\frac{1}{2}$  of their height) to avoid a structural failure. Prior to further inspection,

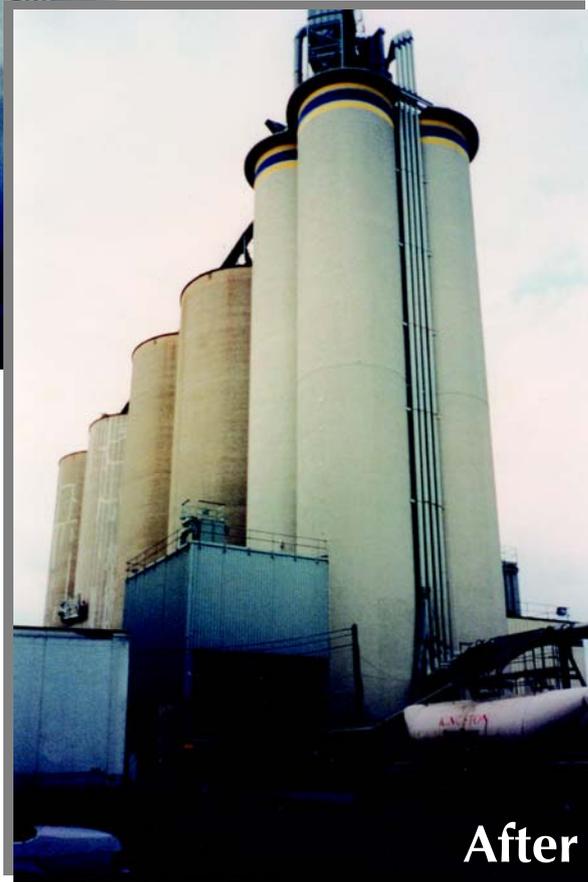
*Immediate left, completed repair strengthening and top coat process*

to the team, and the balance of the project was started. Five additional silos were then repaired and strengthened in this manner. Ongoing quality control included pull-off tests and cores for visual inspection. The final step was to coat the entire silo with a breathable, acrylic topcoat for both durability and aesthetic purposes. The silo was coated with the owner's company colors and logos.

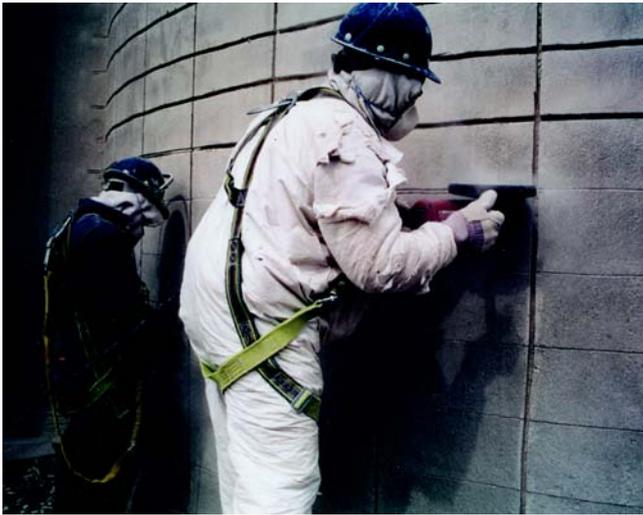
*Grooving process*

All technical issues were solved, verified, and field-tested by the team. Installation of the rods began with the grooving operation. Customized grooving tools allowed technicians to cut the appropriate grooves in one pass. Where the groove intersected the common wall locations, a hole was drilled that was tangent to the curve of the silo to the depth determined by pull-off test results. A two-component, high-viscosity epoxy adhesive was gunned into the deeper vertical grooves.

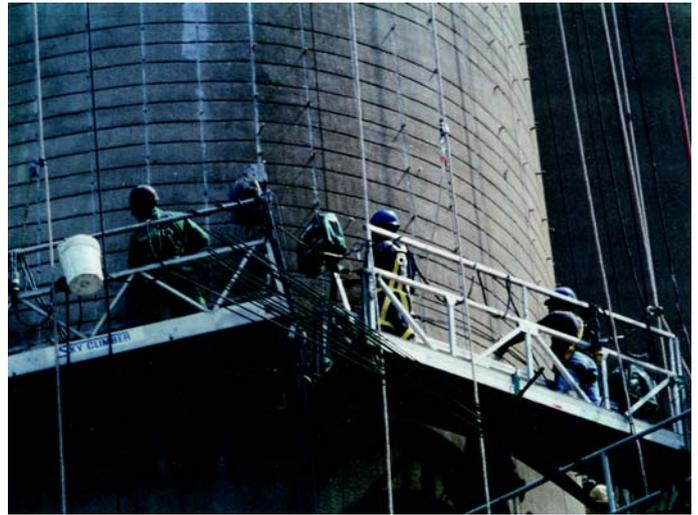
*FRP rod installation*

The rods, some 150 feet long, could be handled in single pieces due to their lightweight properties. The vertical rods were then inserted into the groove and embedded in the adhesive. A second layer of adhesive was applied on top of the FRP rod. Upon completion of the vertical installation, the circumferential rods were installed. Adhesive was installed in the dowel holes in the two common wall intersections and in the horizontal grooves. Starting at the first dowel, a single length rod was inserted into the dowel hole and then placed into the horizontal groove around the circumference until it met the other common wall intersection. The remaining length was inserted into the second dowel hole. The second layer of adhesive on top of the horizontal rod was installed, and the material was then tooled to create a surface appearance that could easily be hidden with a coating for aesthetic purposes.

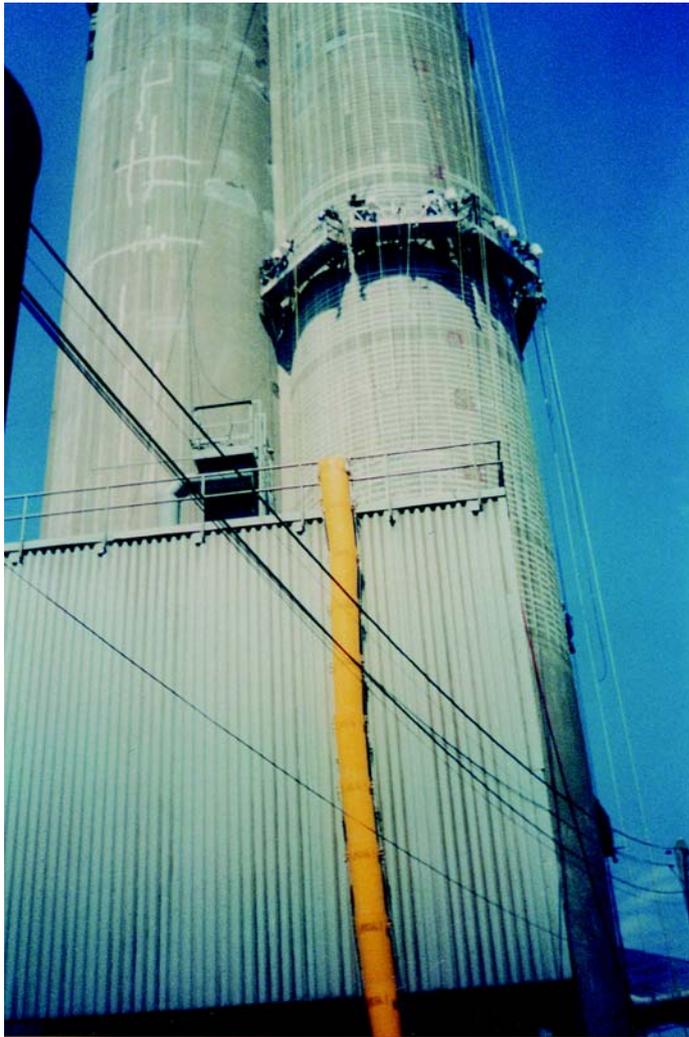
*Custom swing stage access for grooving and FRP rod installation*

Access was accomplished using customized, suspended swing stages. A comprehensive interior and exterior inspection of the silos identified and mapped out all cracks and spalls. The initial repairs consisted of epoxy injection of cracks and surface repairs using a form and cast-in-place placement technique. The repair strategy removed only one silo from service at a time for inspection, repair, and strengthening. Upon completion of each, the owner had full capacity for inventory. This procedure proved to be a major benefit.

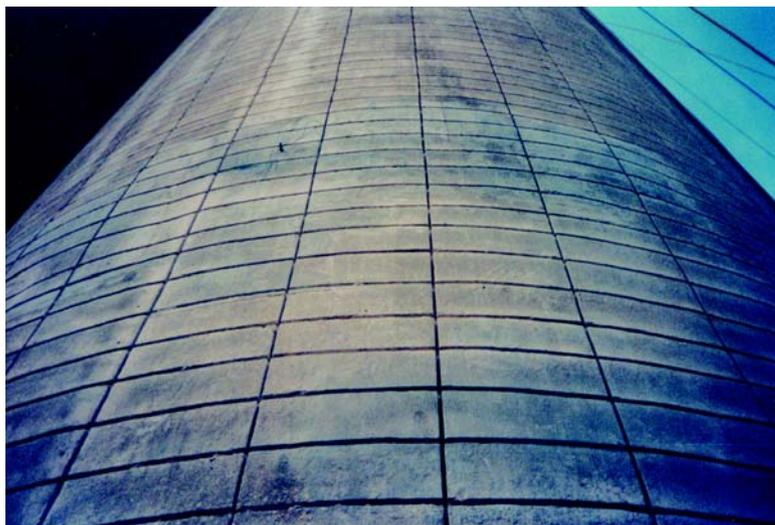
*View of horizontal and vertical grooves prior to installation of FRP rod*
