Test Cleaning of Travertine and Limestone Façade Panels at The World Bank

By Margaret H. Mitnick, P.E.

The World Bank Cleaning

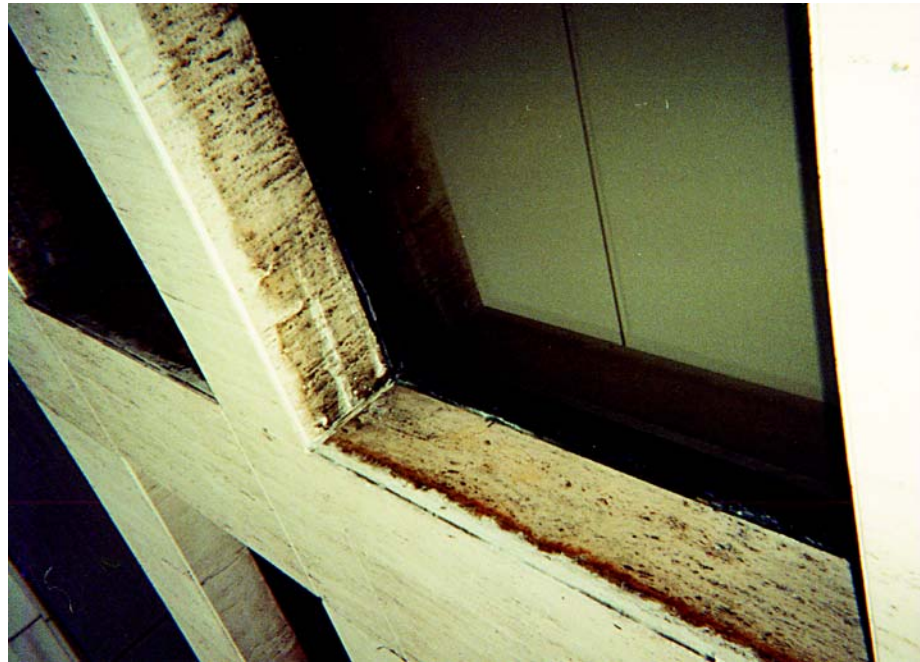
The travertine panels on the D Building exhibited dirt accumulation and staining from rain and atmospheric pollution. The dirt and staining were most notable on the inset panels around the windows. Flexible sealant joints existed between travertine panels. Two weep holes were located at the head of each window at the exterior face of the travertine panels. There was one weep at the base of the wall panels (below the third floor) for each window bay. The pattern of staining and efflorescence was indicative that the weeps were functioning.

Figure 2: Dirt accumulation and staining of the D Building travertine

Three travertine panels were cleaned to provide three different levels of cleaning. After the test panels were completed, The World Bank reviewed the work. Sample cleaning on the travertine was performed by the restoration contractor using a pressure washer with the water pressure at approximately 1,000 to 1,500 psi. The cleaning was performed on the D Building at three locations at window insets above the loading dock. Each of the three locations was cleaned with a different restoration cleaning system manufactured by the same restoration cleaning systems manufacturer.

The sample cleaning products used on the D Building travertine varied in effectiveness. The systems used, from least to most effective, were: limestone and marble cleaner and brightener; heavy-duty limestone and marble pre-cleaner; and polished marble and granite cleaner. The World Bank selected the most effective cleaning system. This system most closely restored the travertine to its original appearance.

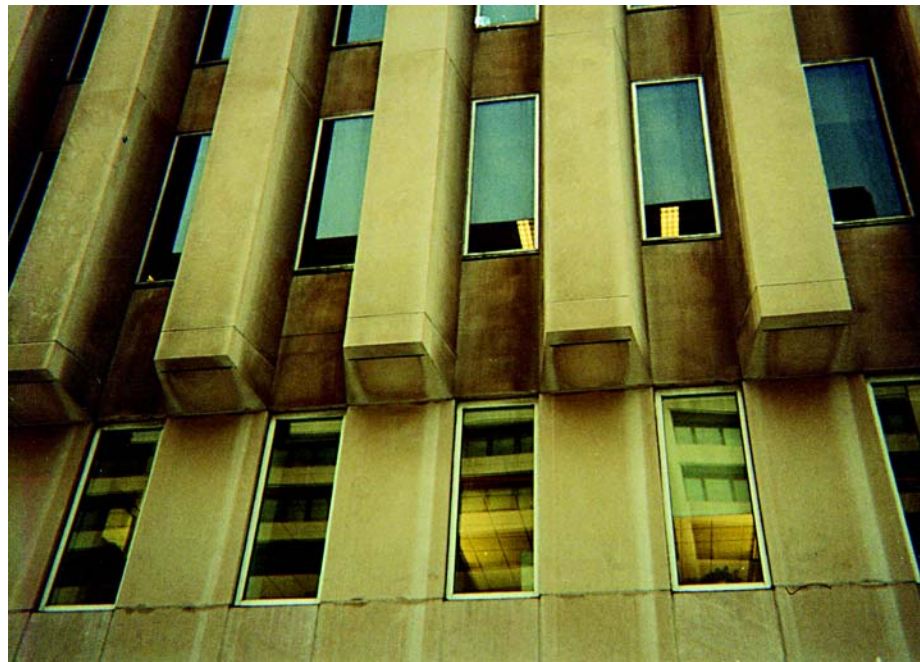
The limestone panels on the E Building exhibited dirt accumulation and staining from rain and atmospheric pollution. The façade consists of vertical tiers that extend beyond the face of the building alternating with tiers consisting of flush windows and vertical panels at each floor. The

Figure 3: The E Building limestone panels at third floor

One limestone panel was cleaned above the third floor. After the test panel was completed, The World Bank reviewed the work. Sample cleaning on the limestone was performed by the restoration contractor using a pressure washer with the water pressure at approximately 1,000 psi. Sample cleaning was performed on the E Building on the inside face of a tier on the west elevation, near the southwest building corner.

The cleaning product used successfully on the E Building limestone was a limestone and marble cleaner and brightener. The World Bank approved the sample cleaning system. This system most closely restored the limestone to its original appearance.

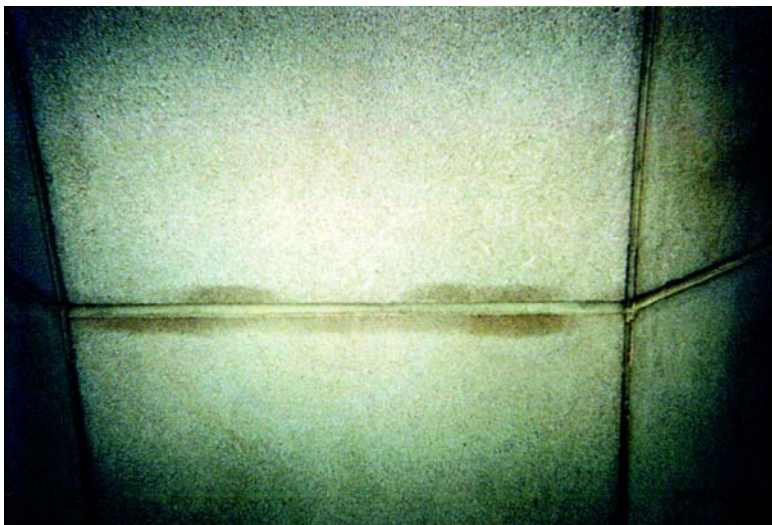
The next phase of the sample cleaning process was to attempt to address the stains on the newer limestone panels in the area below the third floor. The first step was to attempt to determine the material causing the staining. If the material was known, then it would be easier to find a product that could clean the panel without damaging the limestone adjacent to it. Upon review of available contacts from the renovation in 1991 and the available construction documents, it was determined that no specific information was available as to how the limestone was configured at the panel joints. Therefore, the test cleaning was initiated cautiously.

previous test cleaning had been removed; however, the original stains were not. After the test cleaning, it was determined that the source of the stains was likely attributed to a material inside the limestone panels that is bleeding through the stone at the pin locations. Due to the nature of the source of the staining, it is probably not possible to permanently clean the panels.

Figure 4: Stains on newer limestone panels below the third floor of the E Building

It was decided by The World Bank and the engineer that the stains on the limestone panels below the third floor were not easily removed. Removal of the stains would not be included in the scope of work for the façade restoration.
