# Repairs to the Primary Tanks at a Wastewater Treatment Plant

**A**s part of the City of Grand Rapids, Michigan, Capital Improvement Plan, the city required an assessment of the condition of four of their 16 wastewater treatment plant's oldest primary settling tanks (circa 1954). The condition assessment was to determine the cost for rehabilitative repairs and useful service life.

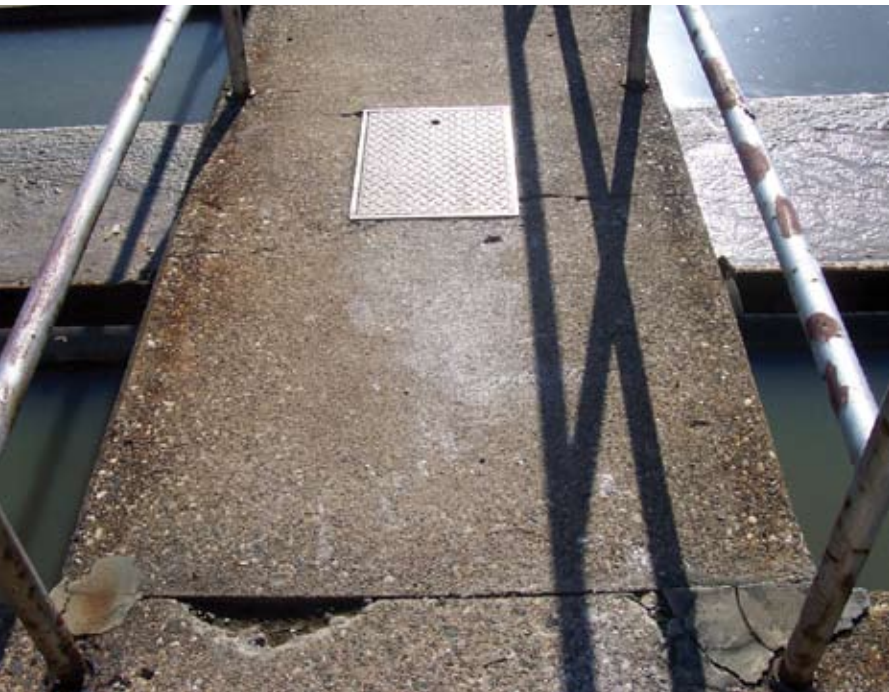
*Original catwalk*

Considerable deterioration also occurred under the portion of the entire catwalk that overhangs the divider wall. Water from the surface leached through existing cracks along the overhang portions. Carbonate stains on the underside of the catwalk overhangs and concrete spalling from the underside of the catwalks had fallen into the process water. Water accumulating on the catwalk surfaces also leached through existing cracks. Existing unmaintained cracks allowed chloride ions to penetrate through and corrode reinforcing bars, which caused spalling. The undersides of the

The walking surface of the catwalk contained isolated areas of deteriorated and crumbling concrete. Asphalt material was used to patch areas where significant deterioration left an uneven walking surface and potential trip hazards to the plant staff. Numerous spalls occurred along the top edge of the overhang, especially at the bases of handrail posts where they were embedded into the concrete. The bases of the posts were exposed at spalled locations and the metal severely corroded. The main catwalk was in poor condition and its durability very limited. Much of the cement paste around the aggregate eroded away to the point where aggregate was loose and concrete crumbled in several locations. Edges of the supported catwalk spalled away from the original substrate at various locations along the catwalk overhang.

The handrail extends around the entire perimeter of the tanks and along both edges of the main catwalk. Widespread corrosion was evident on horizontal rails as chlorides from deicing chemicals had corroded the bases of the handrail posts, which also corroded the embedded portion of the post and resulted in spalling the concrete edge of the catwalk and channel slab.

Repairs to the existing concrete deterioration on the access catwalks over the divider walls were performed. This included edge spalls, delaminating surfaces, existing patches, repairing leaking cracks and joints in the walkway, as well as a cementitious coating to reestablish a sound substrate and smooth walking surface.

Finally, replacement of the entire handrail and other steel operation platforms and ladders at the B-Section tanks was carried out. These were removed and replaced with stainless steel to match other areas of the plant.

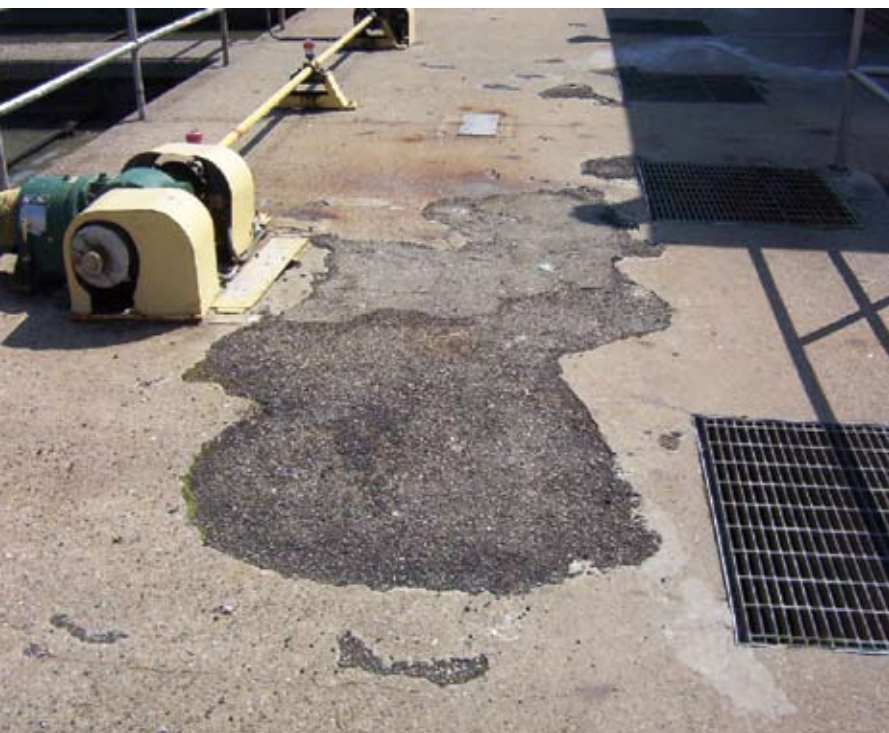
The top surface of the slab had widespread freezing-and-thawing damage and the concrete was severely deteriorated. Cement paste eroded such that the coarse aggregate was significantly exposed, and heavy scaling existed in some areas. Concrete degradation was noticeably evident in numerous

*Original slab*

locations throughout the surface; hence, several bituminous patches scattered over the slab surface. Based on visual observations from coring, layers of horizontal cracks appeared within the top 2 to 3 in. (5.1 to 7.6 cm) of the concrete core. The top layer of slab reinforcing was visibly corroded. This appeared to substantiate the horizontal cracking as observed through the core.

From the underside of the slab, significant cracking with carbonate stains covering most of the area was observed. Concrete spalls on the slab underside were noticed and the bottom layer of reinforcing was exposed and corroded. Concrete spalls are also prevalent along the bottom edge of the slab support beams that span between divider walls and over the influent weir openings.

Additionally, full replacement of the influent and effluent channel slabs and main catwalk with a new cast-in-place reinforced concrete slab with long-term durability characteristics was designed. This included full replacement of the supporting beams spanning between divider walls after demolition of the influent slab revealed significant deterioration. Epoxy-coated reinforcing bars, fibers to control microcracking, slag, and a 100% solids sealer was used for further durability to increase the overall service life. PVC conduit was embedded in the channel slabs to feed other areas of the plant as well as motors and equipment that controlled the primary settling tanks.

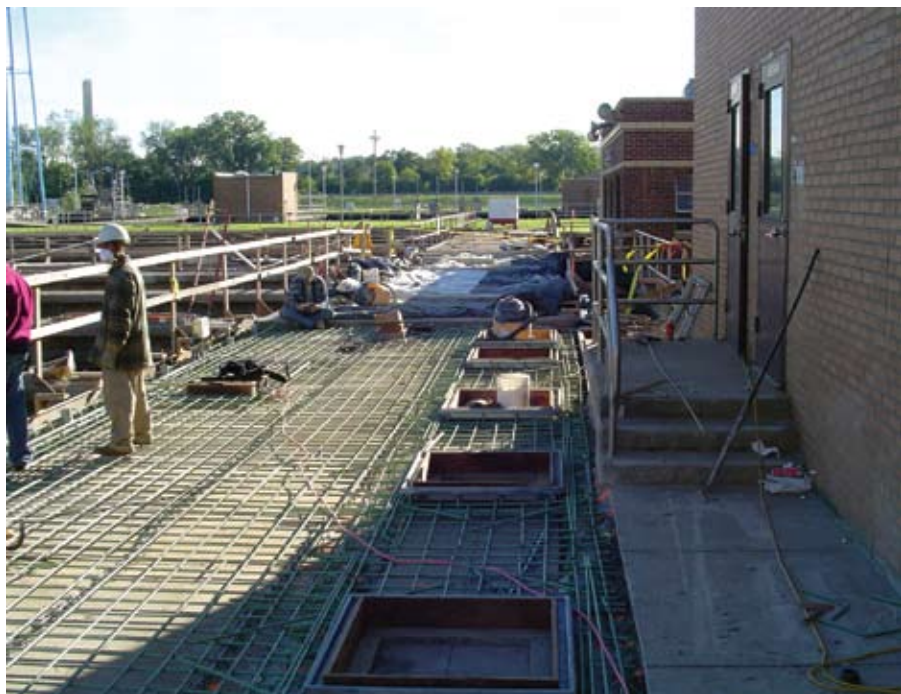
*During construction (forming and steel placement for new slab)*

After demolition, the supported slabs were formed and poured with conventional concrete with 15% substitution of slag and fibers to control shrinkage cracking. Other miscellaneous concrete patching was performed along with waterproofing. New metal grates, frames, handrails, and other equipment were installed.

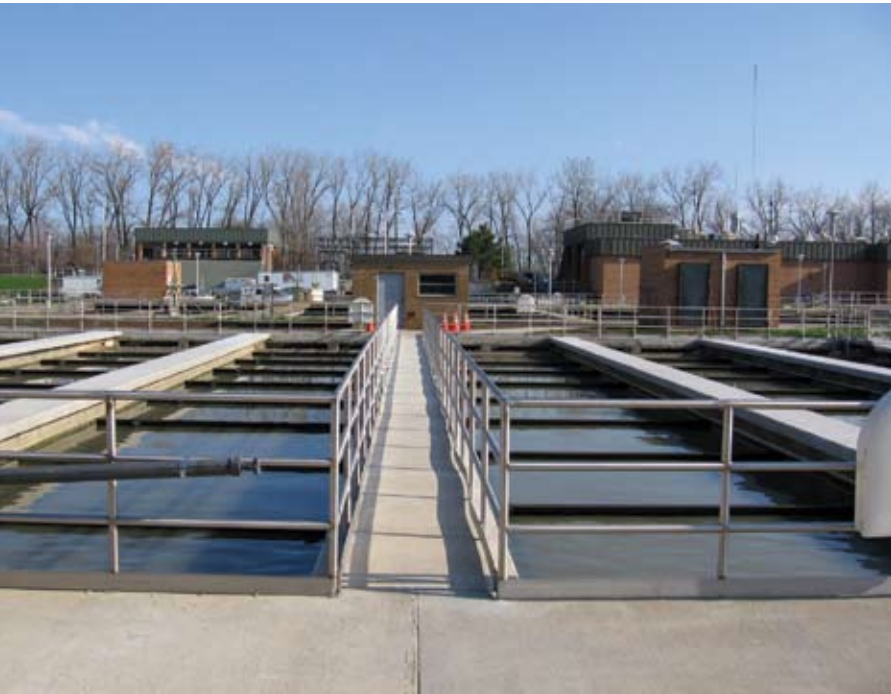
*New catwalk*

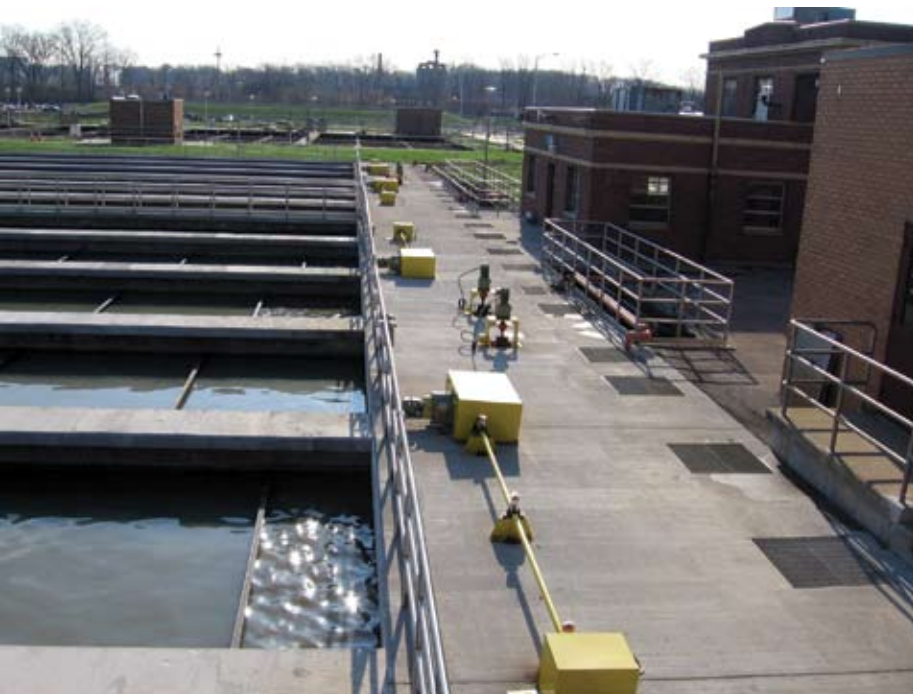
*New slab*

Special features used in the rehabilitation of the primary settling tanks incorporated durability characteristics in the materials selected to meet the project objective of continuing long-term serviceability of the tanks. Concrete durability included 5000 psi (34 MPa) concrete, slag cement, low water-to-cement ratio, and air-entrainment and corrosion inhibitor admixtures. Reinforcing bars in new or existing slabs were epoxy coated. Polypropylene fibers were used in the concrete to minimize shrinkage cracking.
