Half-Cell Potential Corrosion Survey Aids Repair Design

440 West Condominium Plaza Deck Repair

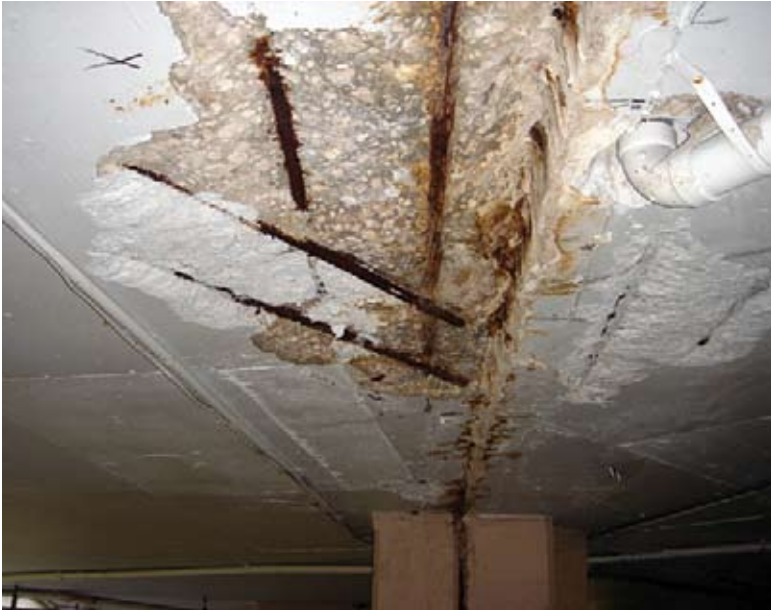
Fig. 5: Corroded steel in 440 West Condominium

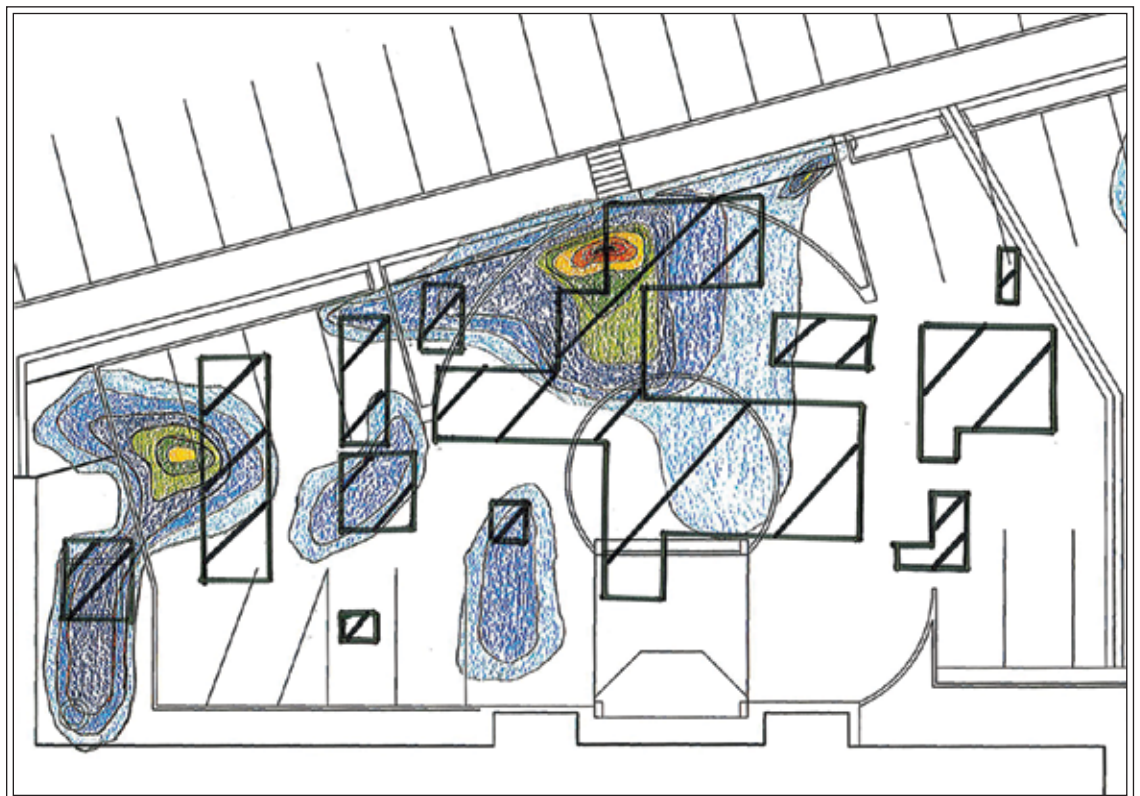
On-site potential measurements varied between -224 mV and -510 mV relative to the reference cell. All readings were more negative than -200 mV, indicating that the reinforcing steel throughout the test area was susceptible to corrosion damage.

- It is important to note that no point within the test area produced a potential measurement more positive than -200 mV. As a result, there appeared to be no safe areas for the reinforcing steel: only areas of medium to severe corrosion risks;
- When the data was plotted on a map of the test area, hot spots of increased electrical potential appeared;
- The colored areas and hot spots indicated where there was a greater potential for corrosion to

occur than on the rest of the deck. As stated previously, the entire area was susceptible to corrosion. The colored areas (refer to Fig. 6) represent those sections that appear to be most vulnerable; and

- Based on the test results, the Far West, Far East, and North-Central locations exhibited the greatest potential for corrosion.

When the concrete repairs that were performed in Work Area A were mapped and overlaid on top of the corrosion potential map, correlations between suspected corrosion potential and actual concrete repairs appeared. Concrete repair areas are shown as the hatched areas with thick black lines (refer to Fig. 6).

Spalling and cracking due to corrosion was most obvious at the North-Central and Far-West side of the test area. However, the steel in that area generally appeared similar to steel in other concrete repair areas with a smaller measured electrical potential.

Additionally, the area where the greatest electrical potential was observed corresponded to the area of the greatest corrosion. The hot spot in the North-Central area contained multiple pieces of reinforcing steel that were so badly corroded that they required replacement. No other section within the test area required replacement.

Fig. 6: Half-cell corrosion test with hatched concrete repair overlay

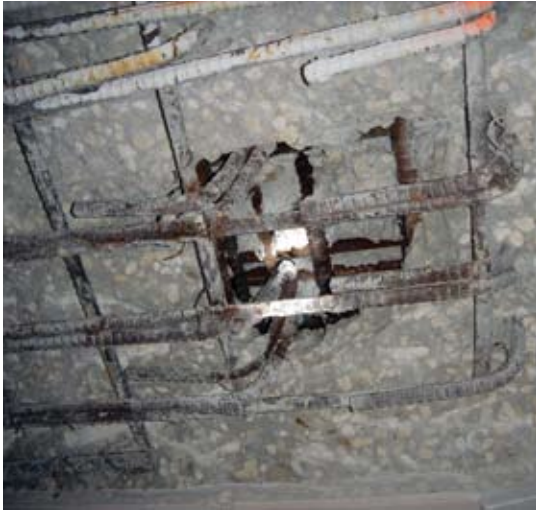
Fig. 7: Concrete and reinforcing steel being prepared for repair
