FIRE DAMAGE EVALUATION AND REPAIR OF PRECAST CONCRETE GARAGE

The evaluation of the extent of damage a concrete structure may have sustained from a fire, as well as the adequacy of affected members to remain in service, involves a systematic assessment of post-fire conditions. This article describes an evaluation of fire damage and subsequent development and implementation of repairs to the Woodlands Waterway Marriot Parking Garage located in Spring, TX.

Woodlands Waterway Marriott Parking Garage Evaluation and Repairs

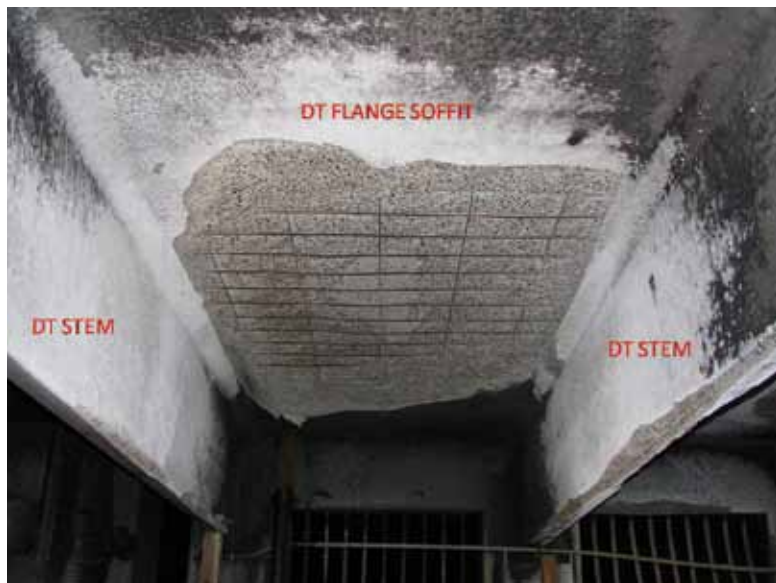
Detailed field observations revealed localized concrete spalls, cracks, and delaminations in the double tees, haunches, and wall panels. The most severe distress occurred in the double tee stems and flange soffits (Fig. 1). The flange soffit spalling was generally less than 1 in. (25 mm) and exposed portions of embedded welded wire reinforcement. Longitudinal spalls were noted at the corners of the stems, and lengths up to 10 ft (3 m) of welded wire reinforcement were visible. The spalls also exposed the bottom prestressing strand in several stems for lengths up to approximately 15 ft (4.6 m).

The spalling occurred due to the following material and structural response mechanisms¹:

1. **Thermal gradient:** During the early stages of the fire, rapidly heated double-tee flange surfaces expanded at a greater rate than the cooler underlying material, resulting in a significant thermal gradient and buildup of stresses near the surfaces. When the shear/tensile capacity of the concrete was reached, a failure plane developed and an outer layer concrete was disengaged.
2. **Restraint:** Upon heating, the surface concrete of the stem or haunches expanded in all directions. At corners, this thermal growth resulted in expansion from two orthogonal

Fig. 1: Double-tee flange soffit and stem affected by the fire

directions. This region of the corner was restrained by the relatively cooler, underlying concrete. Upon further heating, the tensile capacity of the concrete near the corner was reached, and cracking or expulsion of this portion occurred. A series of cracks, typically 1 to 3 in. (25 to 76 mm) from the corners developed, as the thermally growing member “shed” its corners.

Craze cracking was noted in vertical faces of the stems throughout the fire-affected area. Regions judged to have been located closer to the fire and thus to have experienced higher thermal exposure exhibited greater cracking. Craze cracking of surfaces reflect an irrecoverable shrinkage of a shallow zone of the paste matrix due to dehydration associated with the thermal excursion. This condition typically produces a fine, but very shallow and structurally inconsequential, network of cracks that does not impair the overall integrity of the affected member.

The spalled areas at stems, wall panels, and double-tee flanges were patched using conventional concrete repair methodologies. Patch repairs for corner spalls of the stems generally consisted of the removal of loose and unsound concrete, preparation of the exposed steel reinforcement, installation of stainless steel threaded rod anchors, and form-and-pour application of a polymer-modified portland cement-based patching material. The perimeter of the patch was saw cut to avoid feather edges. In addition to the threaded rod anchors, longitudinal threaded rods were installed along the corner spall repairs to control shrinkage cracking of the patch material. The spall repair at the flange soffit was accomplished using low-pressure spray-applied mortar (Fig. 2). Trowel-applied and form-and-pour repair techniques were considered; but given the overhead application, it was felt that the low-pressure spray technique would provide a higher level of assurance because the repair material was bonded to the sound concrete. Exposed steel reinforcement was cleaned by wire brush/hand methods and coated with an epoxy-modified cementitious material to improve bond with the repair material and provide enhanced corrosion protection.

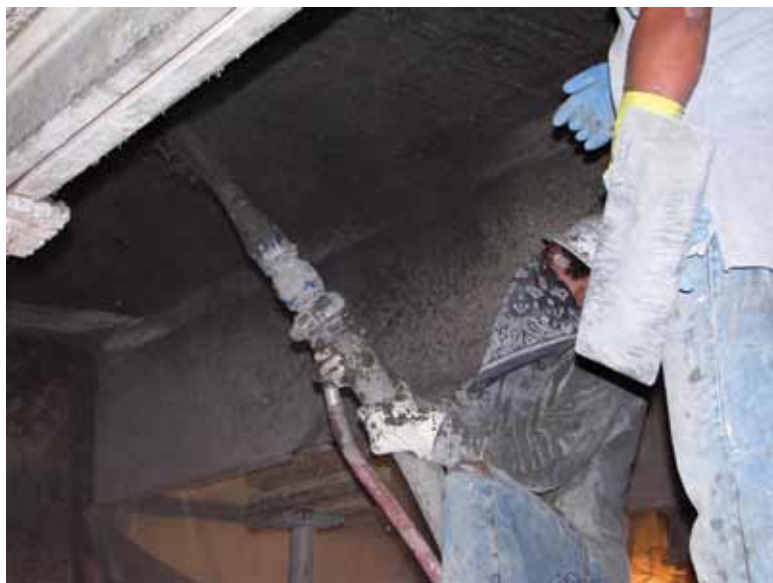
Fig. 2: Application of spray-applied mortar on double-tee flange soffit

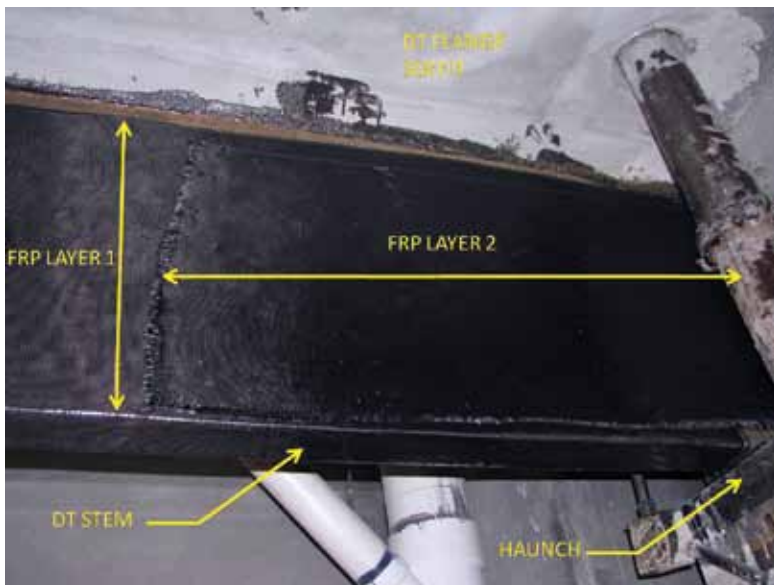
Results of the structural analysis indicated that the flexural capacity of the affected double tees was adequate to resist code-required design loads. The analysis, however, also showed that the shear

capacity of the double tees could be slightly inadequate. Therefore, it was decided to provide supplemental shear reinforcing over a portion of the double-tee span.

Fig. 3: Double-tee stem FRP repair

Design of the FRP system was performed following guidelines presented in ACI 440.2R-08.² Two plies, or layers, of a bidirectional carbon FRP system were used. The first layer consisted of a “U-wrap” configuration along the portion of the stem located approximately 15 ft (4.6 m) from

the support. This layer provided the necessary supplemental shear capacity. The upper end of the fabric was extended to within several inches of the flange soffit. In addition to providing the shear capacity, the fabric also served to confine the repair material for the corner spalls. The second layer consisted of a short section of fabric placed at the end of the stem. This layer was oriented in a plan view “U-shaped” configuration such that it extended around the end of the stem (Fig. 3 and 4) and for 3 ft (0.9 m) on each face toward the midspan of the member. The purpose of the second layer was to provide supplemental strength to a localized region of the stem exhibiting more extensive cracking.

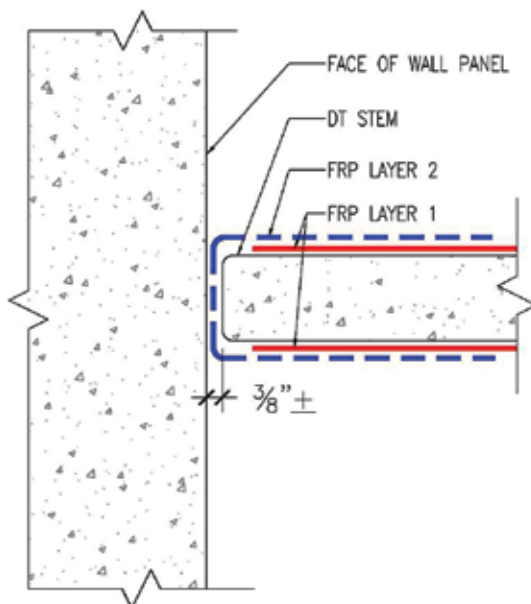
Fig. 4: (a) Schematic plan view of end of double-tee stem showing FRP layers; and (b) installation of FRP Layer 2

1. Patch materials along the stem corners were allowed to cure, and cracks 0.01 in. (0.3 mm) and wider were epoxy injected.
2. Surface preparation was specified to achieve a texture equivalent to ICRI Concrete Surface Profile (CSP) 3. Corners at the end of the stems were ground to eliminate sharp edges.
3. Initial cutting of the FRP material was performed in the presence of the fabric manufacturer.
4. A solvent was applied to the concrete surface immediately prior to epoxy adhesive application.
5. The FRP material was saturated in the epoxy adhesive.
6. After allowing the solvent to flash off the concrete surface, the epoxy adhesive was applied to the concrete surface and allowed to set for several minutes.

7. The first layer of FRP was installed and pressed into place.
8. The second layer of FRP was installed immediately after the first layer. Epoxy adhesive was applied to the end of the stem prior to the application of the second layer. Due to the tight gap between the end of the stem and the face of the wall, a sacrificial FRP extension wrapped on a piece of cardboard was used to facilitate pulling the FRP around the end of the stem.
9. All repaired areas were painted with acrylic-latex coating.
