# GUGGENHEIM MUSEUM: LABORATORY AND FIELD EVALUATION OF CONCRETE REPAIR PRODUCTS

BY AMANDA THOMAS TRIENENS, GLENN BOORNAZIAN, AND NORMAN R. WEISS

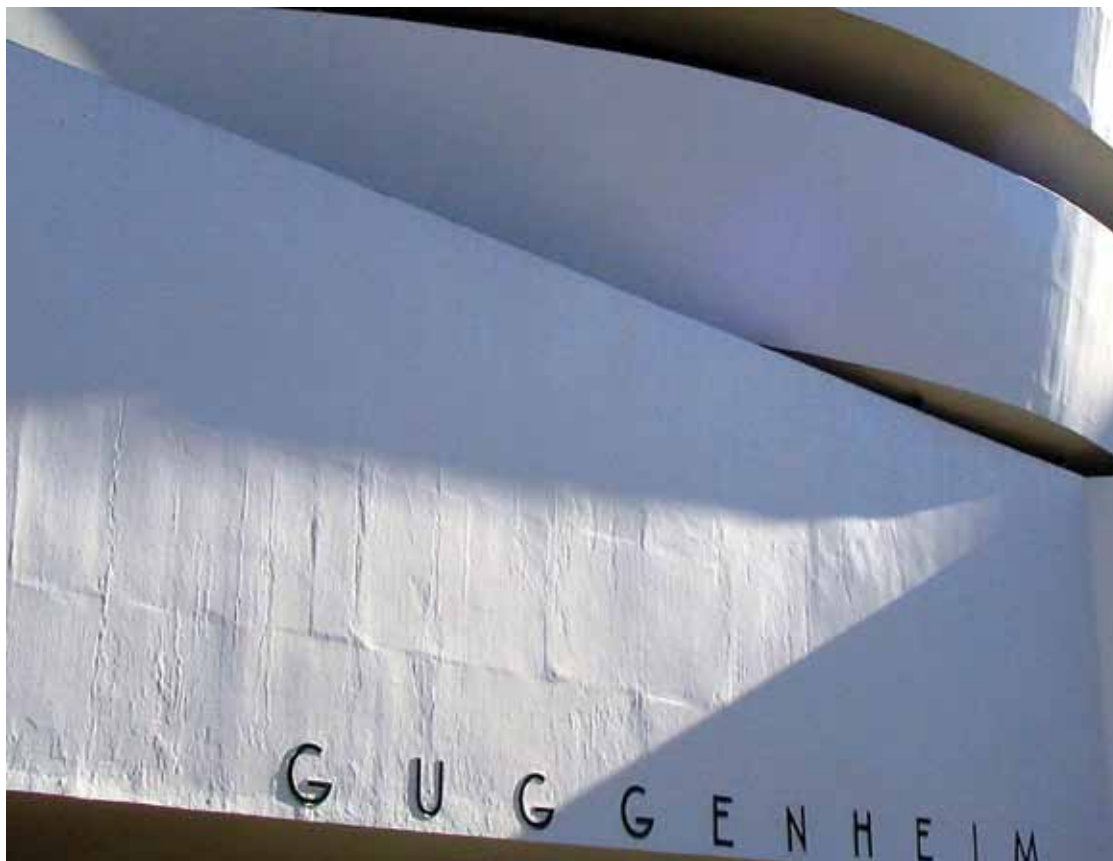
*The Solomon R. Guggenheim Museum before restoration*

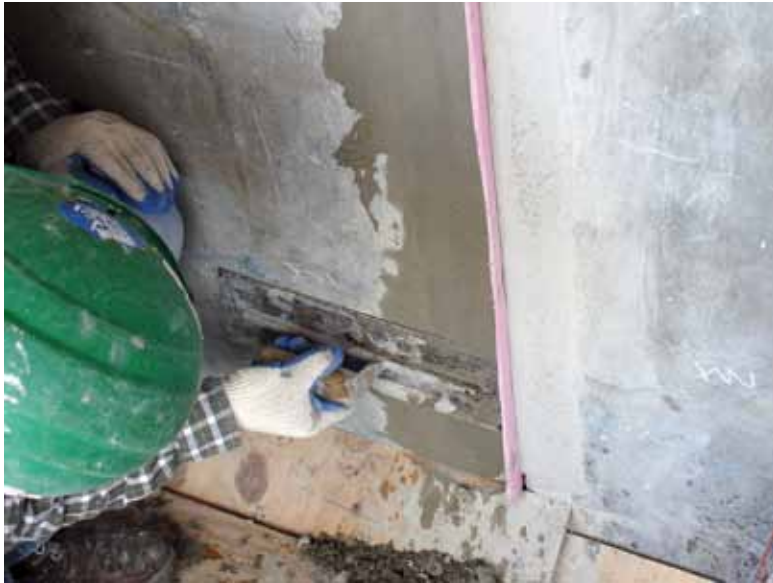
*In-place mockup of repair materials being conducted*

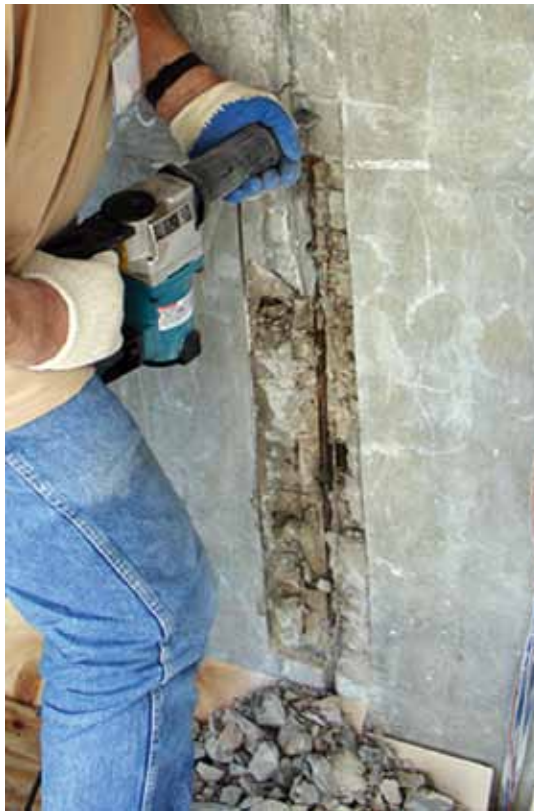
*Demolition for in-place mockup*

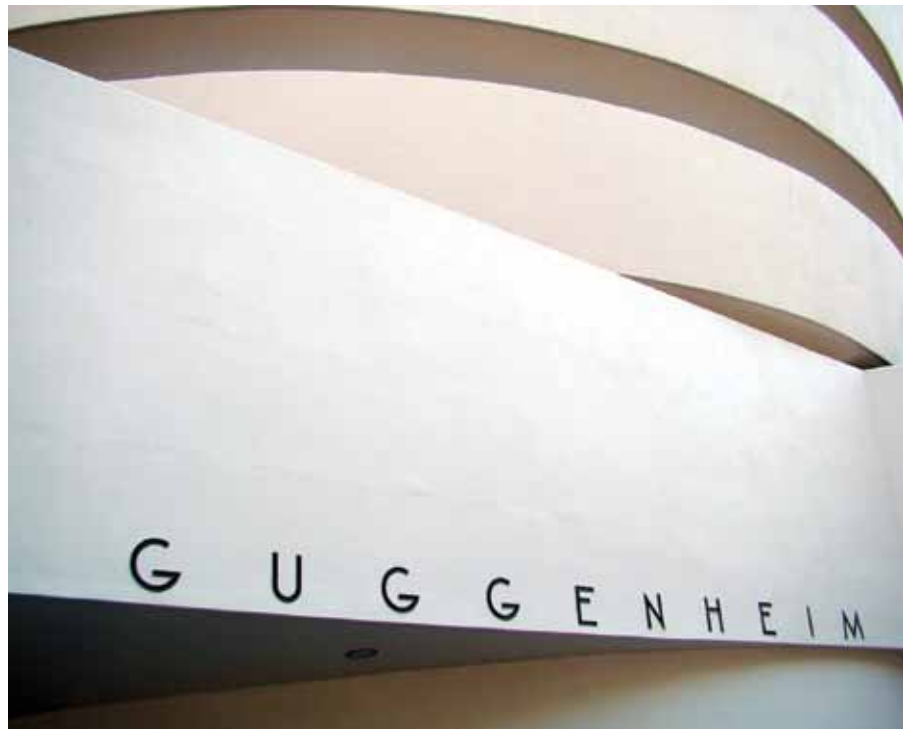
*The Solomon R. Guggenheim Museum after restoration*
