NEW YORK HALL OF SCIENCE GREAT HALL RESTORATION

BY ASIM JABBAR AND JEFF BINDER

New York Hall of Science Great Hall

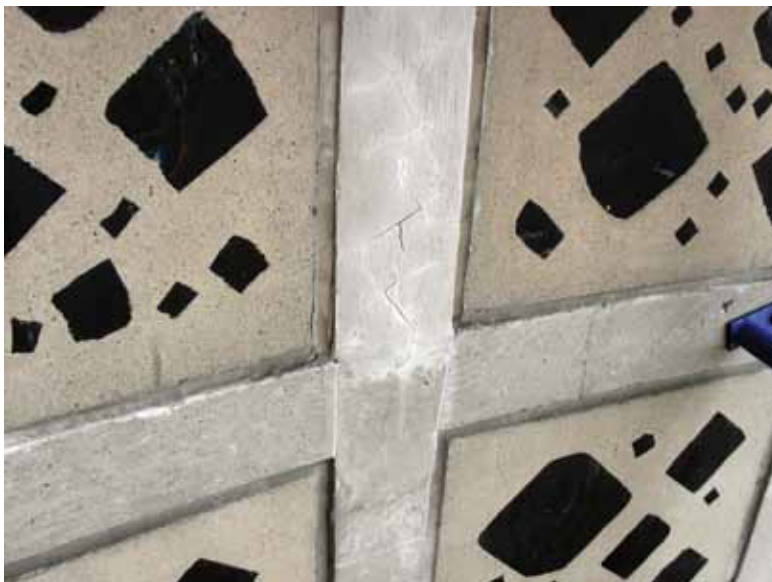
Deterioration could be seen at various spots on the building, mainly due to inadequate reinforcing steel coverage

Areas of the exterior cast-in-place structure that hold the panels together were showing signs of wear. Concrete spalling and deterioration, mainly due to inadequate reinforcing steel coverage, were seen at various locations. The precast panels showed cracking between pieces of glass and the edges of the panel, and the surface sand finish was being washed away.

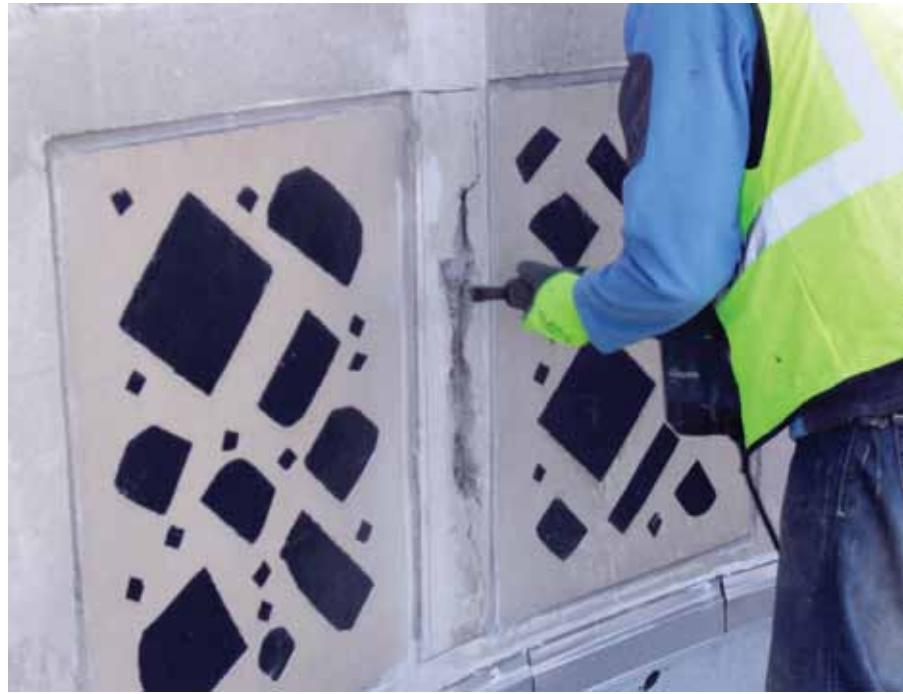
The first step was to chip out delaminated concrete until sound concrete was reached

The initial repair step was saw-cutting the concrete at the limits of the repair based on the sounding report. This, along with the duct tape, allowed the demolition crew to identify the areas that needed chipping without referencing the sounding reports and gave the repair a clean cut on each end. During demolition, the delaminated concrete was chipped with electric chipping hammers and chisel bits were altered to provide more control and less vibration until sound concrete was reached and the front layer of the No. 8 reinforcing steel was exposed. If more than 50% of the reinforcing steel was exposed, a 2 in. (50.8 mm) wide channel was chipped out behind the reinforcing steel so it could be cleaned before new concrete was placed.

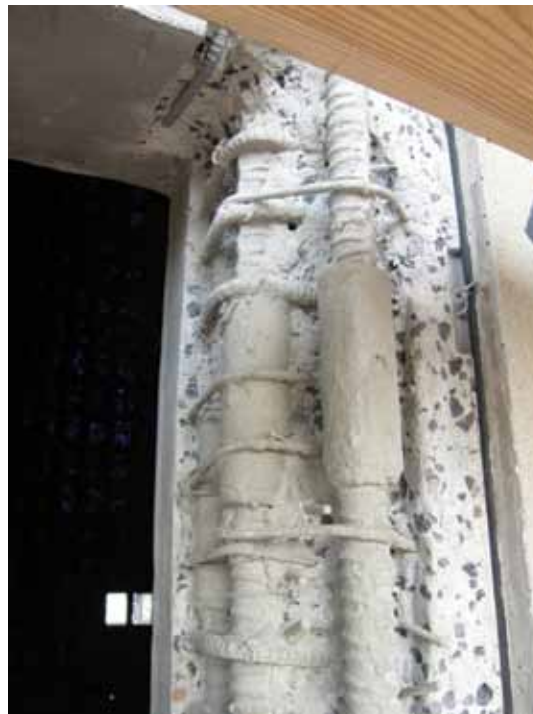
Once the steel was cleaned, it was immediately primed for corrosion protection

Cleaning the rusting bars, however, was challenging, as wire wheel grinders could not clean the back of the bar with just a 1 in. (25.4 mm) clearance behind and a 2 in. (50.8 mm) channel along the bar. The repair team decided to use abrasive blasting to target the back of the bar with aggregate rebounding from the sound concrete. The solutions worked well and cleaned the bars to bare metal per specifications. Once the steel was cleaned, another crew primed it for corrosion protection prior to patching.

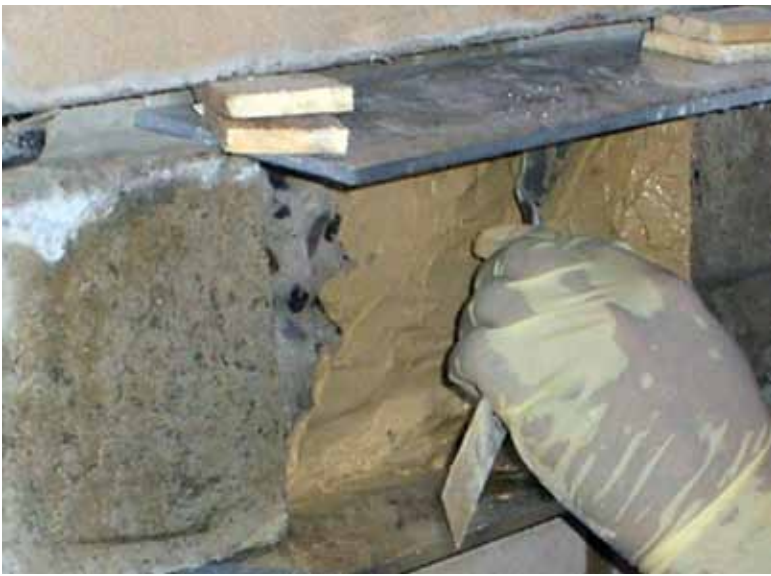
To ensure that the sides of the patches stayed square and in line with the existing substrate, small pieces of methylmethacrylate were set in place to give applicators a side edge for the patch

line with the existing substrate, small pieces of methylmethacrylate were used to give technicians a side edge for the patch. Once the top coat was finished, the sand was applied. Because the sand was the key to making the patch match the existing substrate, it became very important to find the correct sieve for each repair to filter the larger aggregates. Once prepared, it was applied by pressing a sand-covered trowel into the finished surface.
