# NONDESTRUCTIVE EVALUATION AND REPAIR OF CONCRETE MASONRY UNIT WALLS

BY HEMANT S. LIMAYE AND ASHOK M. KAKADE

## A CASE HISTORY

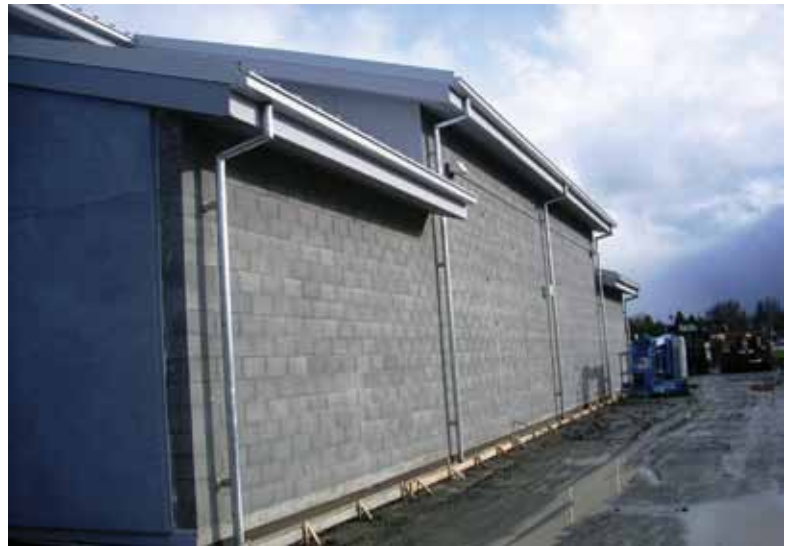
A one-story building using the CMU walls was under construction (Fig. 1). As part of the quality assurance program, four cores were removed by the testing agency to observe the condition of the grout from a completed CMU wall of the building. Two of the cores showed unacceptable quality of the grout (Fig. 2); hence, questions were raised regarding the quality of the grout in the rest of the masonry units of the wall. The wall was built with a standard 12 in. (305 mm) CMU and the construction, including placement of the grout, was observed by the testing agency. So, in this case, the existence of the grout was not in doubt but the quality of the grout was questionable. Based on

Fig. 1: Exterior view of the CMU wall

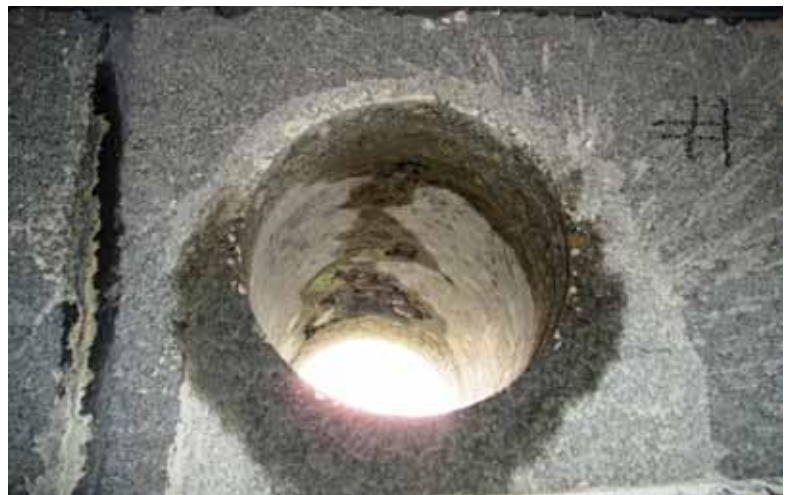
Fig. 2: View of the core hole showing honeycombing of the grout on the upper portion

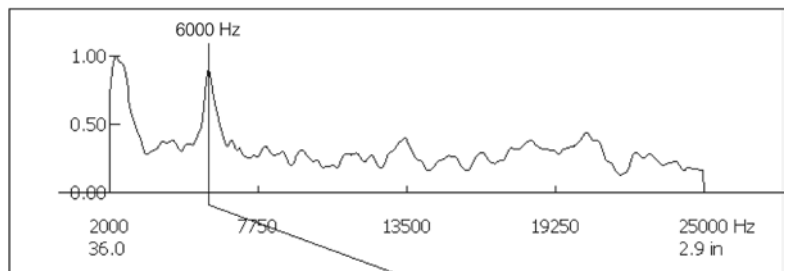
For each test, the amplitude ratio versus frequency graph was monitored using the impact-echo equipment. Results were classified based on the quality and repeatability of the obtained signals. Figure 3 shows the representative graph of amplitude versus frequency, where the grout in the cavity was well consolidated and bonded. A frequency of 6000 Hz corresponds to a thickness of 12 in. (305 mm) based on a propagation velocity of 12,000 ft/s (3658 m/s). In theory, the test response obtained should be identical for all the well-grouted cells. Significant deviation from the “normal” response indicates an anomaly, such as a void or debonding of the grout. Figure 4 shows a graph with a primary frequency of 4444 Hz, indicating an anomaly.

Fig. 3: Impact-echo test result indicating acceptable grout condition

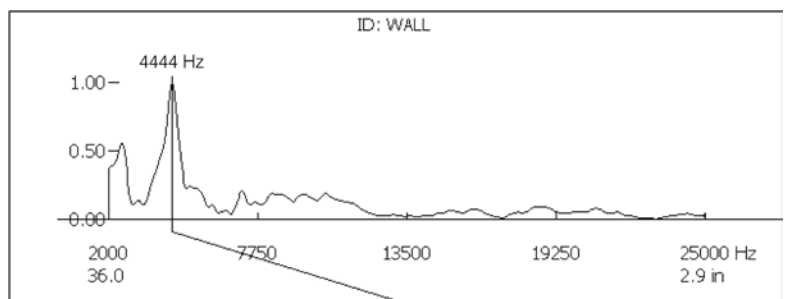
The impact-echo testing indicated responses representing honeycombing and debonding at the interface of the CMU and the grout. Sometimes the debonding was at the interior face or at the exterior face or sometimes at both faces. At some locations, results were nonrepeatable within the surface area of each cell, indicating a variation from the normal response. Locations with potential anomalies and inconclusive results were identified on the wall for further evaluation. Most of the significant anomalies were detected between the fourth and sixth courses from the top in the middle and right portions of the main wall, as viewed from the interior. Details of the grout placement were not available for review to determine the cause(s). No significant anomalies were detected in the two rooms at the tested locations.

Fig. 4: Impact-echo test result indicating unacceptable grout condition

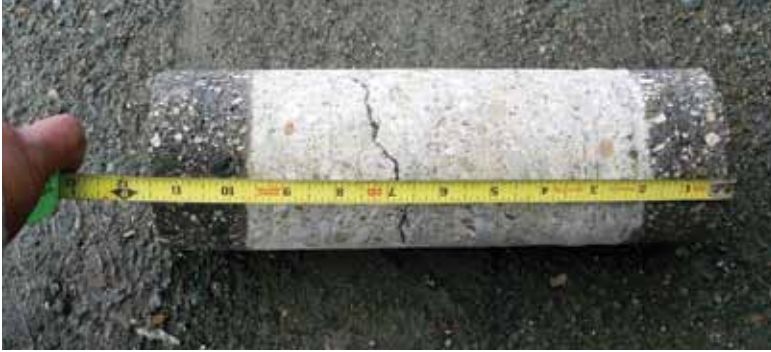
To confirm the test results, two cores were removed from the cells with potential anomalies. The cores and their respective core holes showed cracked grout and a delamination at the interface of the CMU and the grout (Fig. 5 and 6). A partial depth core was removed from the cell to observe the grout condition around the reinforcing steel. At the partial depth core, the exterior face of the CMU was delaminated, but the grout around the vertical reinforcing bar was

Fig. 5: The core with a crack in the grout

Based on the impact-echo test results and observations of the cores, the recommended repair method included epoxy injection of the grout in the

suspected areas. The repair material chosen was a two-component epoxy adhesive with low viscosity and minimal heat generation during curing. Because there was a possibility of debonding of the grout at both the exterior and interior interfaces, it was necessary to inject the repair material by drilling holes in each cell from both sides. It was also necessary to identify the cells with reinforcing steel prior to drilling of the holes. The method allowed not only the achievement of good distribution of the repair material, but also the avoidance of damaging buildup of internal pressure. As a precaution, epoxy injection was first performed in a trial area to ensure the proper operation of the system and to ensure that not too much of the repair material was getting absorbed by the CMU to cause bleeding and discoloration.

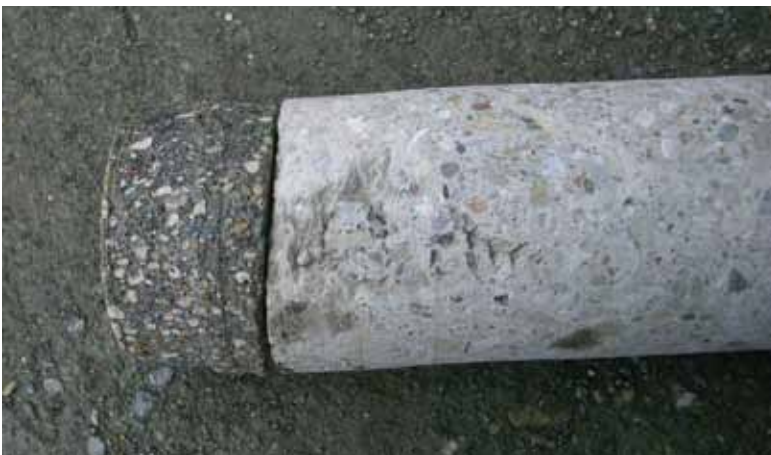
Fig. 6: Core showing the debonding of the grout at the interface of the CMU and grout

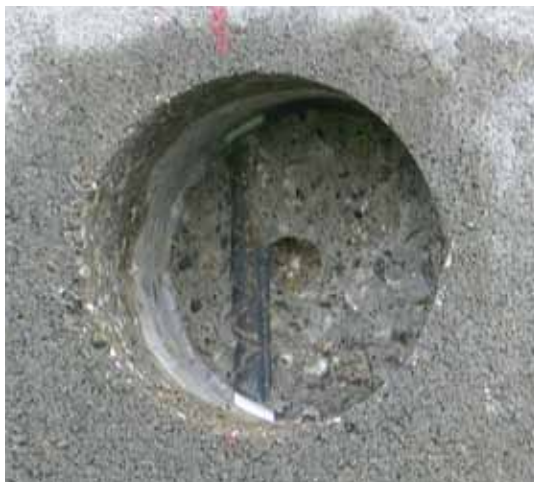
bonded adequately (Fig. 7). In addition, a core was drilled and removed from the cell where the impact-echo testing showed acceptable grout condition. The core showed well-consolidated and bonded grout, thus confirming the test results.

Fig. 7: Partial depth core showing good bond around the reinforcing steel
